Inspection Report

1234 No Where Ln
Plano TX 75024

Built Right Home Inspections

PROPERTY INSPECTION REPORT

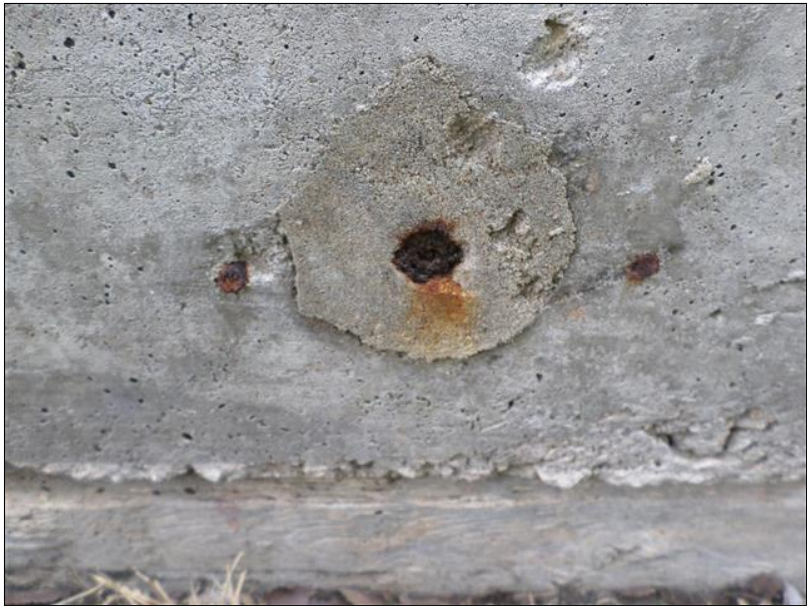
A. Item 1(Picture)

- (4) Foundation post tension cables are visible and show signs of rust. Recommend sealing cable ends to prevent further rusting and damage to foundation.

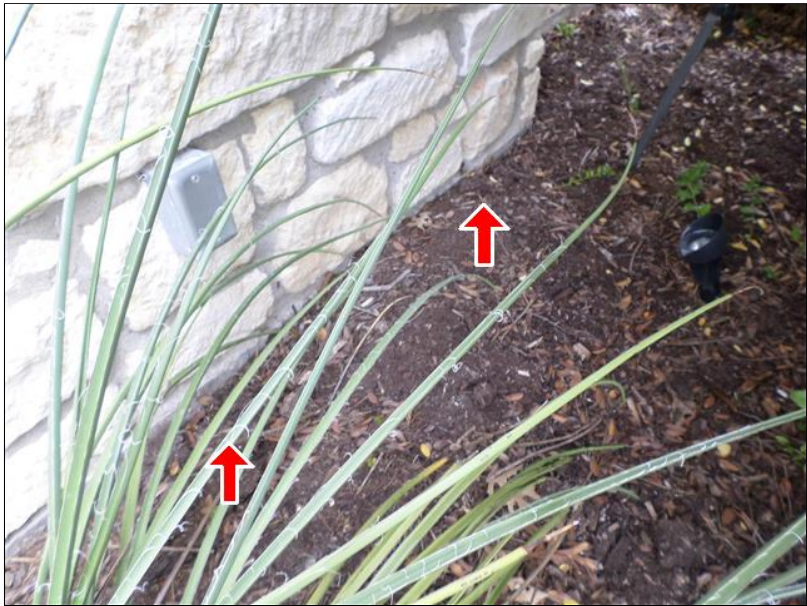
B. Item 1(Picture) Front of home

- (1) High soil levels in front yard. The foundation is not visible in some areas. There should be 4-6" of foundation visible to help prevent water or pest intrusion.

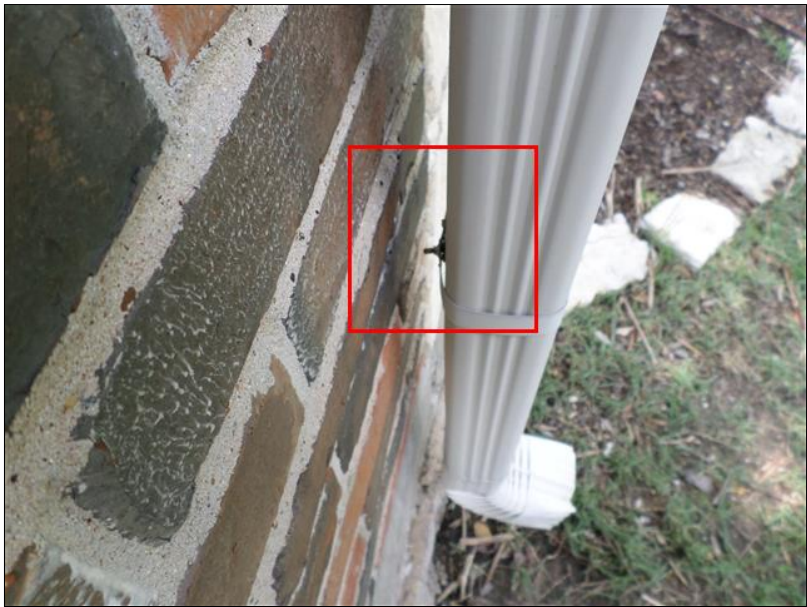
B. Item 2(Picture) Multiple locations

(2) The downspout is loose and needs securing to the wall at multiple locations around the home.

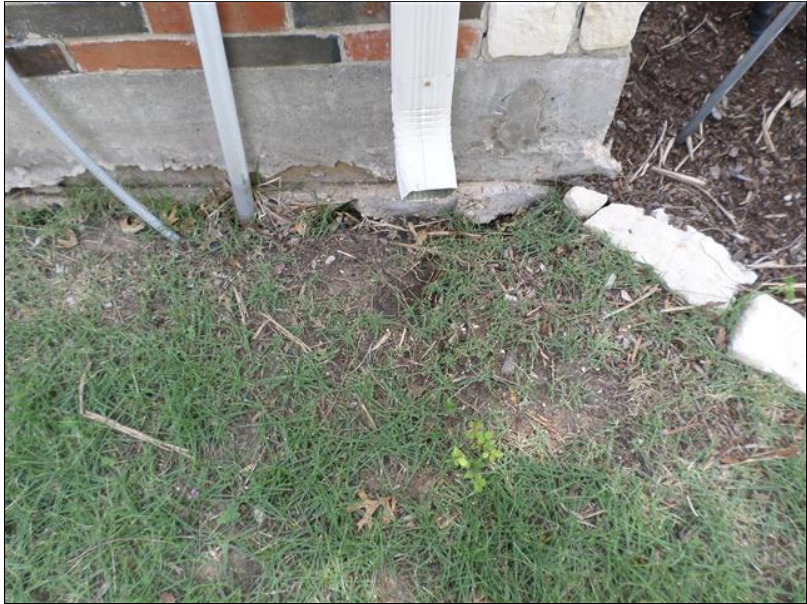
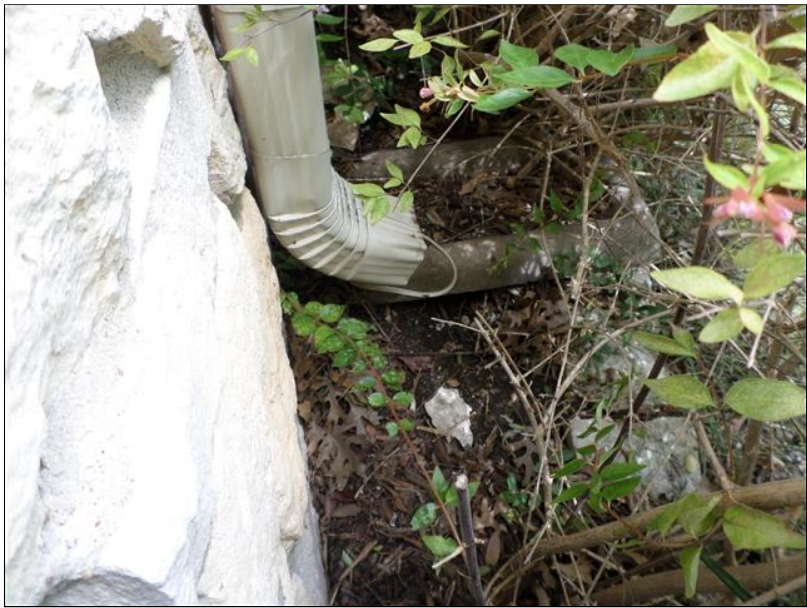
(3) Gutter down spouts should empty onto a splash block several feet from the foundation to prevent water intrusion and/or erosion. There are multiple locations around the home that need improvement.

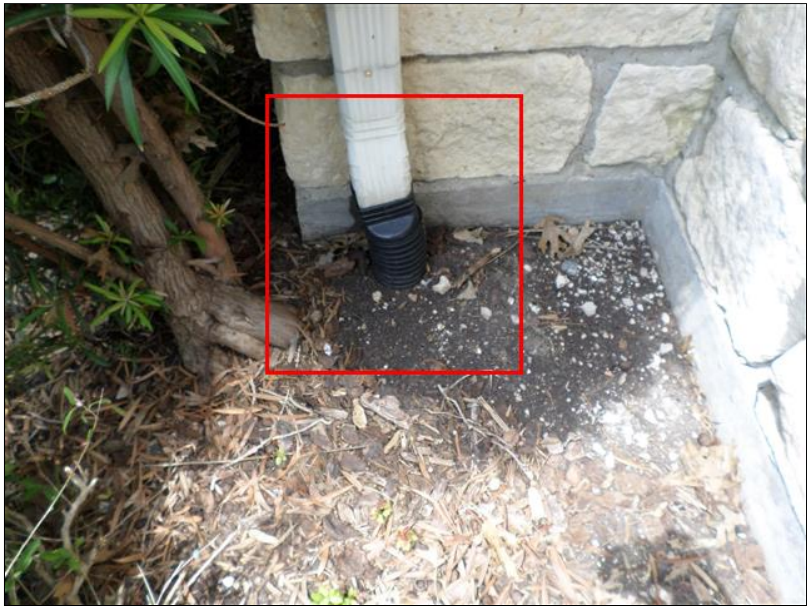
B. Item 5(Picture) Front of home

(4) Some gutters empty into drains below the ground level. Unable to determine if the drains will operate as intended. Recommend observing area during heavy rain to assure the drains are operating as intended.

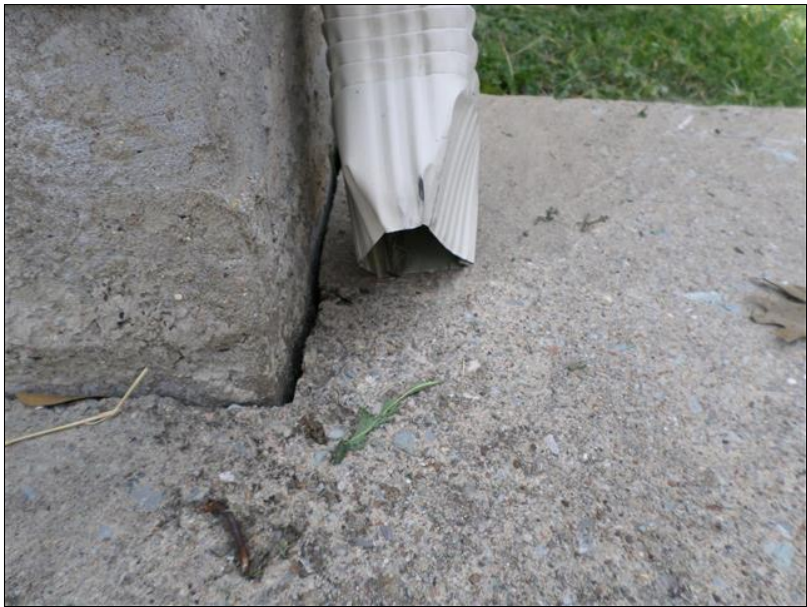
B. Item 6(Picture) N/W corner

(5) Gutter damaged near garage, could cause obstruction and cause gutter to not drain.

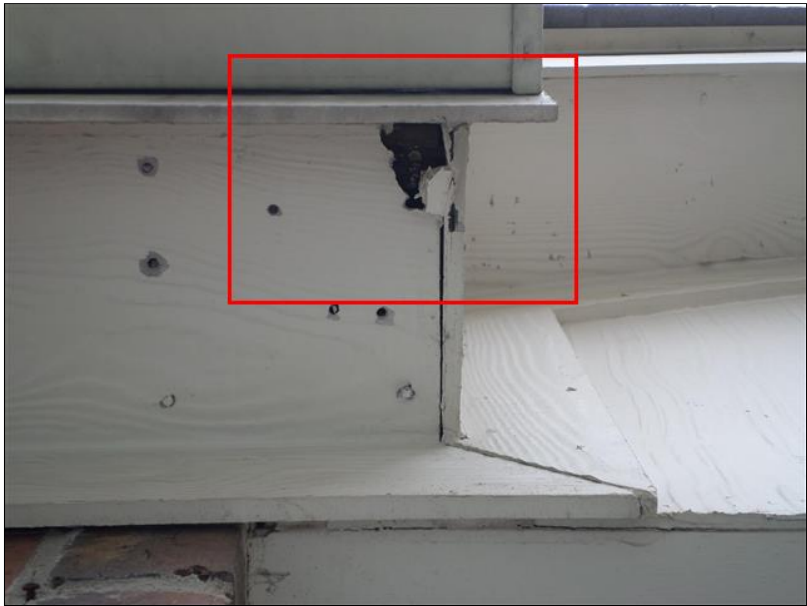
D. Item 3(Picture) South side pool area

(2) Soffit had damage near south side of pool. Recommend repair to prevent pest from entering.

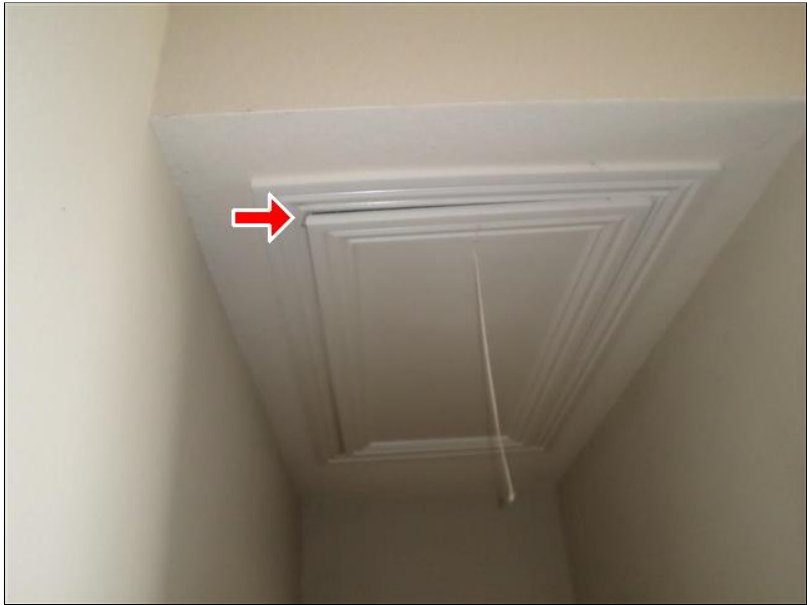
D. Item 4(Picture)

(3) The east attic access does not make a good seal. Recommend qualified contractor insulates door to prevent heat and cooling loss.

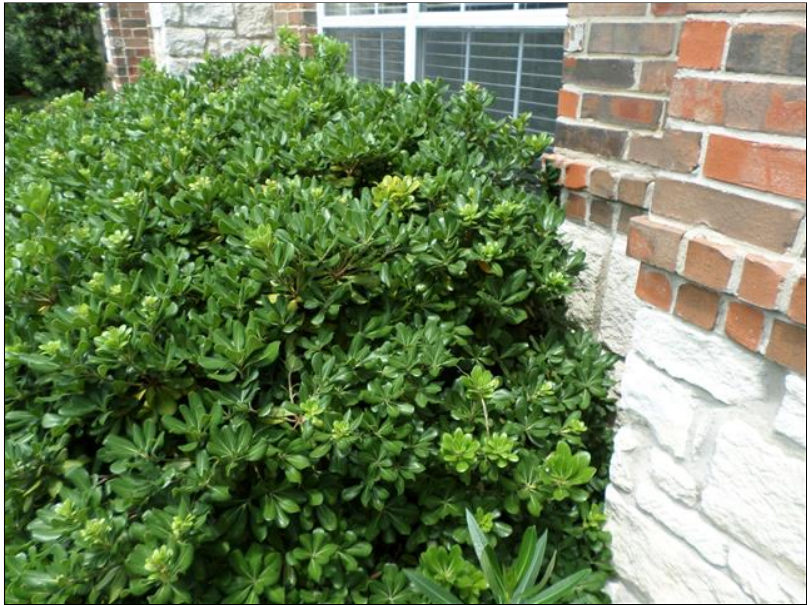
E. Item 8(Picture) Front of home

(3) Due to thick foilage, some areas were able to be seen. Recommend keeping foilage trimmed back away from the exterior walls.

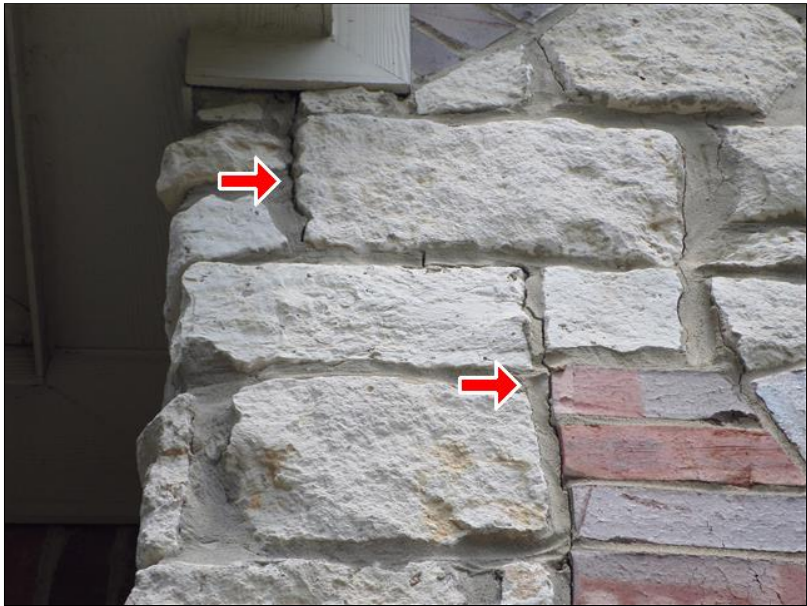
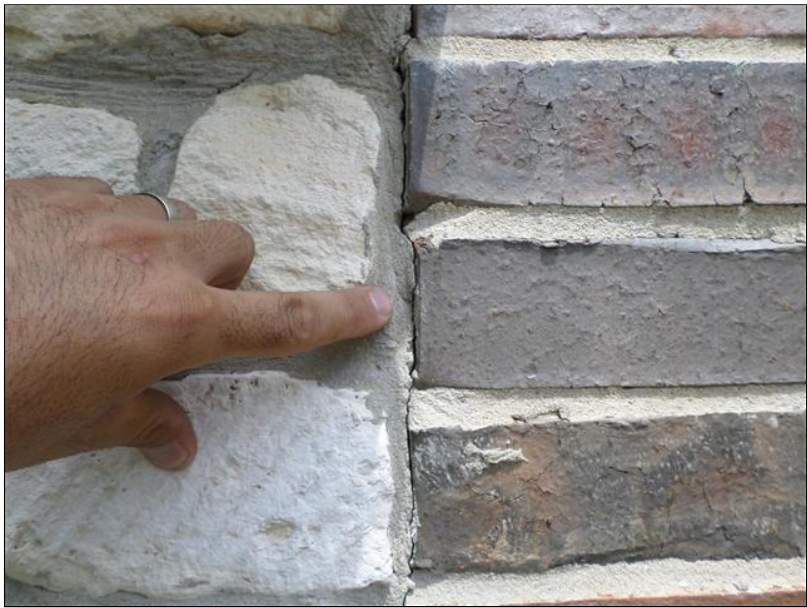
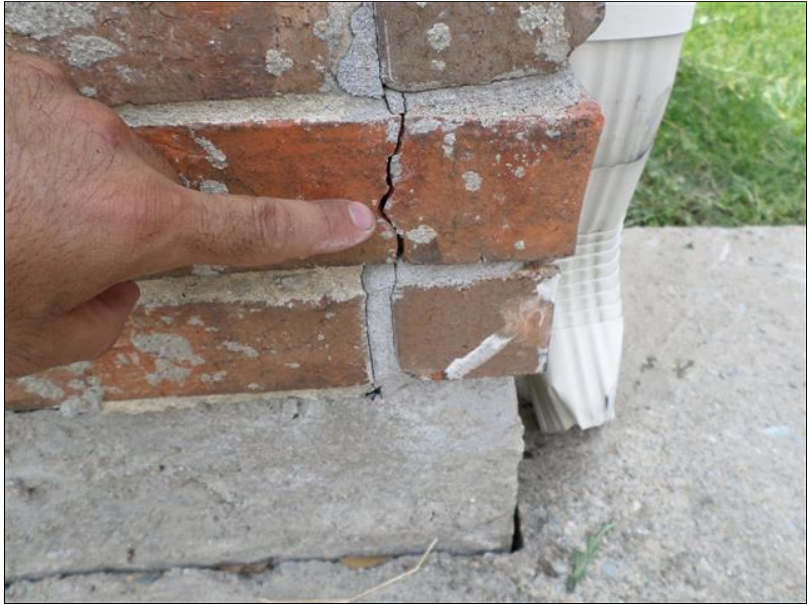
(4) Brick exterior walls had stepped cracking visible in mortar joints. The inspector recommends patching cracks with an appropriate material to avoid continued damage from freezing moisture. This condition is cosmetic only at this time.

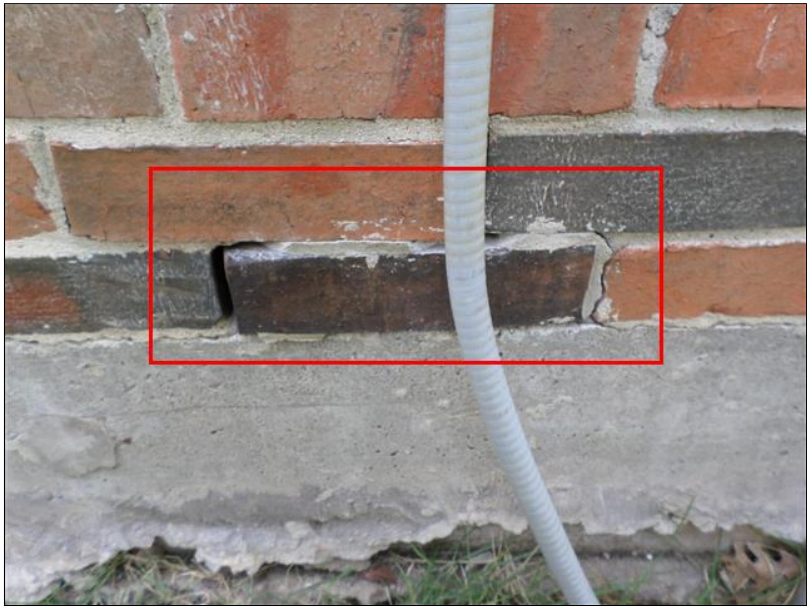
E. Item 12(Picture)

(5) Multiple bricks were loose at lower wall in several locations, east and west walls. Recommend qualified contractor repair to prevent water intrusion.

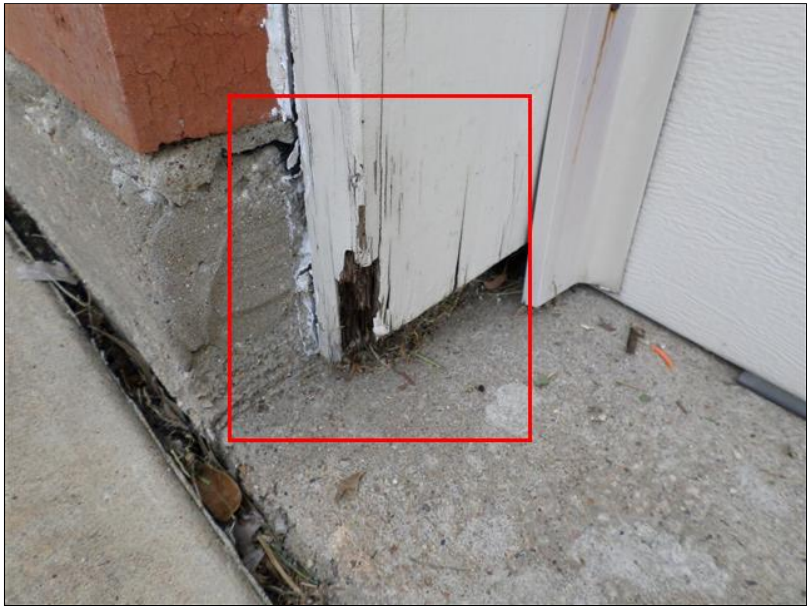
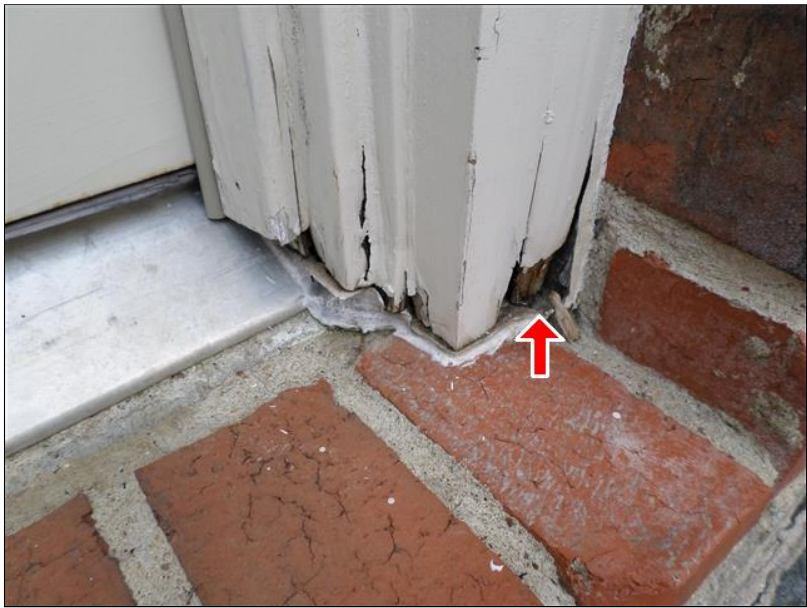
(7) Several areas of wood rot on exterior near door ways. Recommend qualified contractor repair.

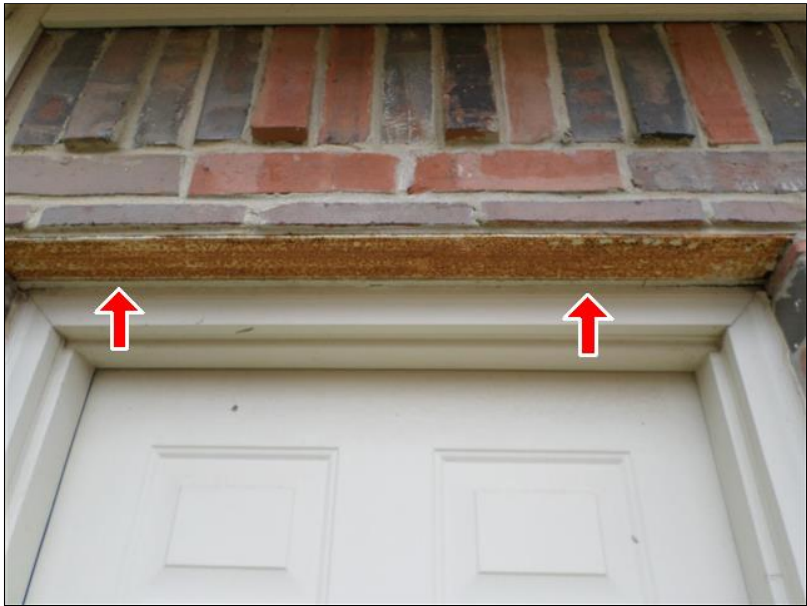
E. Item 17(Picture) North side of home

(8) Steel lintels installed to support brick above a door or window openings had significant rust which has affected the wall structure in these areas. Further damage will occur unless this condition is corrected. There are multiple locations around home that need this corrected to prevent future damage.

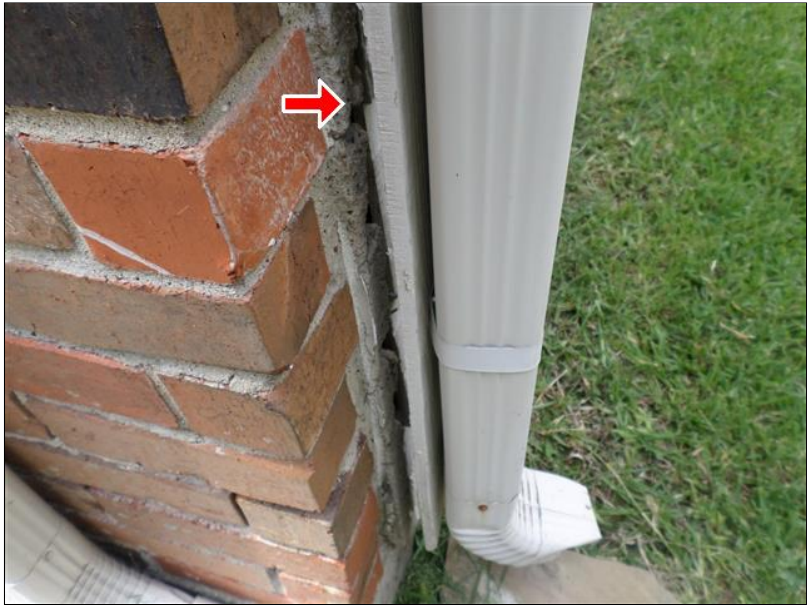
E. Item 18(Picture) N/E corner of home

(9) Trim has been pulled loose from bricks at N/E corner of home. This area has gutter attached and could cause further damage if not corrected. Recommend qualified contractor repair.

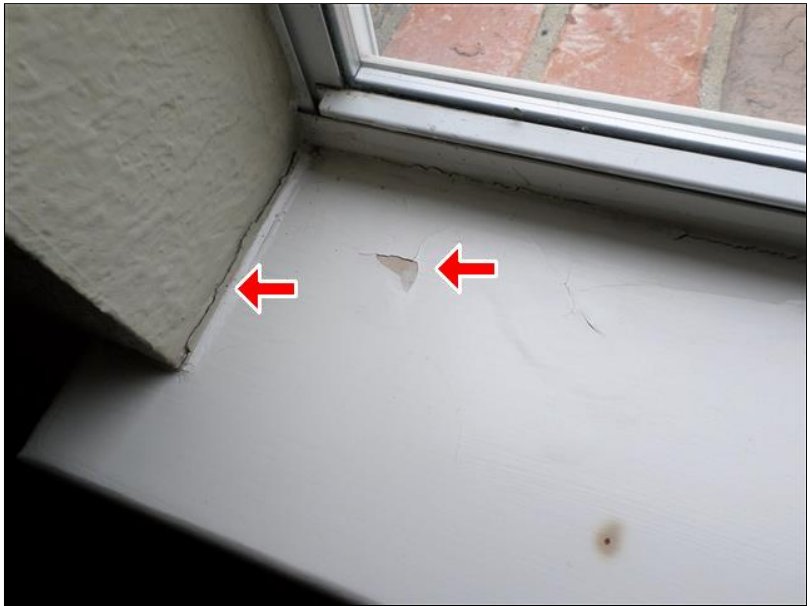
E. Item 19(Picture)

(10) Several areas on interior need painting and/or caulking around window sills.

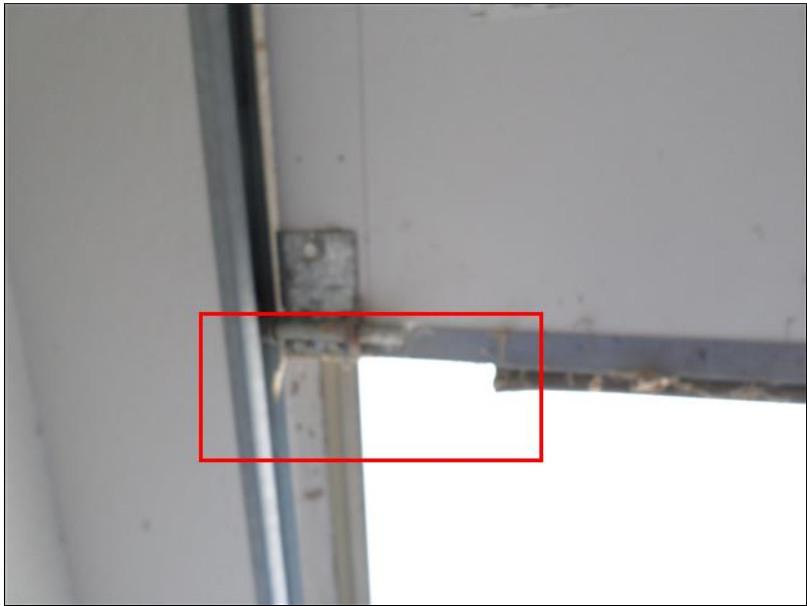
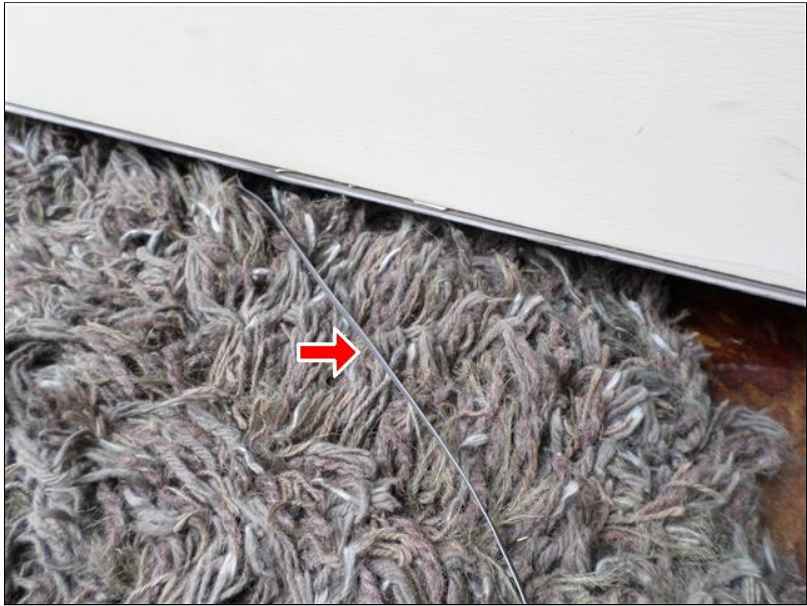
G. Doors (Interior and Exterior)
Comments:
(1) Weather striping on multiple doors is damaged. Recommend repair to keep home efficient and to keep pest out.

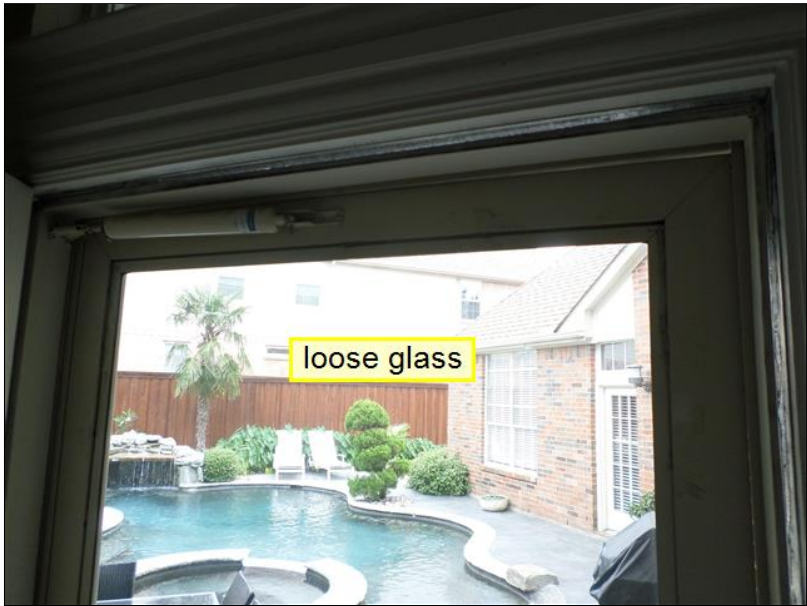
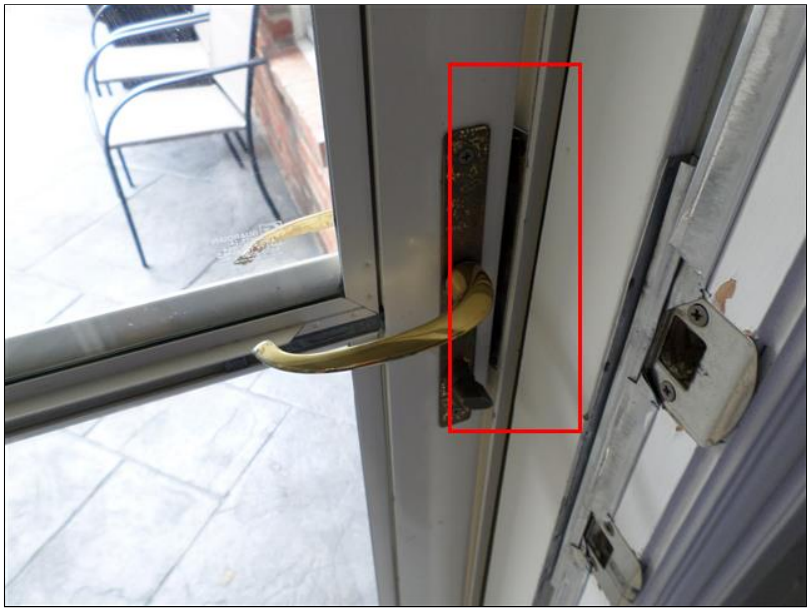
(2) Screen door near pool has loose glass and does not close tightly due to broken latch.

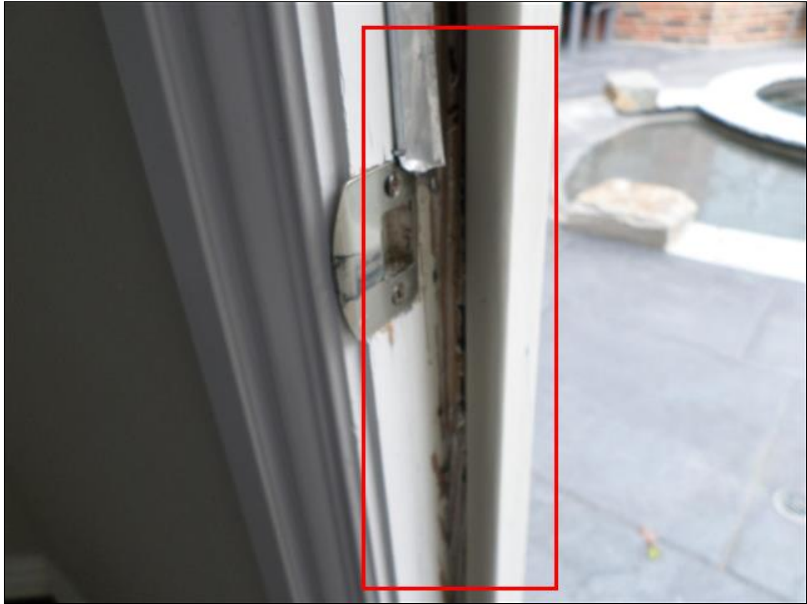
G. Item 5(Picture) Rear door near pool, south wall

(3) Rear door near pool has damaged door frame.

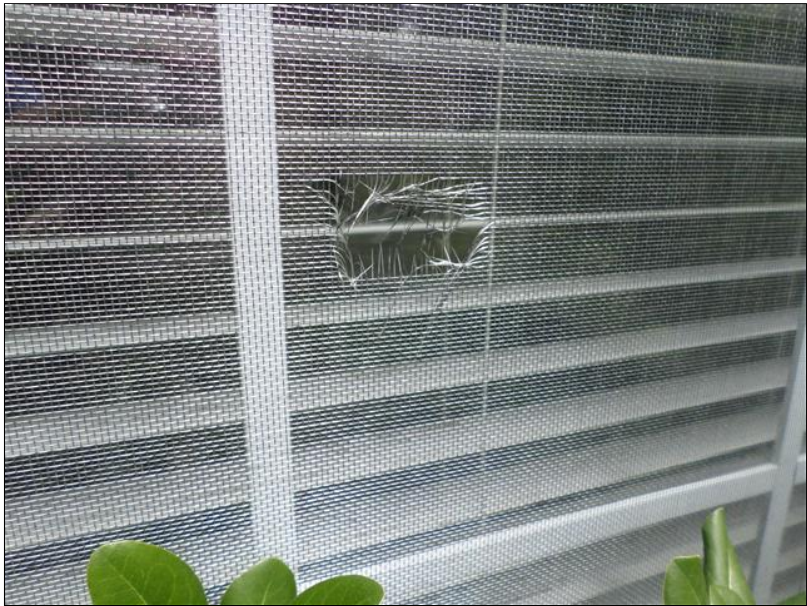
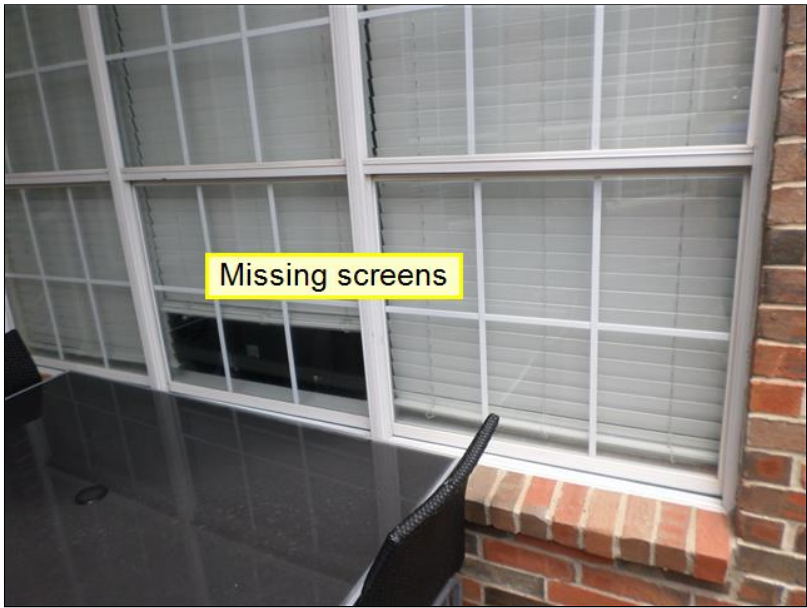
- (1) A few of the window screens were missing or damaged at the time of the inspection.

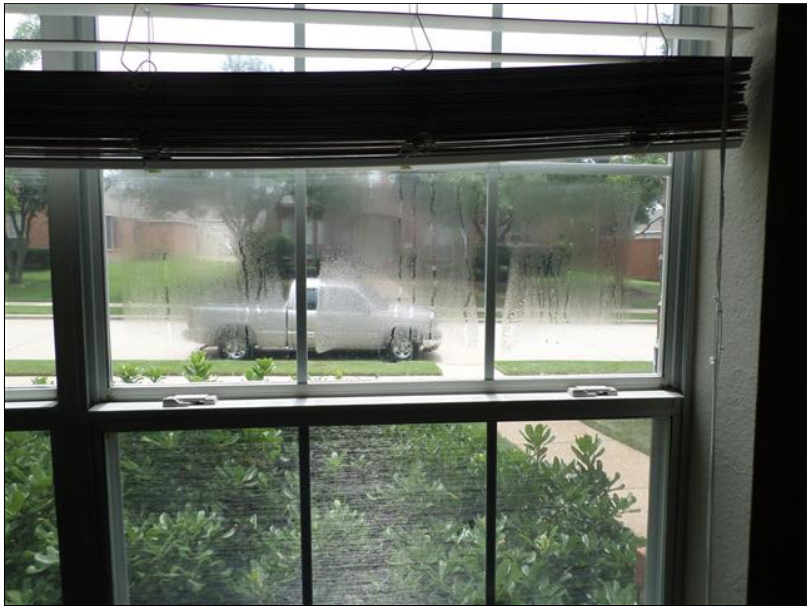
H. Item 3(Picture) Front of home

(2) Multiple windows are cloudy (lost seal) throughout the home. Some window are not as noticeable as others. In order to correct the cloudy appearance of glass, a replacement of glass pane or the unit will be necessary. A qualified contractor should inspect and repair as needed.

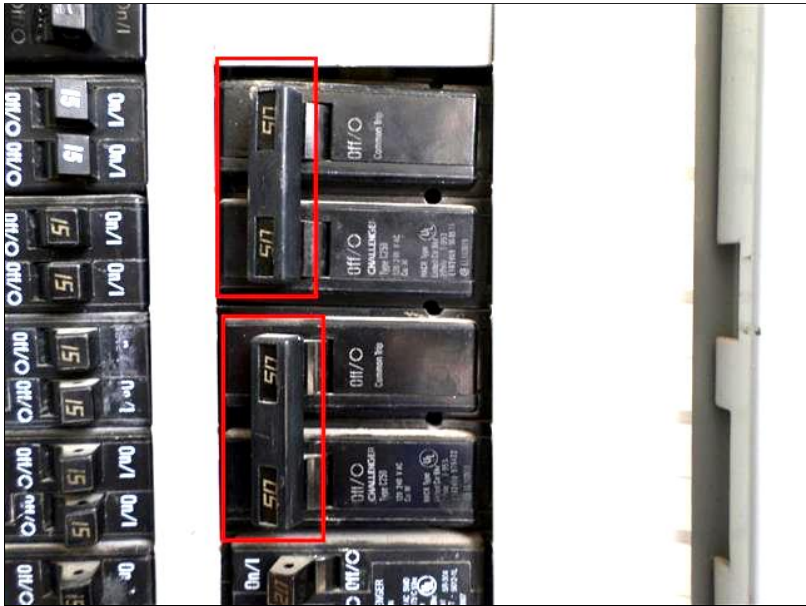
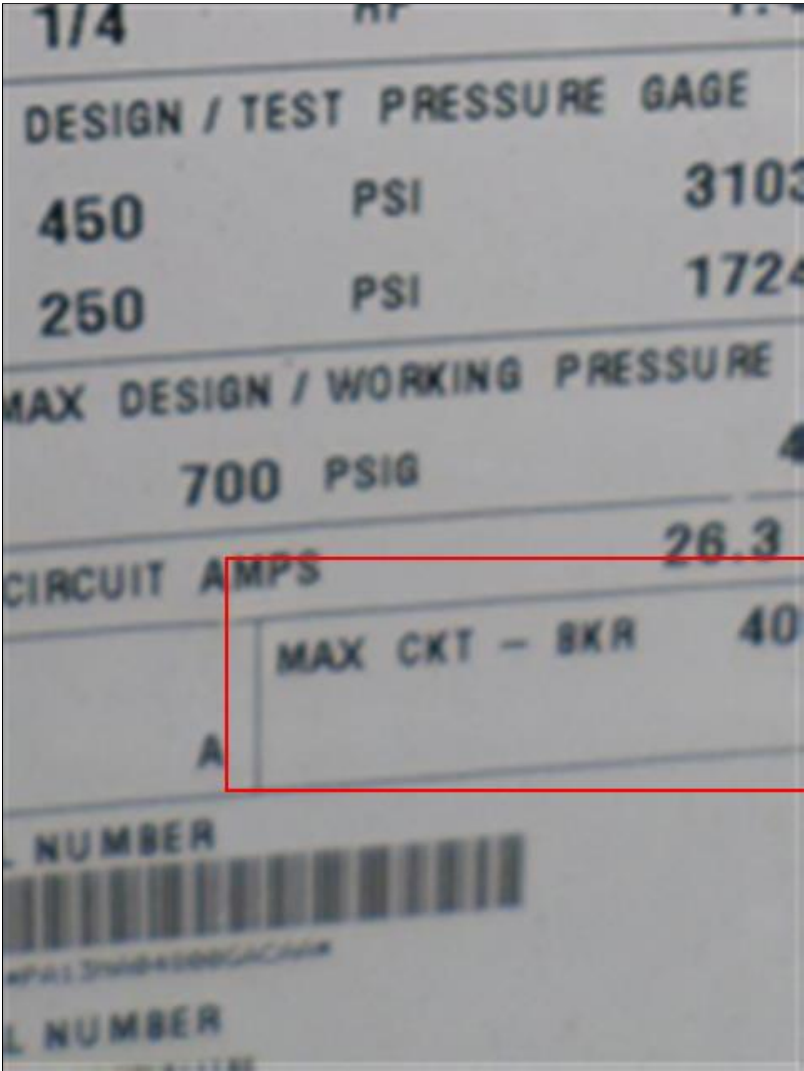
(1) A/C units have breakers that are too large for units installed in the main panel. Recommend qualified electrician assesses further and repairs.

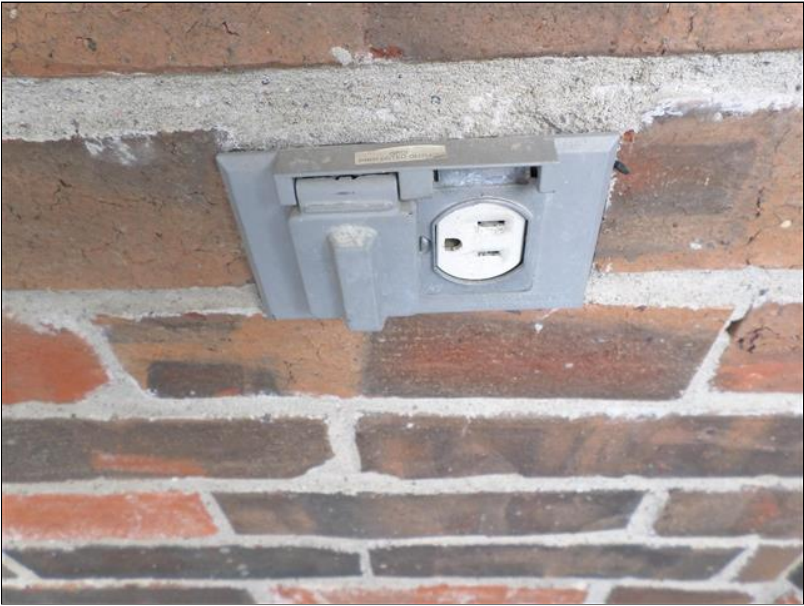
B. Item 1(Picture) Pool area

(1) Exterior outlet has broken weather cover. Recommend repair to prevent water intrusion.

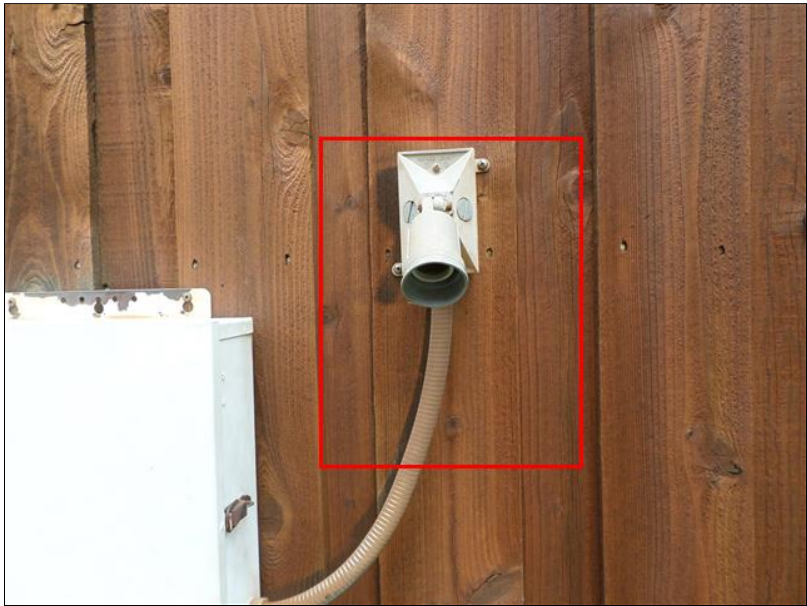
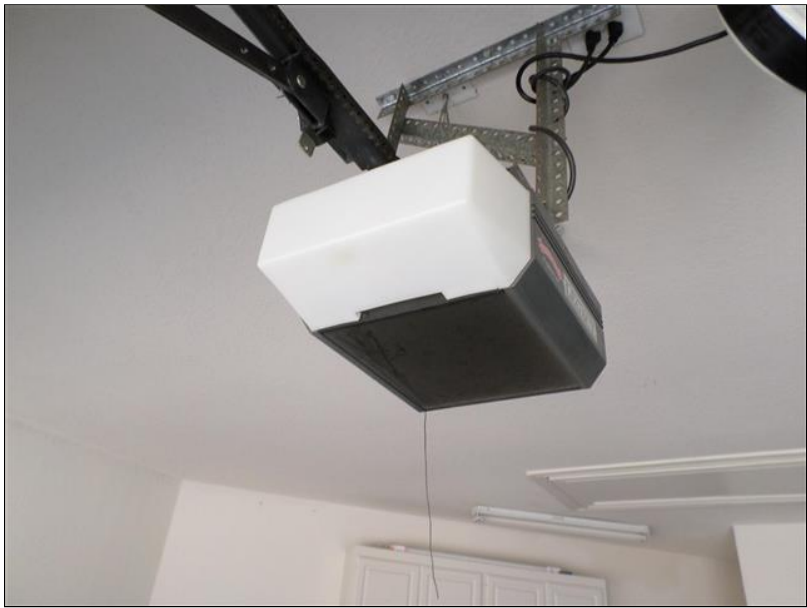
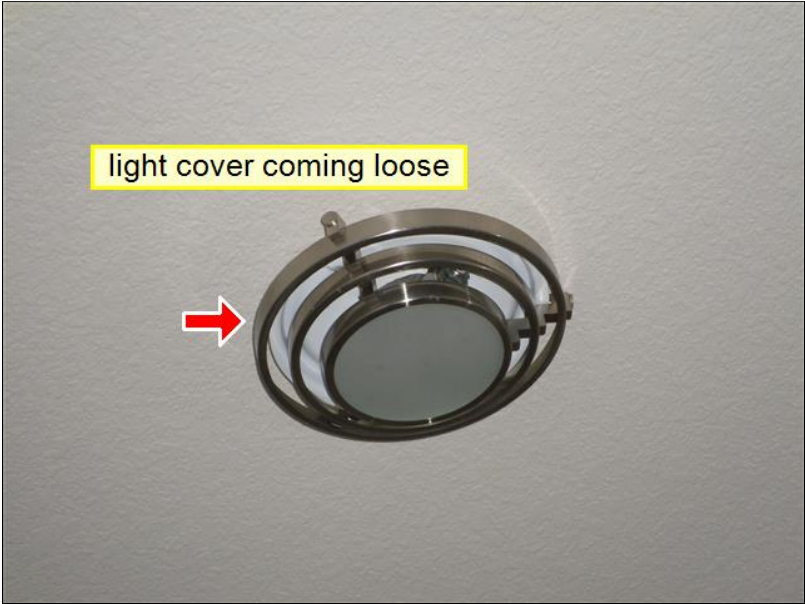
(2) Some light fixtures in the home appeared to be inoperable. The bulbs may be burned out, or a problem may exist with the fixtures, wiring or switches. If after the bulbs are replaced, these lights still fail to respond to the switch, this condition may represent a potential fire hazard, and the Inspector recommends that an evaluation and any necessary repairs be performed by a qualified electrical contractor.

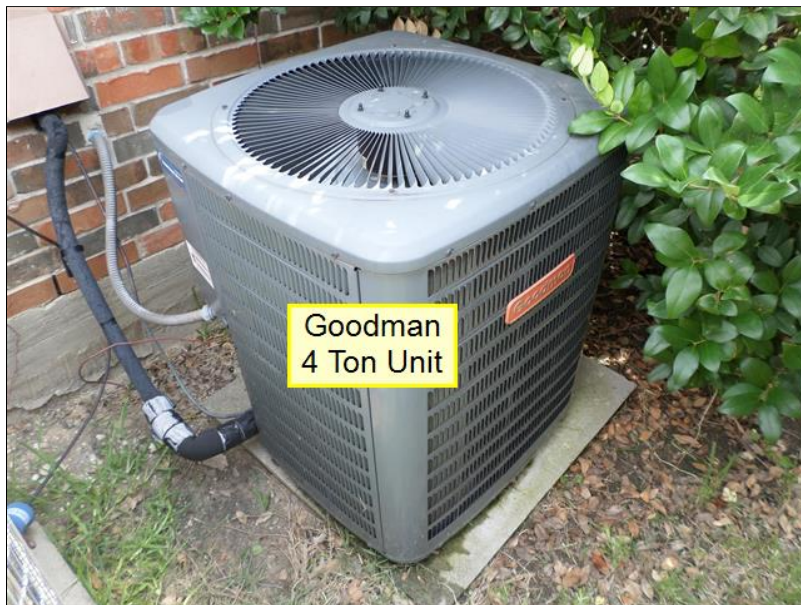
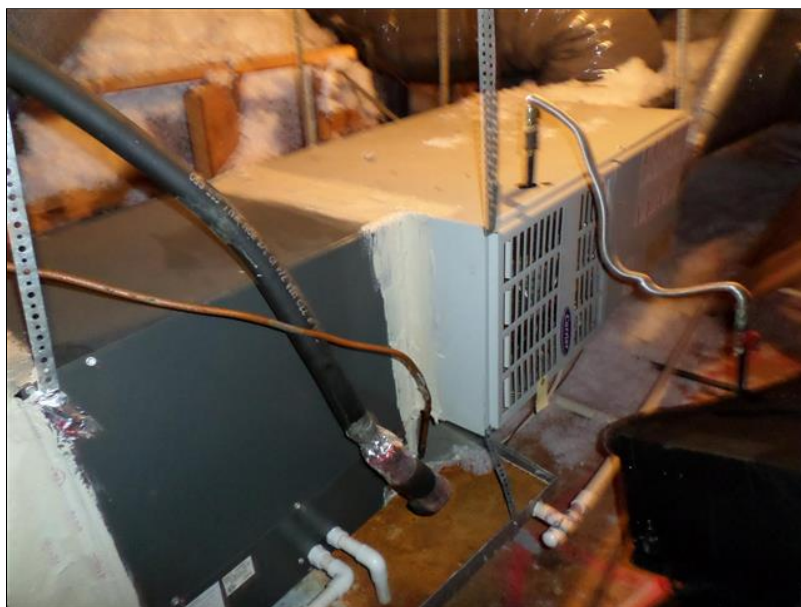
(1) (Main Living Area Unit) The ambient air test was performed by using thermometers on the air handler of Air conditioner to determine if the difference in temperatures of the supply and return air are between 14 degrees and 22 degrees which indicates that the unit is cooling as intended. The supply air temperature on your system read 62 degrees, and the return air temperature was 78 degrees. This indicates the range in temperature drop is normal.

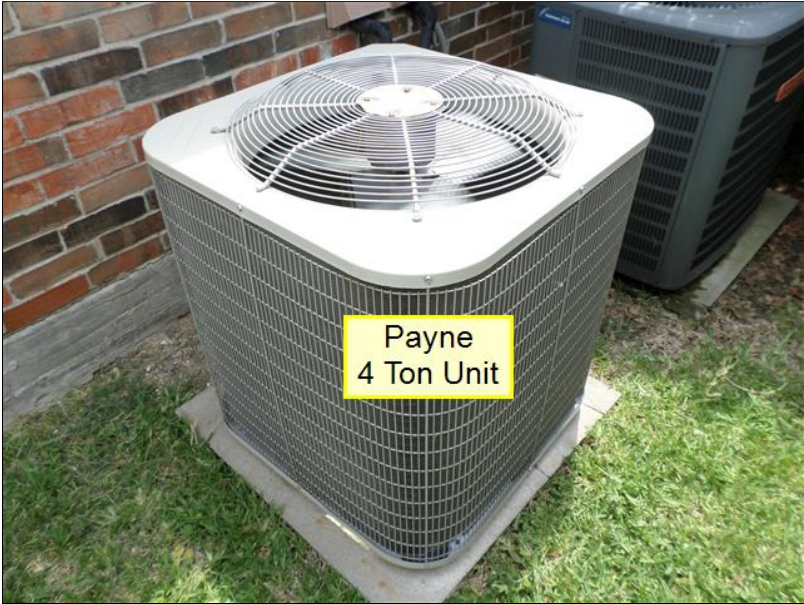
B. Item 3(Picture) Master bedroom

(2) The ambient air test was performed by using thermometers on the air handler of both Air conditioners Air conditioner to determine if the difference in temperatures of the supply and return air are between 14 degrees and 22 degrees which indicates that the unit is cooling as intended. The supply air temperature on your system read 63 degrees, and the return air temperature was 80 degrees. This indicates the range in temperature drop is normal.

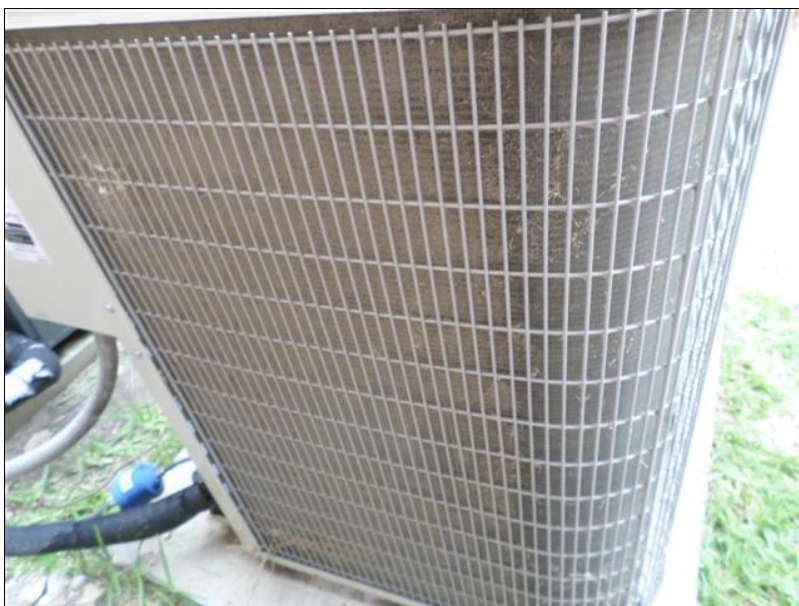
B. Item 6(Picture)

(4) Recommend washing the exterior a/c condensing coil to keep unit performing efficient.

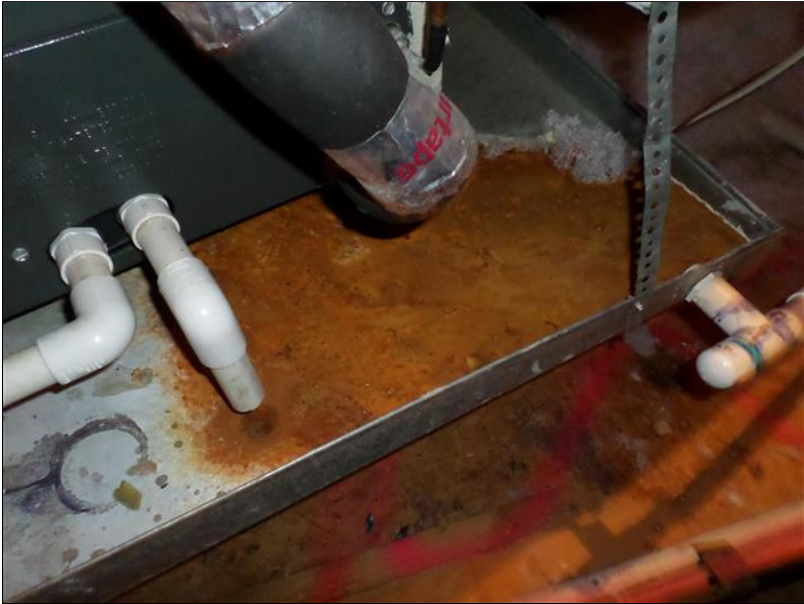
B. Item 7(Picture)

(5) The emergency condensate drain pan under the indoor EVAP coil housing has a rust build-up. This indicates that the pan has held water in the past and should be closely monitored. Rust and/or debris may be partially clogging the condensate drain lines. The primary and secondary drain lines should be flow checked and cleaned if necessary as well as being checked for proper termination. This is the master bedroom unit in walk in attic.

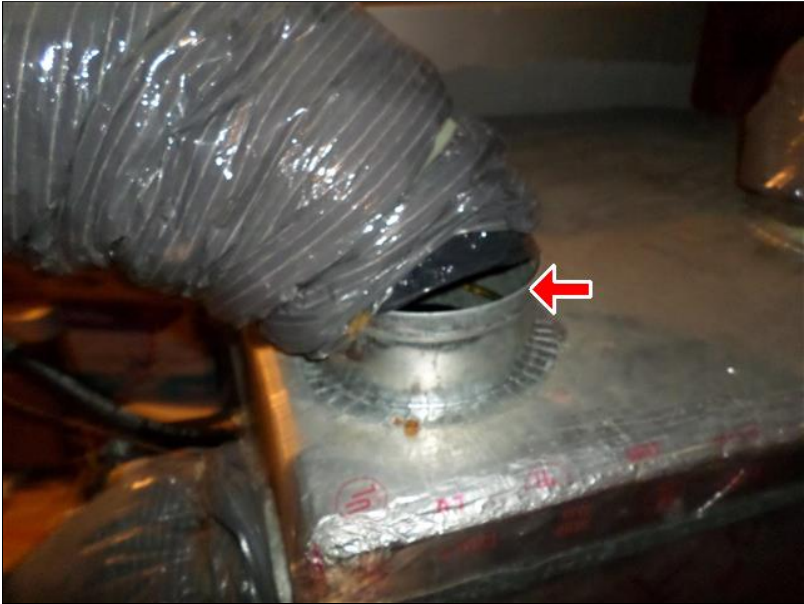
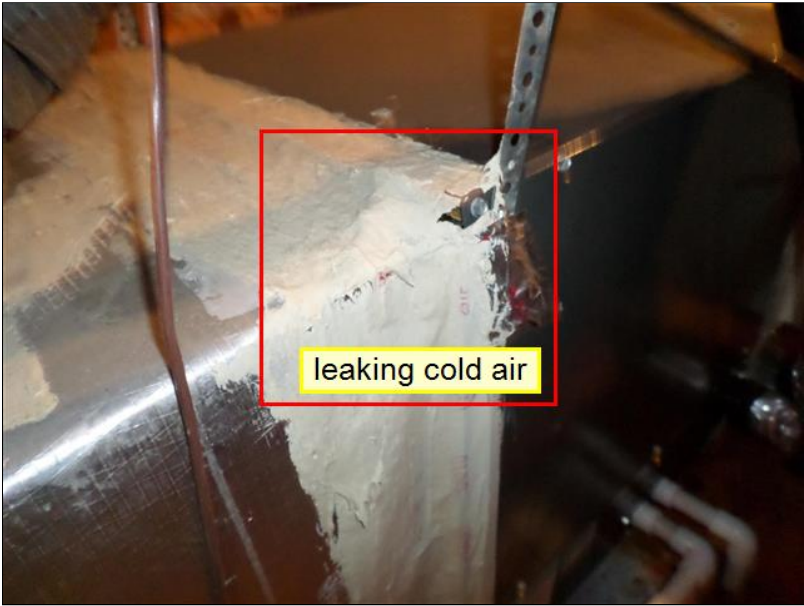
- 1. Ducting is coming loose at air handler in attic over garage. Recommend repair to prevent heat and cooling loss.
- 2. Joints at air handler are leaking air. Recommend qualified contractor seals all joints to make unit more efficient.

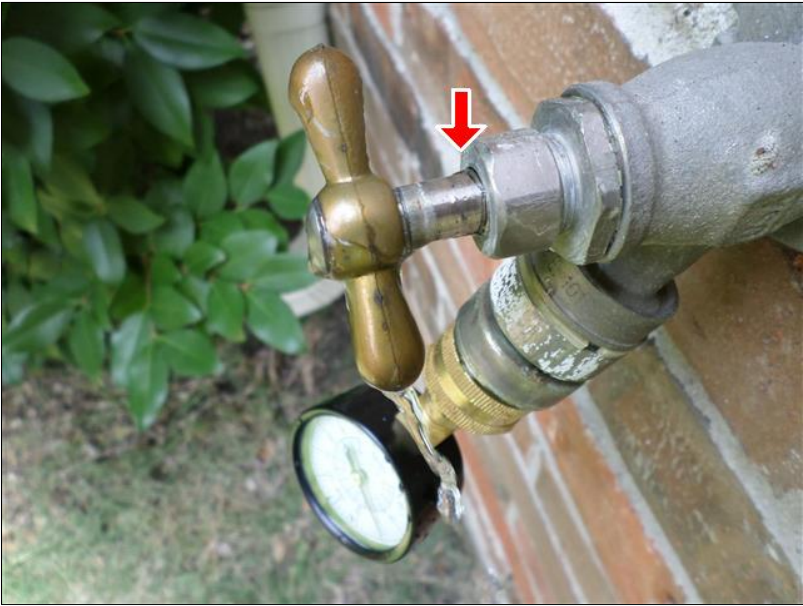
A. Item 1(Picture) West side of home

(1) The control knob on faucet leaks when opened.

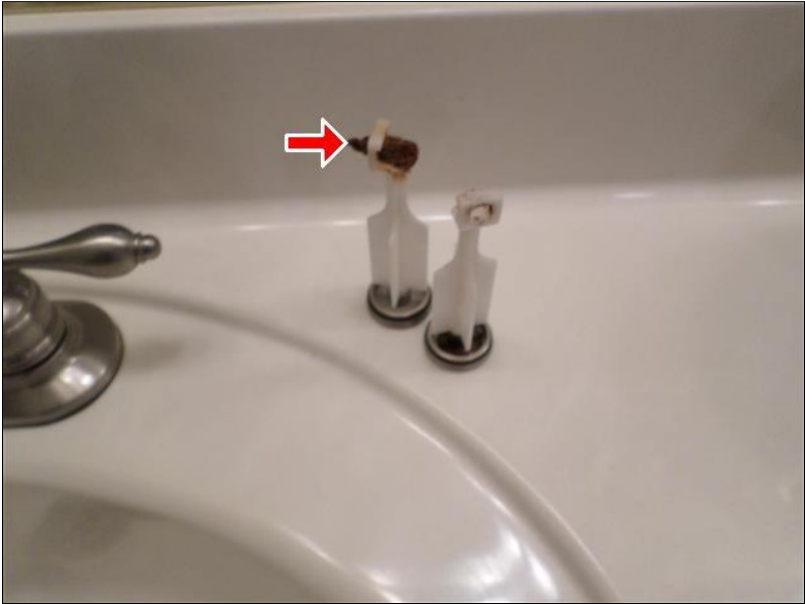
A. Item 2(Picture) East bathroom

- (2) Water pressure in master bath sink is very low. Recommend qualified plumber assess further if higher pressure is desired.
- (3) East bathroom sinks have drain plugs removed, appears one of two is damaged.

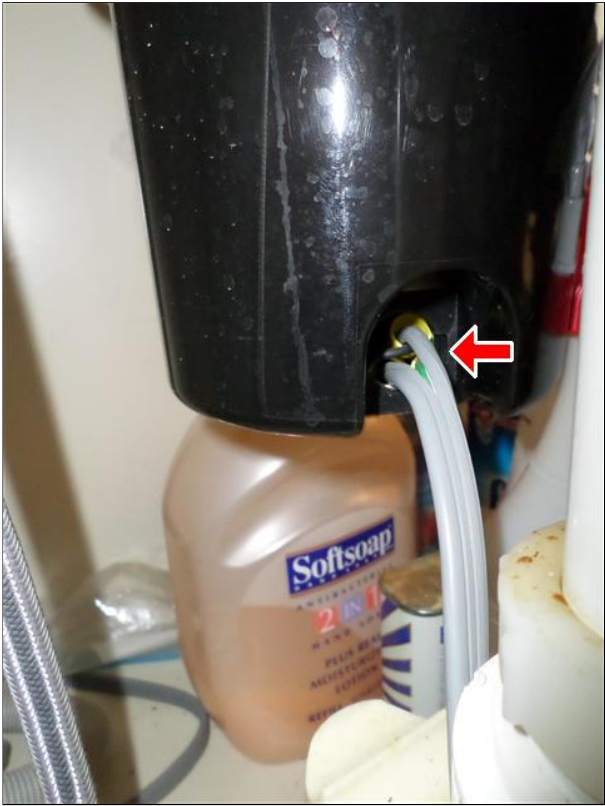
B. Item 1(Picture)

The food disposer wiring is missing a romex connector (anti-strain device). I recommend repair as needed.
