Inspection Report

1234 No Where Ln
Plano TX 75024

Built Right Home Inspections

PROPERTY INSPECTION REPORT

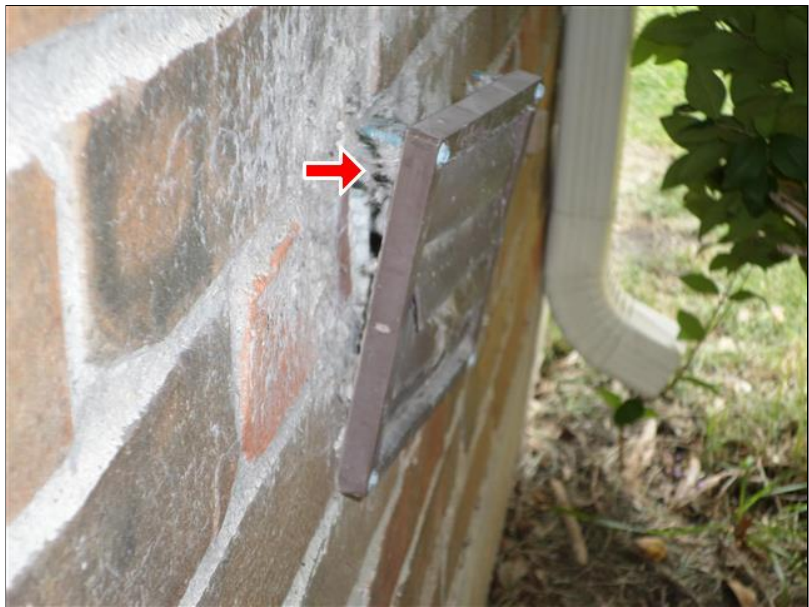
H. Item 1(Picture) West wall

The dryer vent cover is loose on exterior wall. Recommend repair to prevent pest intrusion.

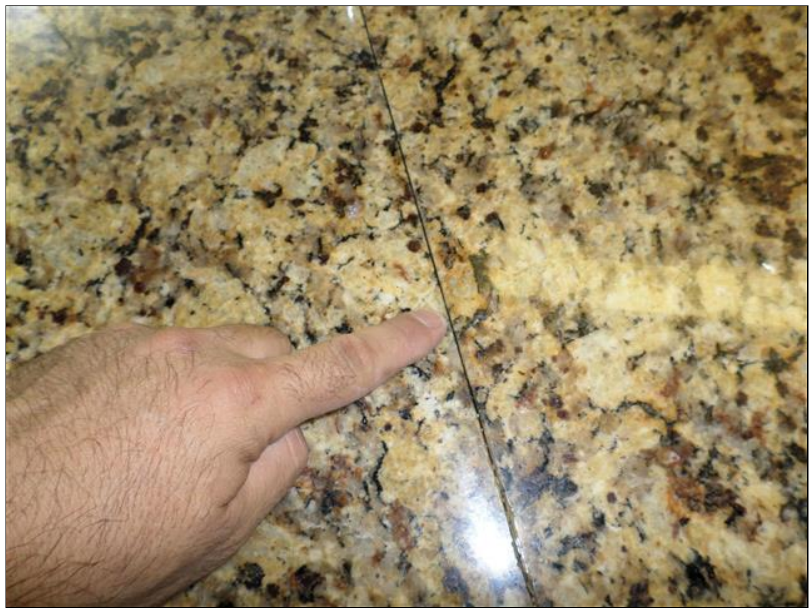
I. Item 1(Picture) Kitchen counter top

Comments:
Recommend sealing joints in the kitchen counter top.

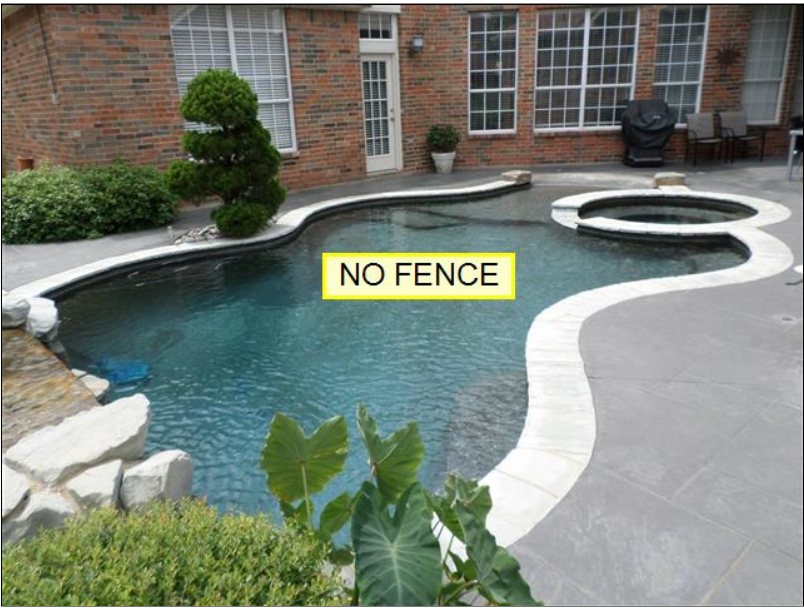
B. Item 1(Picture)

Type of Construction: Gunitite (concrete)
Style: In ground
Comments:
(1) There is no pool barrier around perimeter. Every window and door that has access to pool should be on a alert or chime to notify.

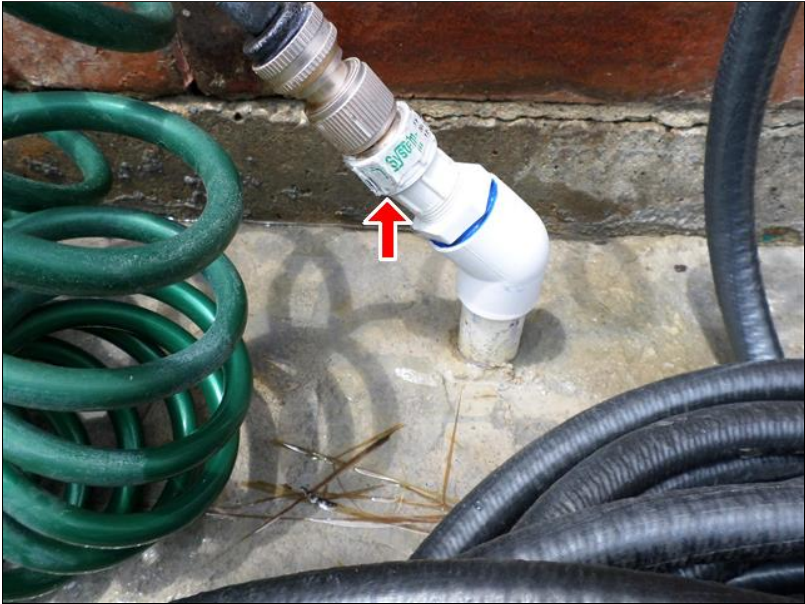
B. Item 2(Picture)

(2) Hose connection at pool fill line is leaking. Recommend repair to prevent water loss.

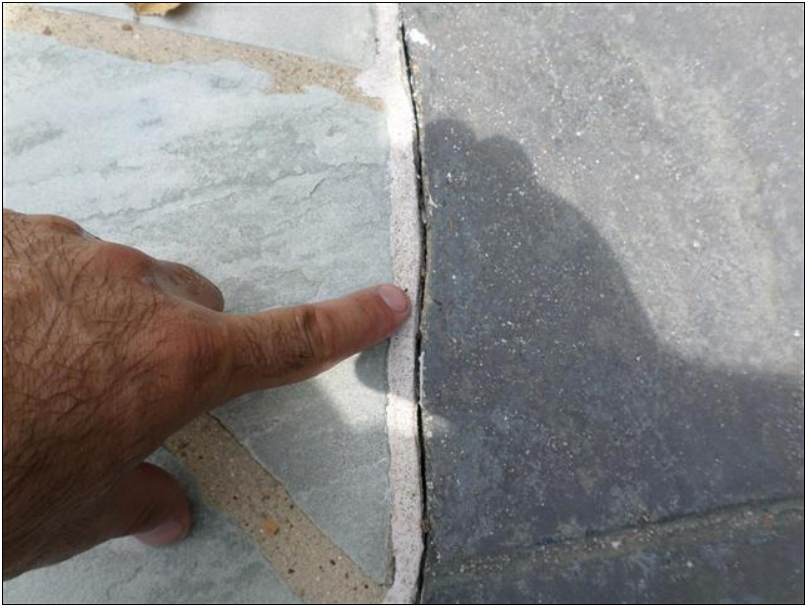
B. Item 3(Picture)

(3) Mastic seal around pool should be re-sealed by qualified contractor.

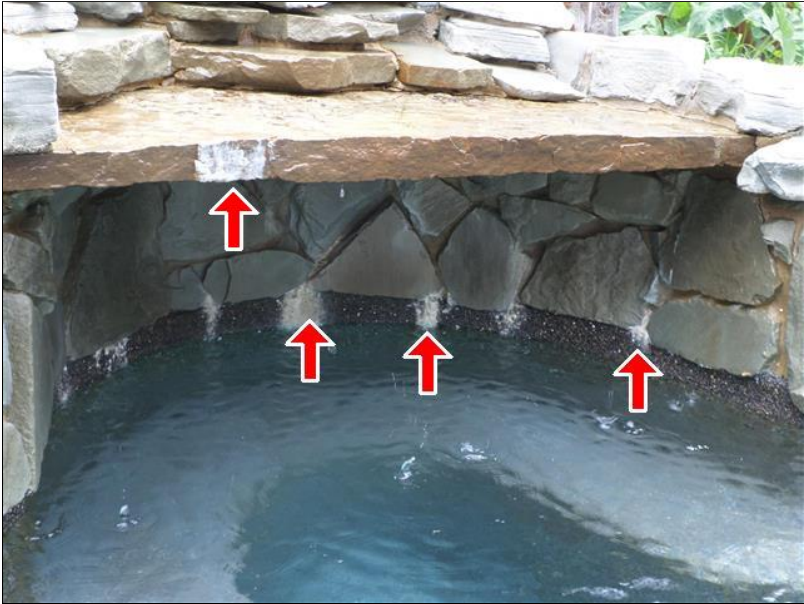
B. Item 4(Picture)

(4) Scaling is present on the rocks near waterfall. Recommend qualified contactor remove scale to prevent staining.

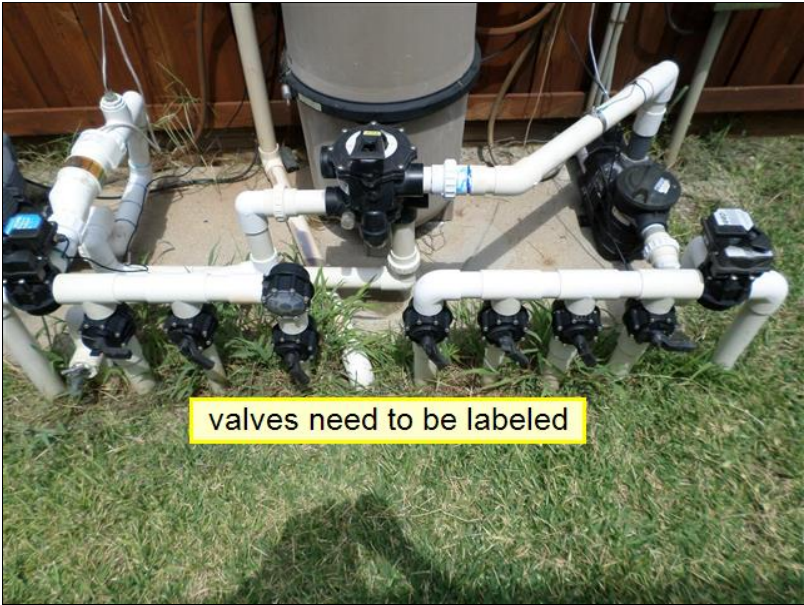
B. Item 5(Picture)

(5) Pool equipment needs valves re-labeled.

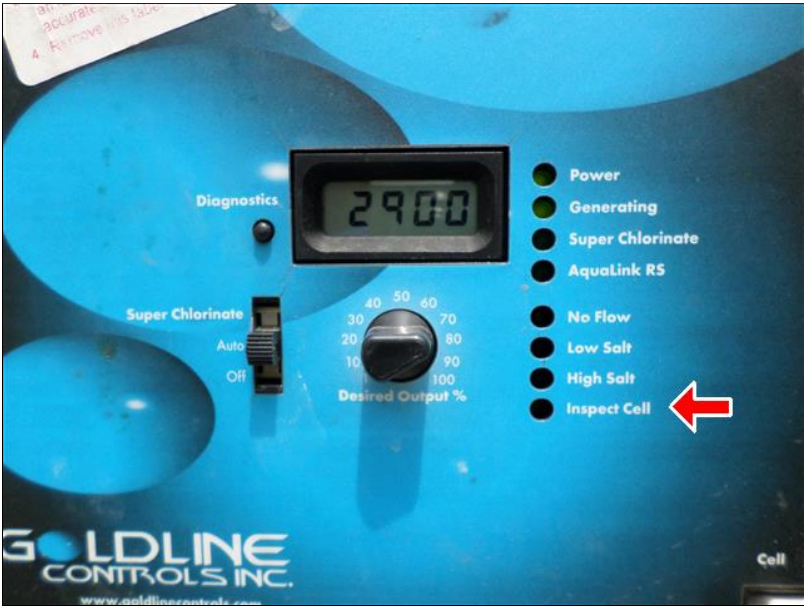
B. Item 6(Picture)

(6) Pool chlorine control center indicates chlorine cell needs to be cleaned. Recommend qualified pool contractor assess system and provides you information on how to operated and maintain pool.

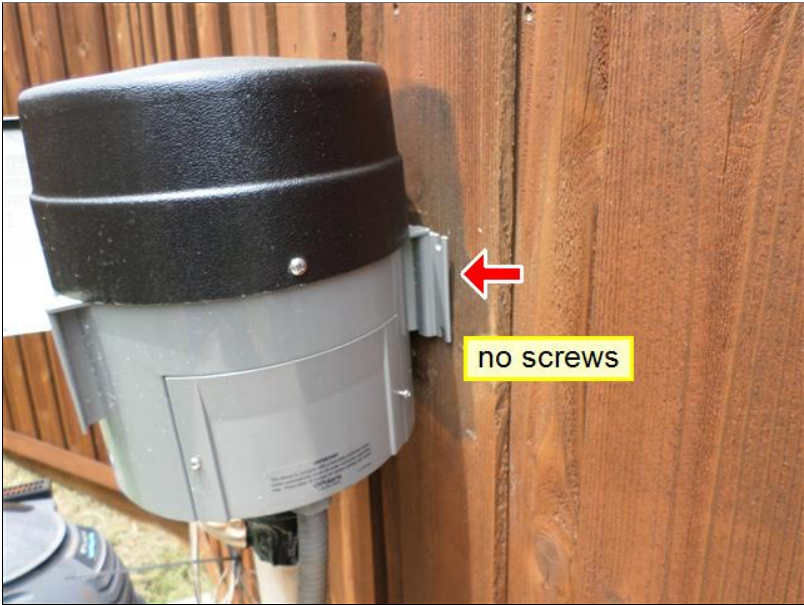
B. Item 7(Picture)

(7) Air blower for spa needs to be properly mounted to the fence or other stable object to prevent damage to piping.

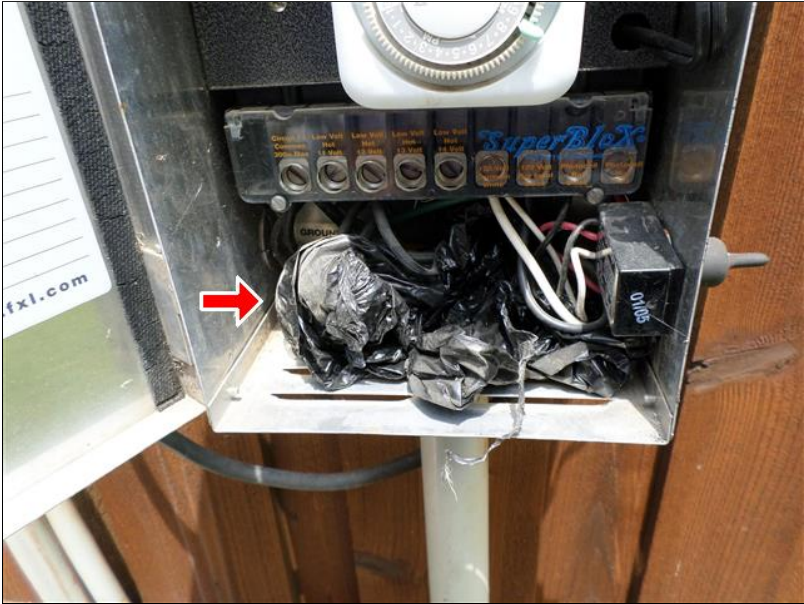
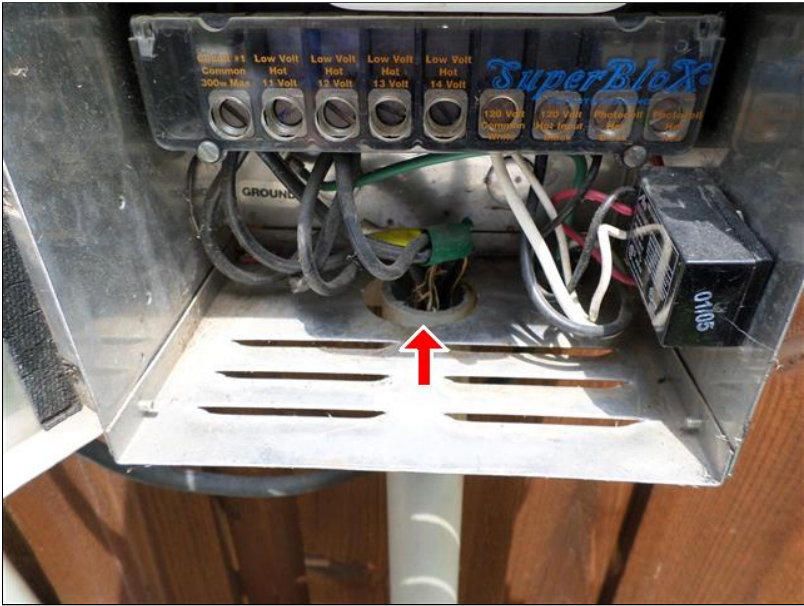
(8) Control panel near pool equipment has plastic bag in box, appears bag may be used to prevent water intrusion. Recommend qualified contractor seals properly.

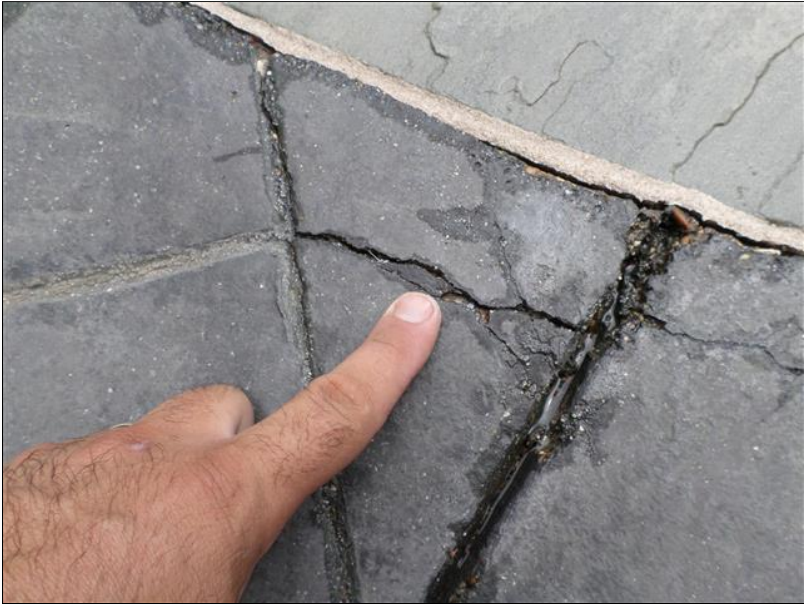
B. Item 10(Picture) Near spa

(9) Pool decking had small area of cracking. Recommend sealing cracks as needed.

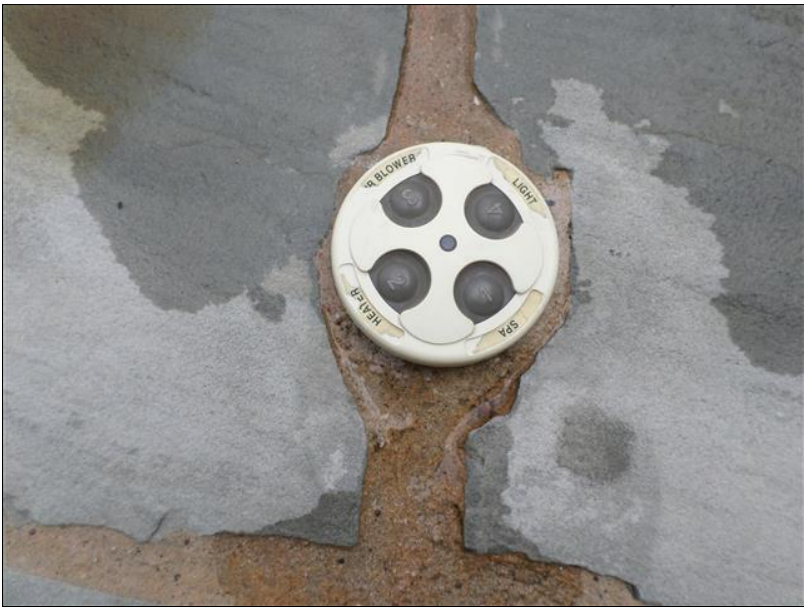
B. Item 11(Picture) Spa control, near spa

(10) Remote controls for spa was not working at time of inspection.
