# Inspection Report

# PROPERTY INSPECTION REPORT

**Concerning:** 1234 No Where Ln, Dallas, TX 75214

**By:** Brian Ruiz Trec#10502 / Built Right Home Inspections 8/7/2014

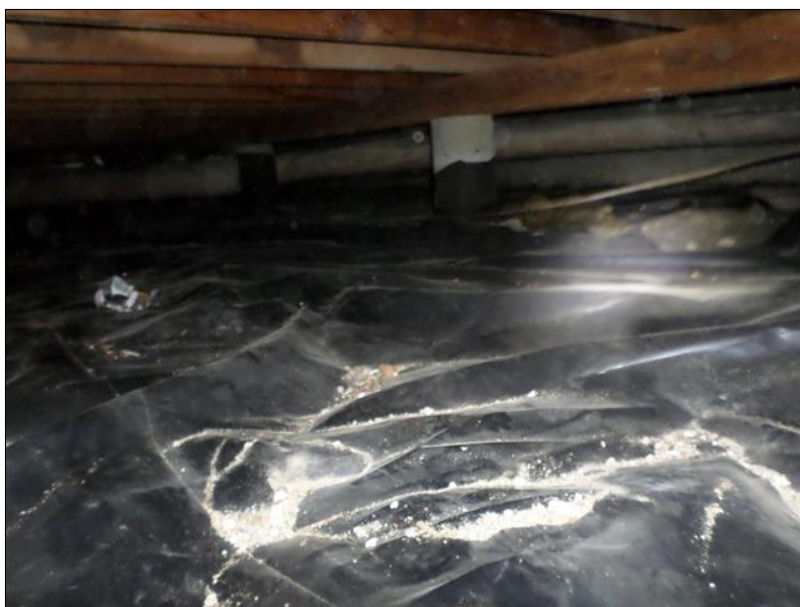
A. Item 1(Picture)

- (1) The crawlspace was accessed through an interior floor hatch in the closet below the stairs.
- (2) The floor of the crawlspace was covered with a plastic soil cover which consisted of sheet plastic spread across the floor of a crawlspace. Soil covers are installed to help minimize moisture evaporation into crawlspace air from the soil. Edges at overlaps and the crawlspace perimeter were not sealed. There was a small area of ground that was not covered.

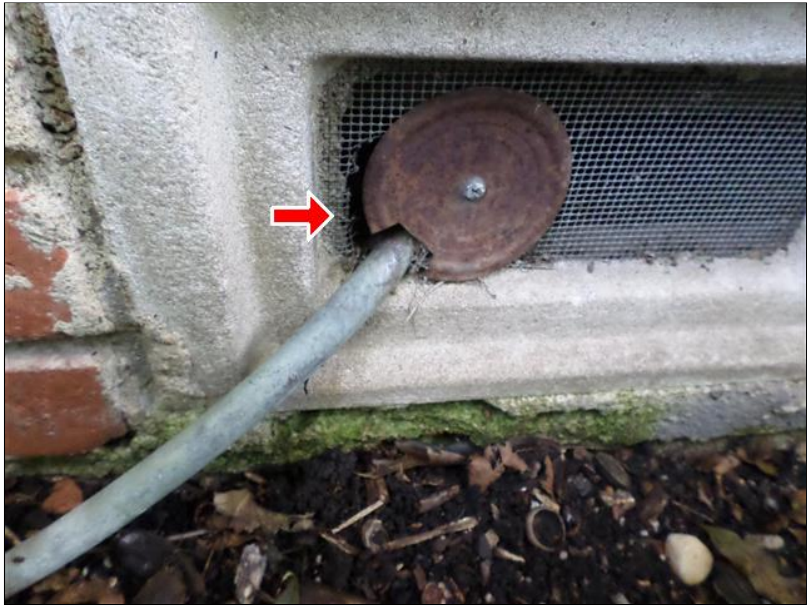
A. Item 3(Picture) Rear of home

(4) Crawl space vent on rear of home has damaged screen. Recommend repair to prevent pest from entering the crawl space.

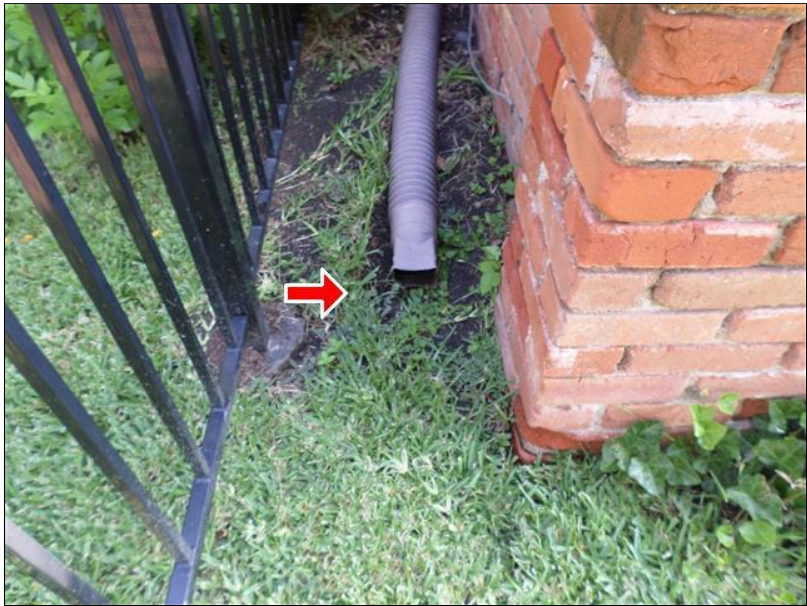
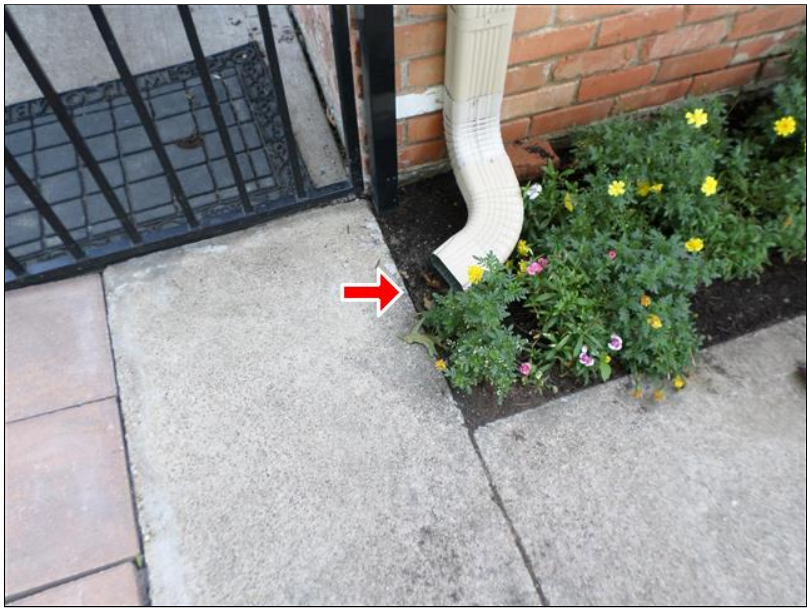
B. Item 1(Picture) South side of home

Comments:  
(1) Gutter down spouts should empty onto splash blocks several feet from foundation to prevent water intrusion and/or erosion. Multiple locations need this repair.

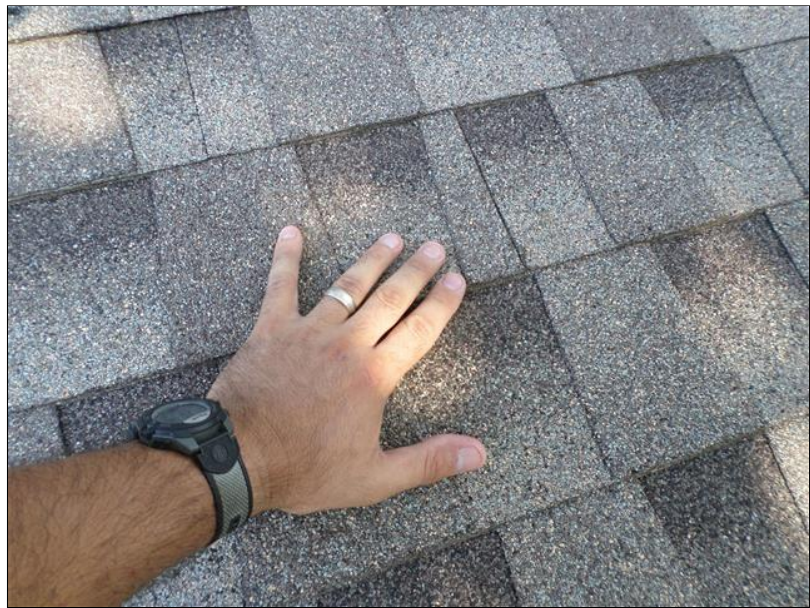
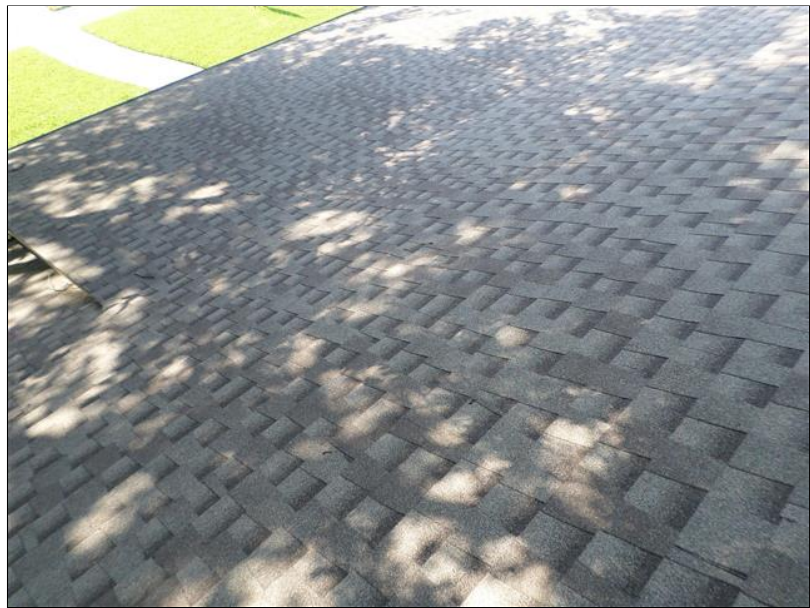
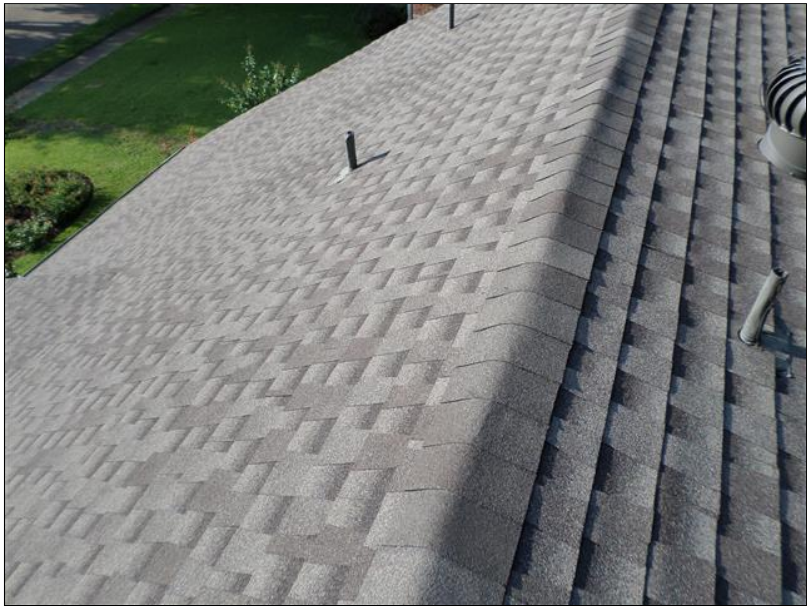
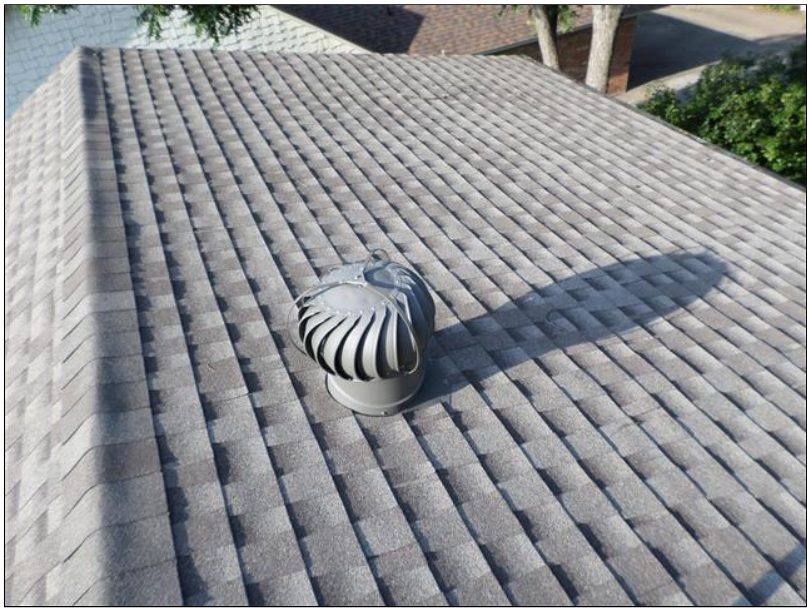
C. Item 1(Picture)

(2) Roof shingles are in good condition. No hail or wind damage observed day of inspection.

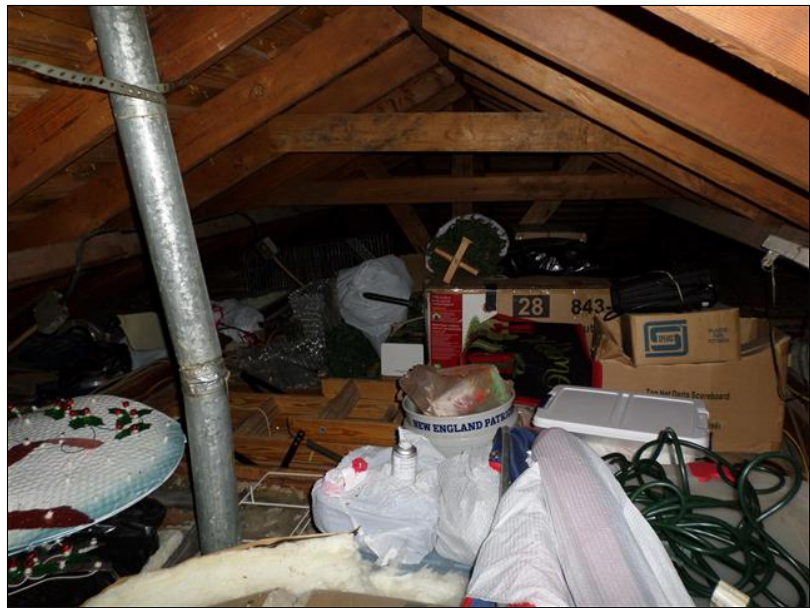
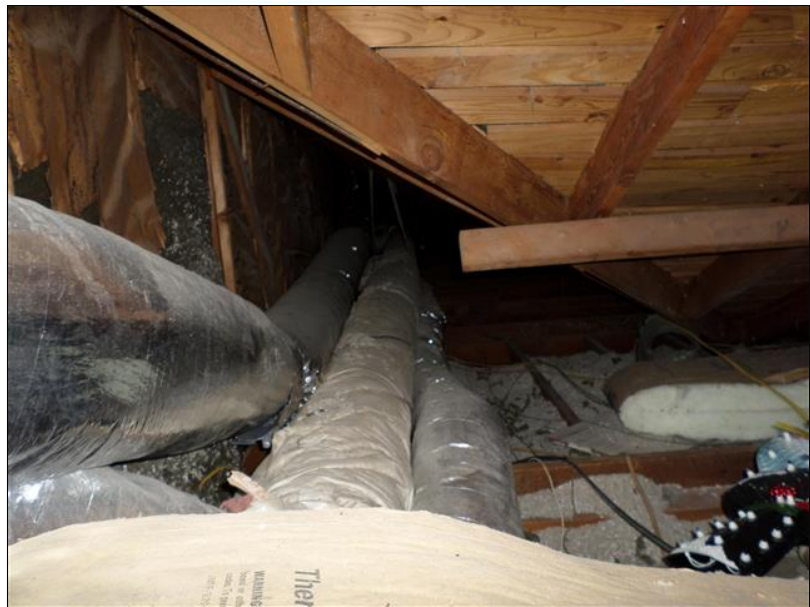
D. Item 1(Picture)

(1) Portions of the attic could not be accessed for inspection. Mechanical equipment, ducts and storage blocked some areas of attic.

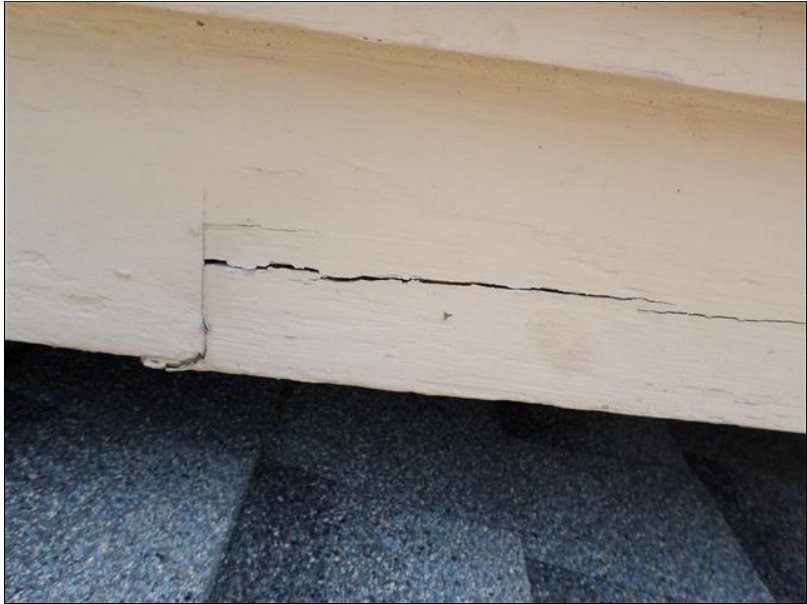
D. Item 3(Picture)

(2) Fascia board on second floor, front of home is cracked this is cosmetic only. Recommend periodically checking for further cracking.

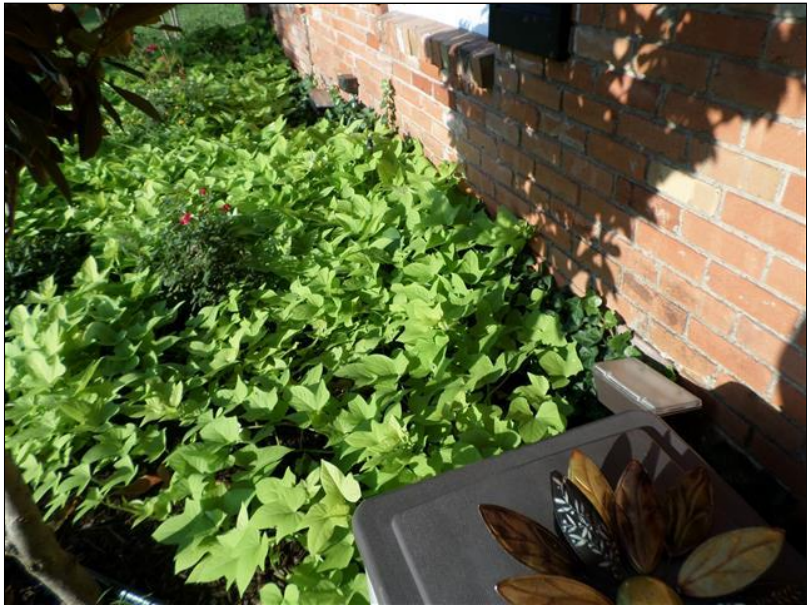
E. Item 1(Picture)

(1) Due to thick foilage, some areas were able to be seen. Recommend foilage be kept trimmed back from foundation and walls.

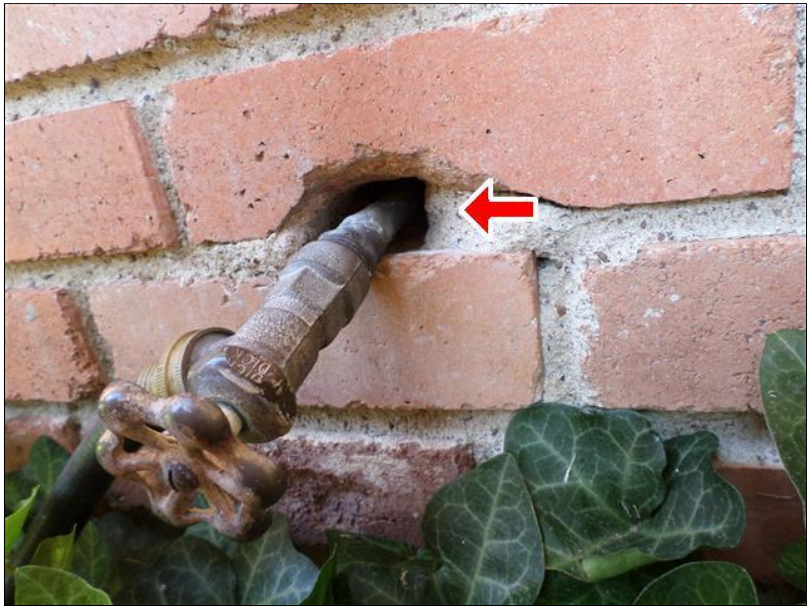
E. Item 2(Picture) Left of front door

(2) All drain's or anything exiting through exterior wall should be properly sealed.

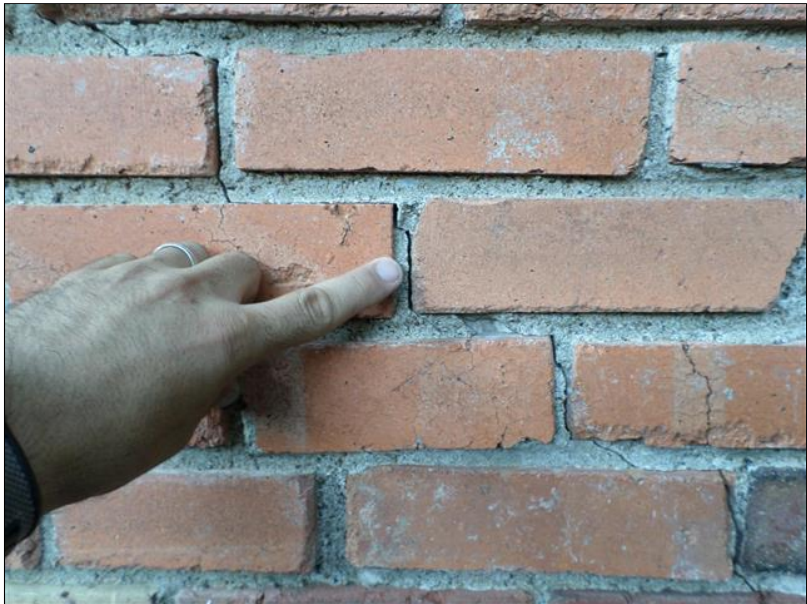
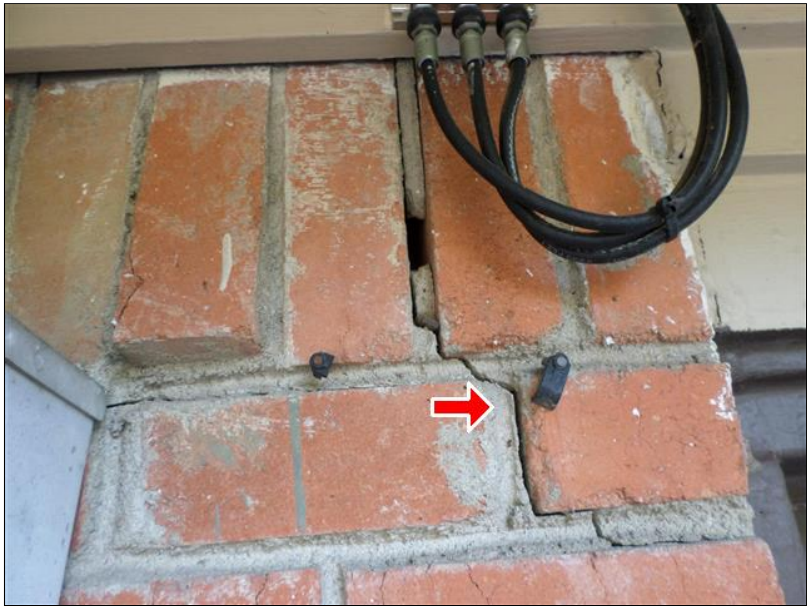
E. Item 5(Picture) North and South walls

(3) Brick exterior walls had stepped cracking visible in mortar joints. The inspector recommends patching cracks with an appropriate material to avoid continued damage from freezing moisture.

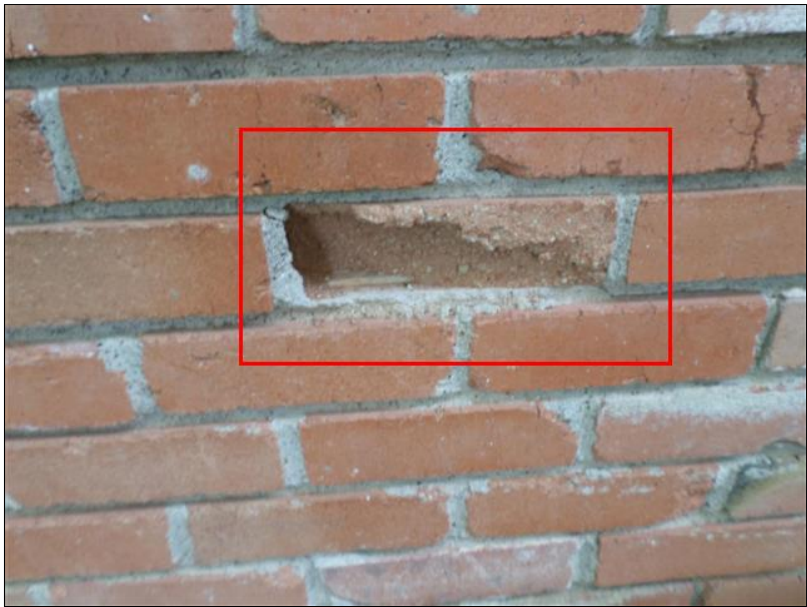
E. Item 8(Picture) Back Patio

(4) Brick covering exterior wall had damaged brick at back patio. Cosmetic only at this time.

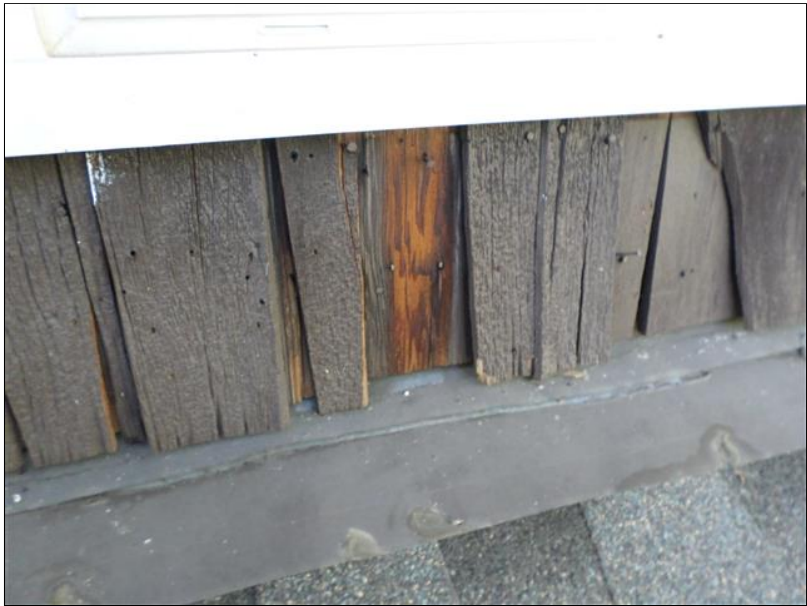
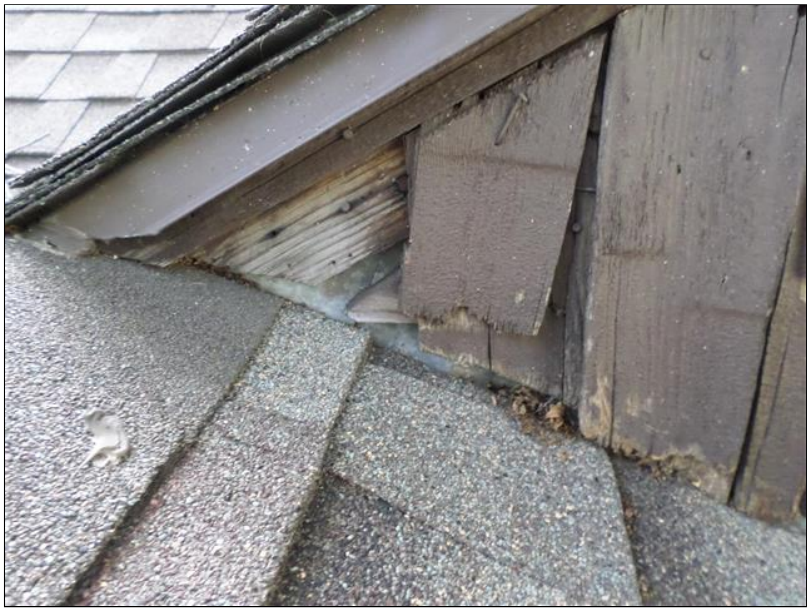
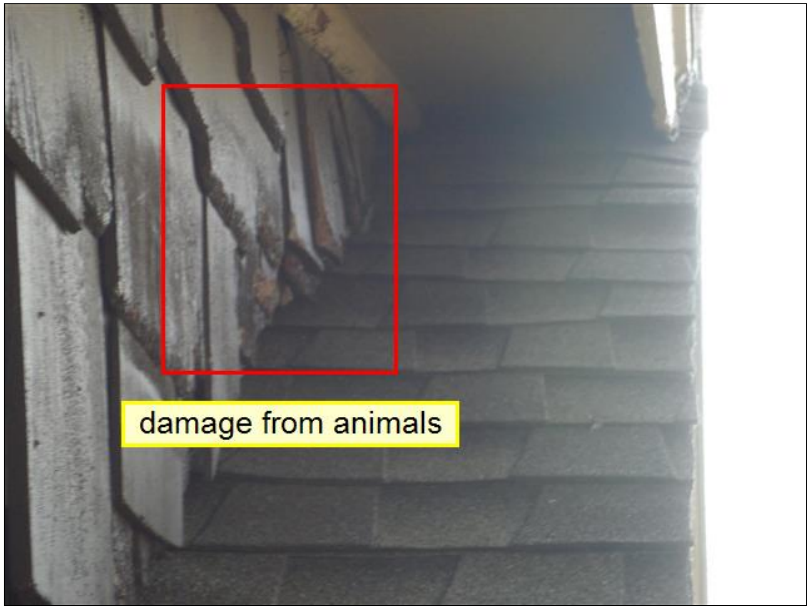
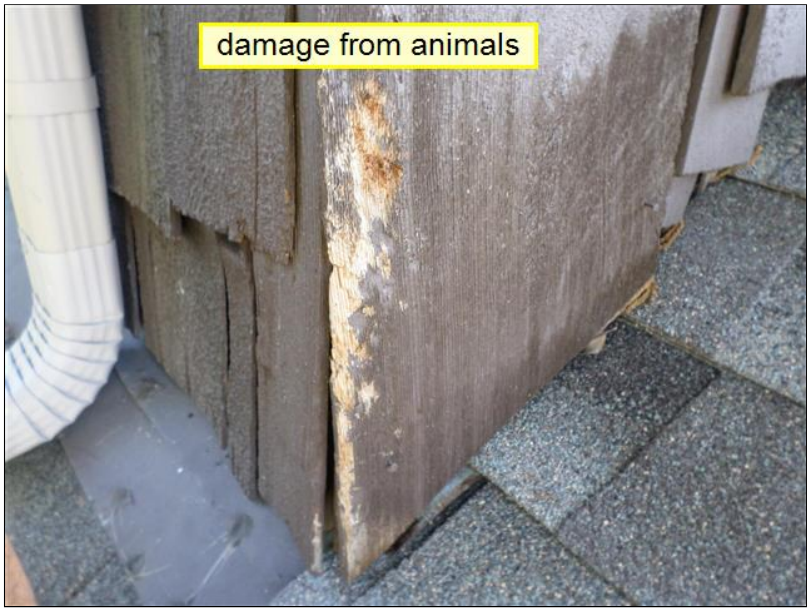
E. Item 10(Picture)

(6) The wood shingle exterior wall covering the second floor west and south side had damaged shingles visible at the time of the inspection.

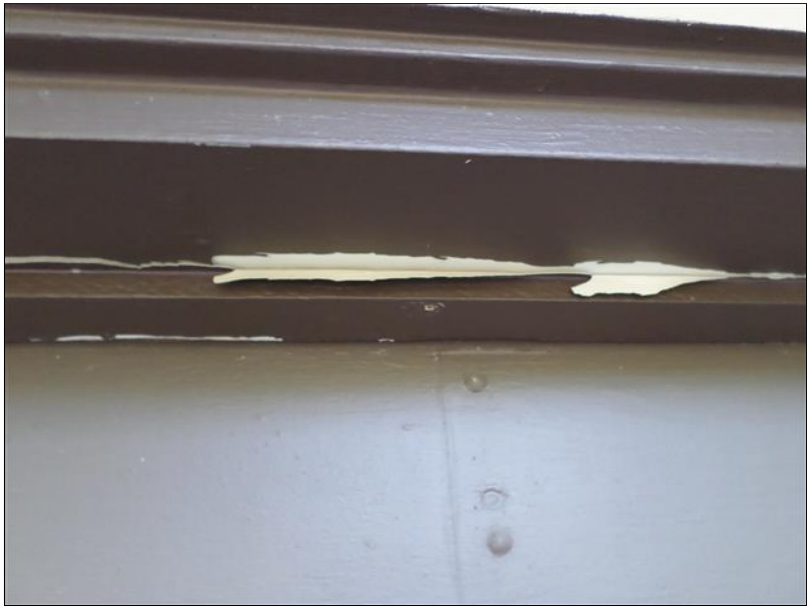
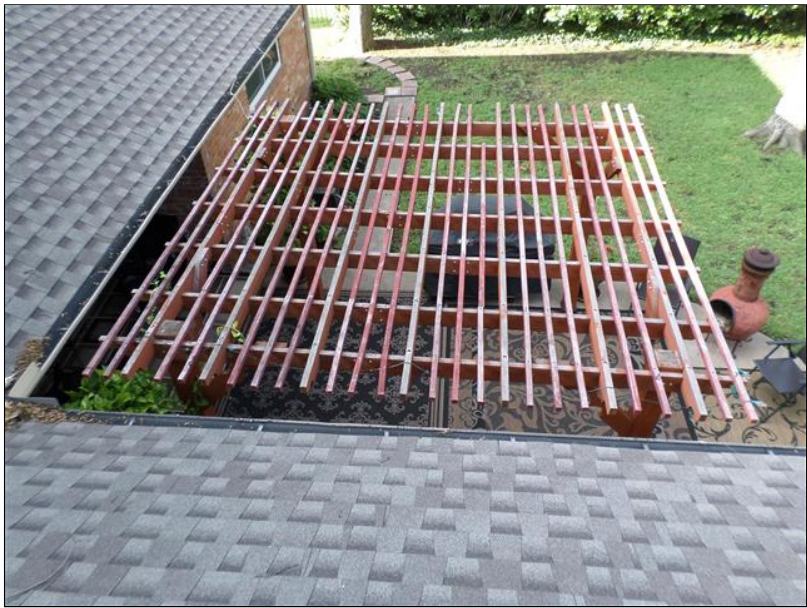
E. Item 14(Picture) Above Garage

(7) Exterior paint above the garage and arbor has peeling paint. Recommend repair to prevent future damage.

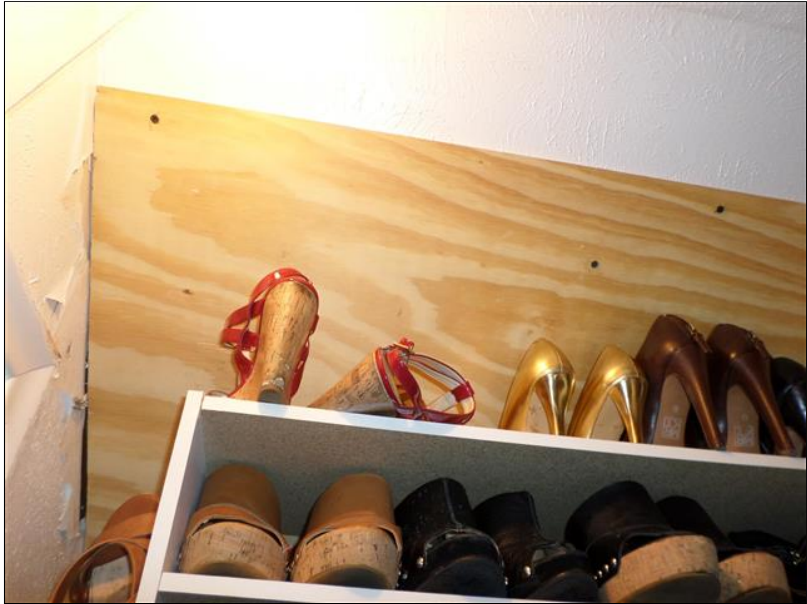
E. Item 16(Picture) Master closet

(8) Wall in master bedroom closet has had a repair and was not properly finished. Unknown why hole was cut, recommend asking current home owners about the repair.

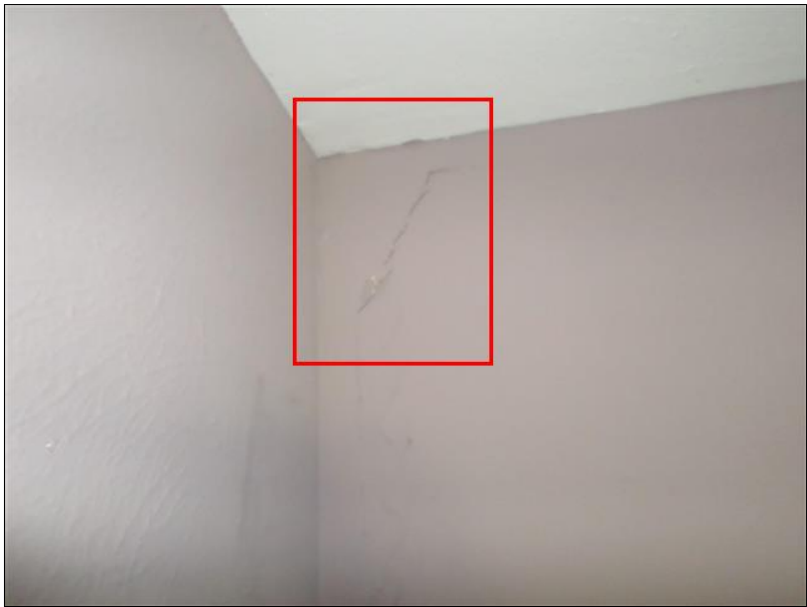
E. Item 17(Picture)

(9) Several walls had minor cracking in upstairs bedrooms, cosmetic only. Repair as needed.

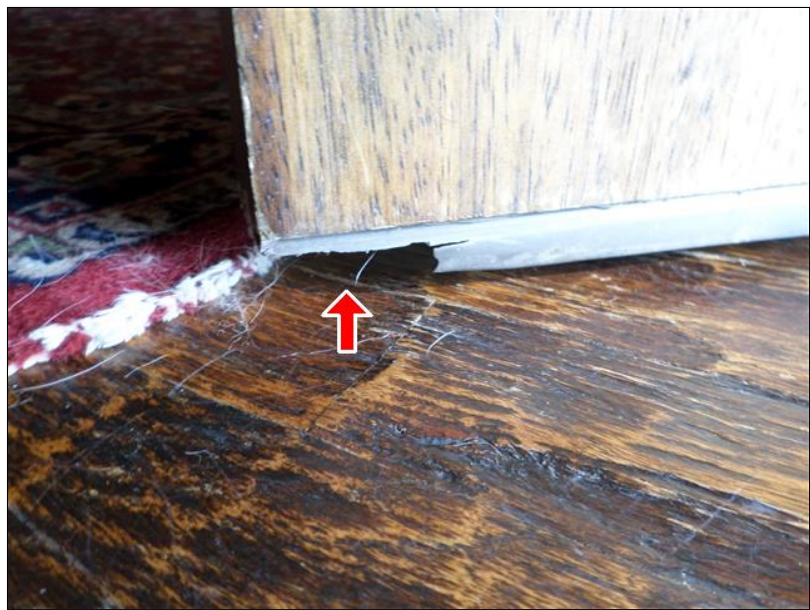
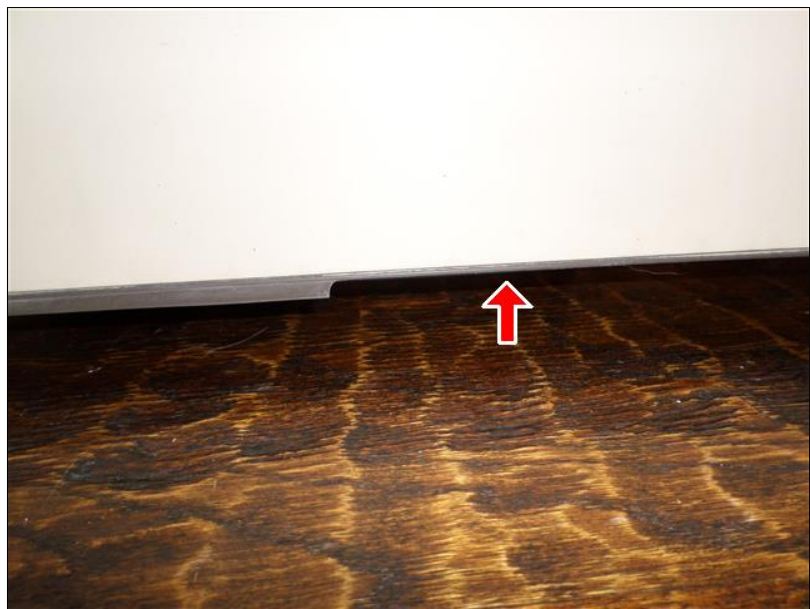
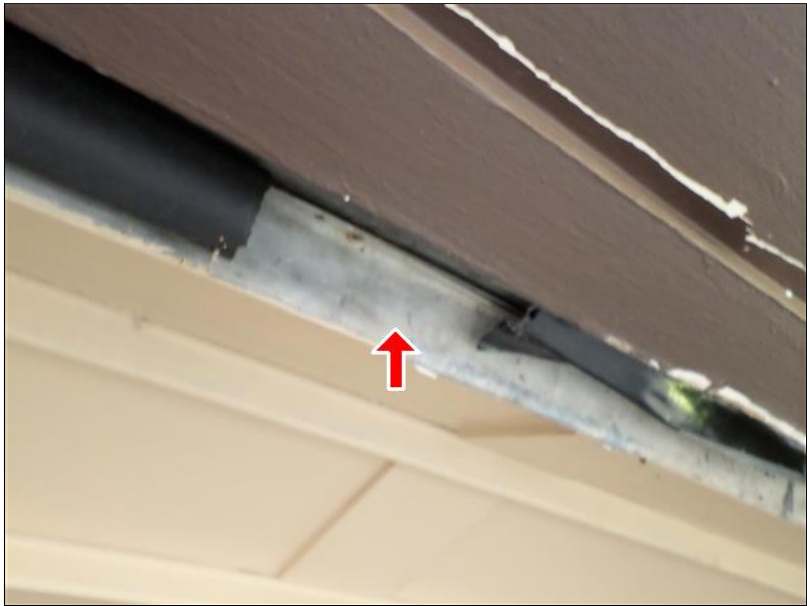
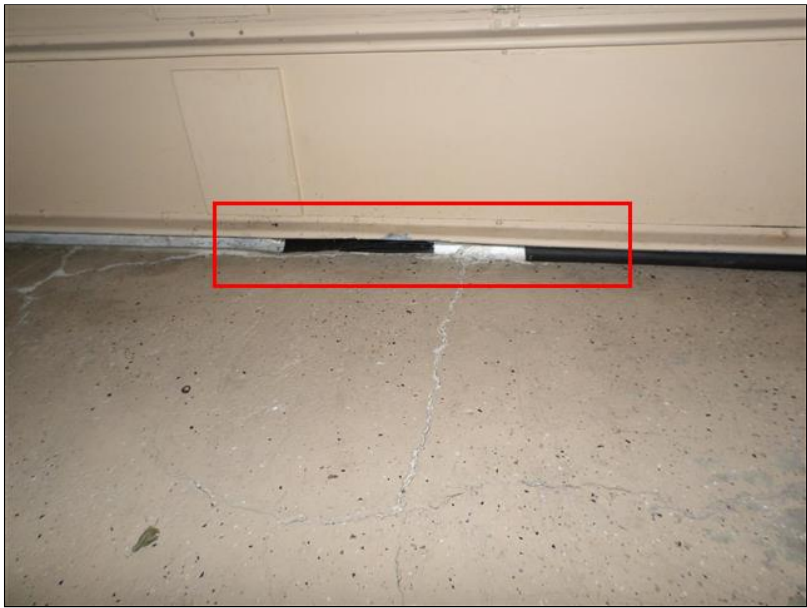
G. Item 1(Picture) Front door

(1) Several doors have damaged weather stripping along the lower edge. Recommend repair to prevent heat and cooling loss.

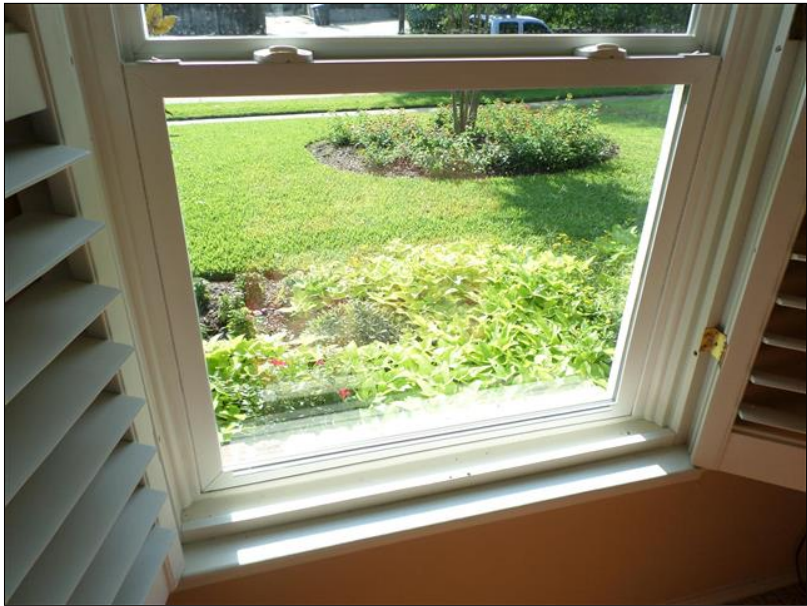
H. Item 1(Picture) No screens

Comments:  
Multiple windows screens are missing.

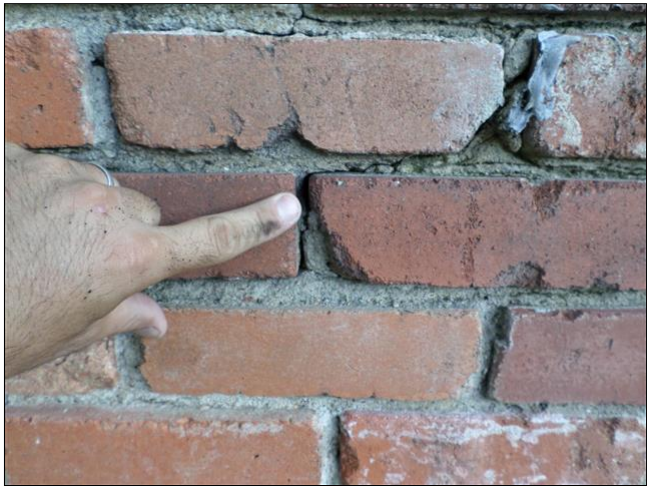
J. Item 1(Picture) Chimney

(2) Exterior bricks on chimney have cracking in the mortar joints. Recommend sealing cracks to prevent freezing water from causing damage.

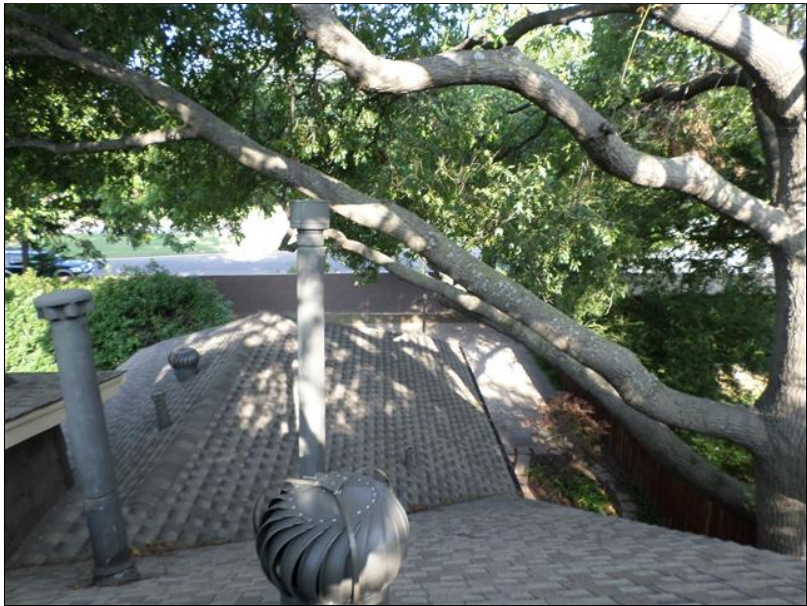
L. Item 1(Picture)

(2) The tree limbs that are in contact with roof or hanging near roof should be kept trimmed back away from roof.

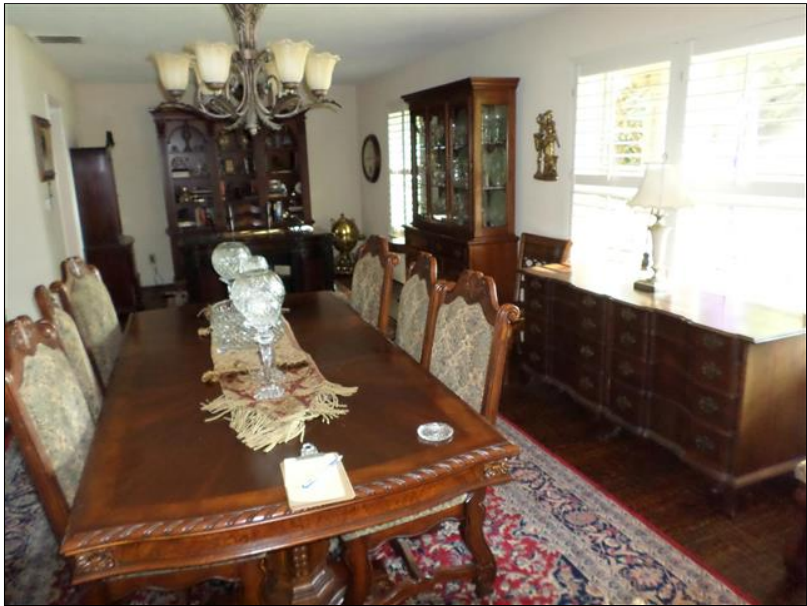
L. Item 2(Picture)

(3) House was occupied time of inspection. There were many areas not accessible to inspect due to stored items and furniture.

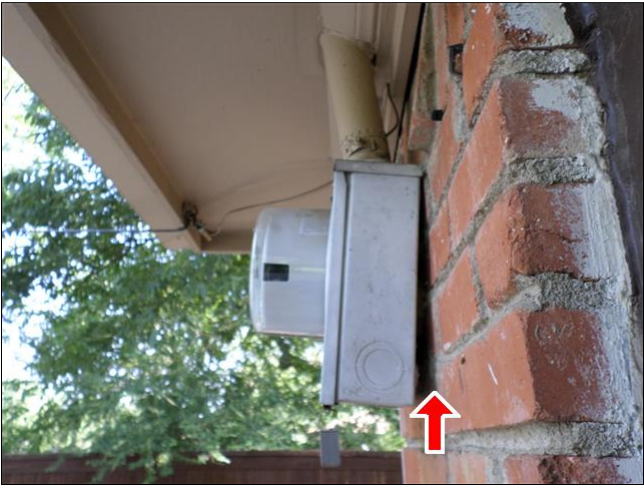
A. Item 1(Picture)

(1) The meter base box outside has pulled loose from siding and can allow debris and water to become trapped behind panel which will eventually deteriorate the siding. Recommend qualified electrician assesses meter box further.

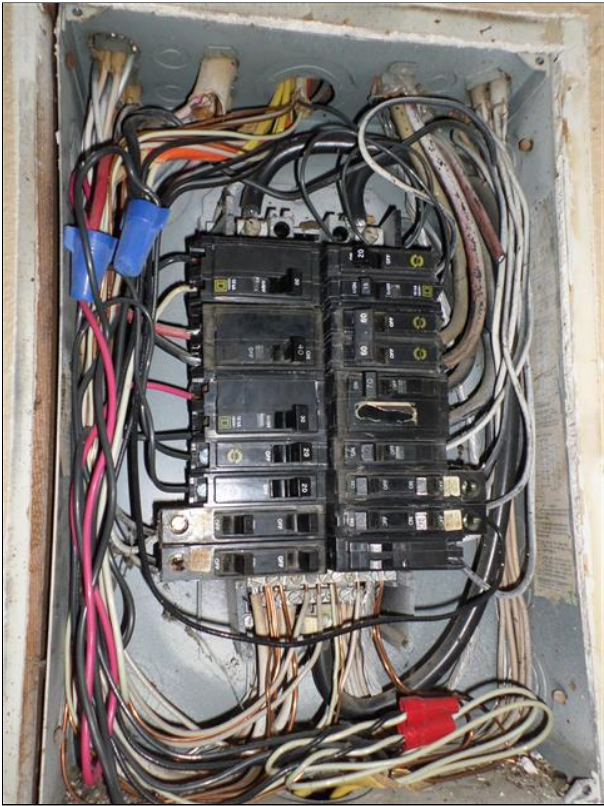
A. Item 3(Picture)

(3) The Inspector was unable to confirm amperage rating of the main electrical service panel due to missing or illegible label information.

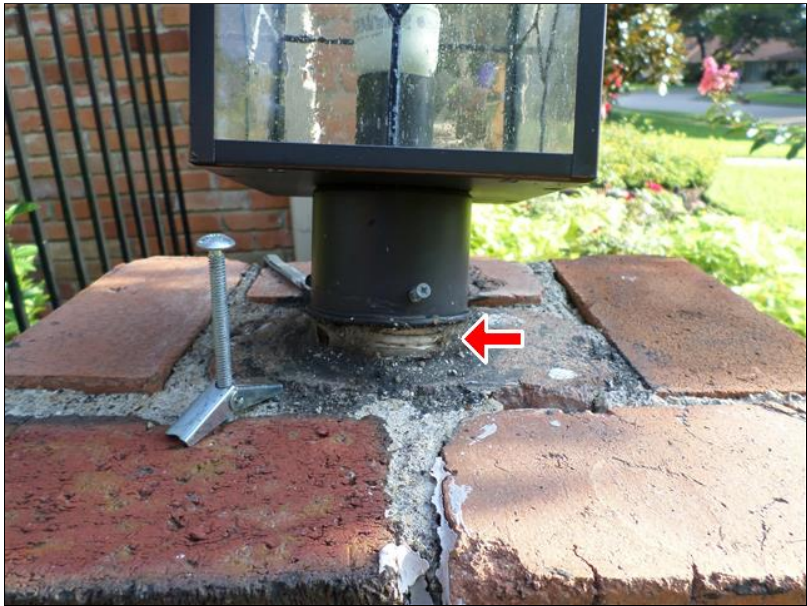
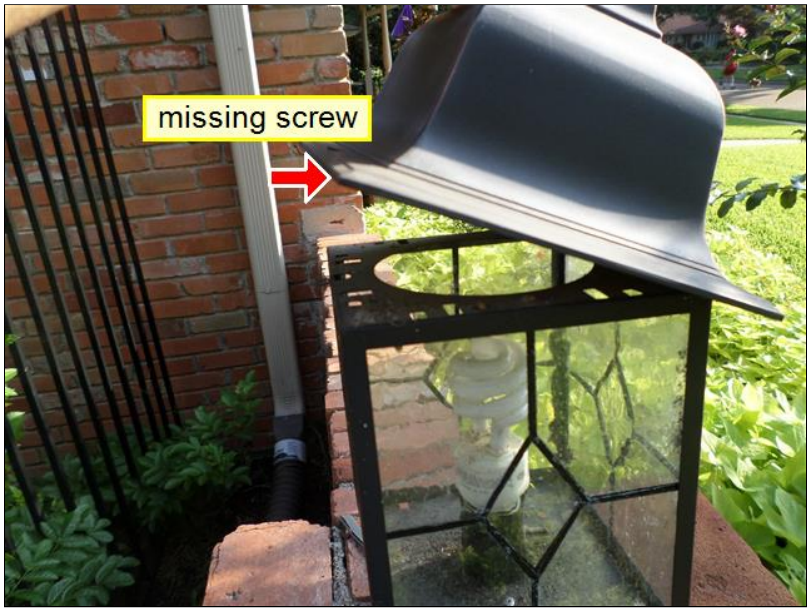
B. Item 1(Picture) Left of front door

- (1) Exterior light on brick column, left of front door needs to be fastened and resealed.

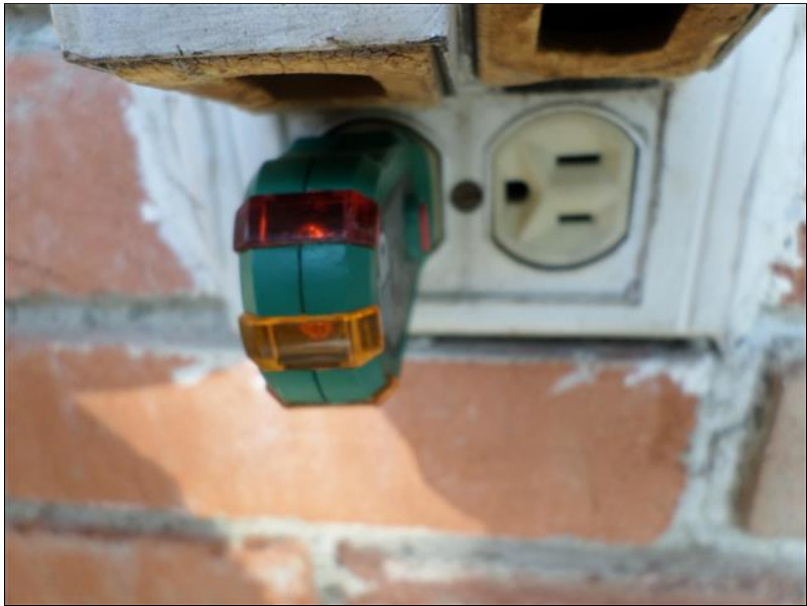
B. Item 3(Picture) Front porch

(2) Exterior outlet on front porch indicated hot/neutral reversed. Recommend repair by qualified electrician.

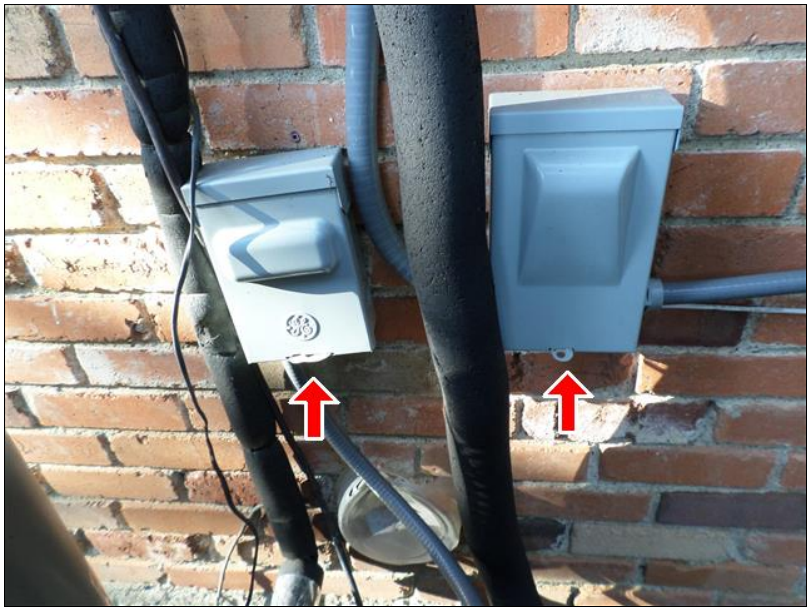
B. Item 4(Picture) A/C disconnect

(3) Exterior electrical panel should have a locking mechanism.

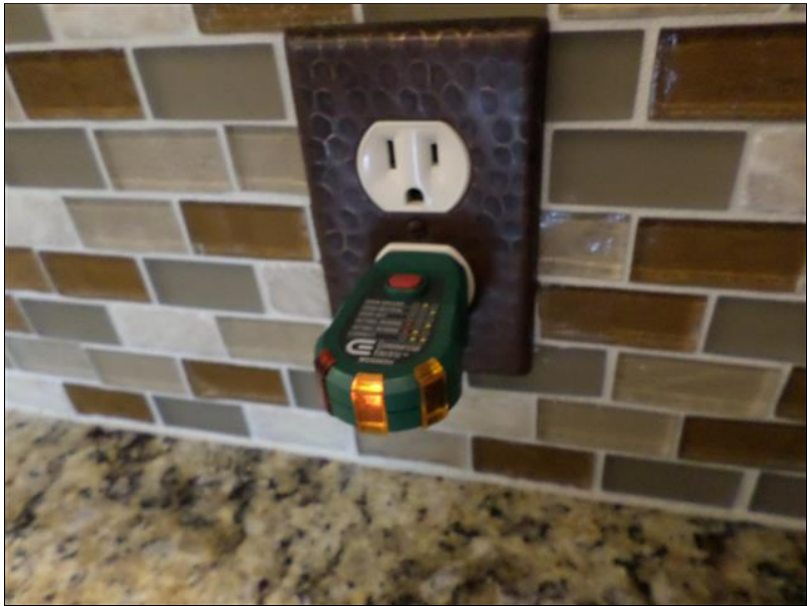
B. Item 5(Picture)

(4) Multiple outlets throughout the home showed to have a open ground. Recommend qualified electrician repairs as desired.

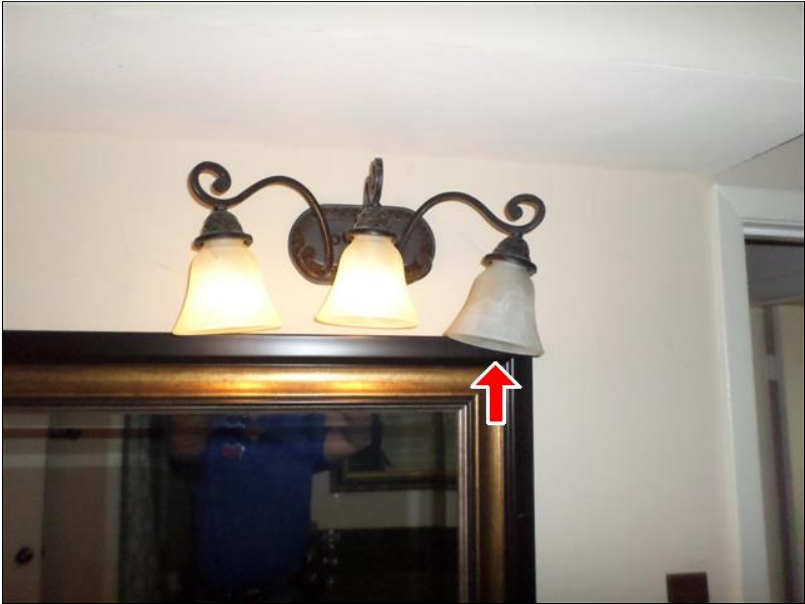
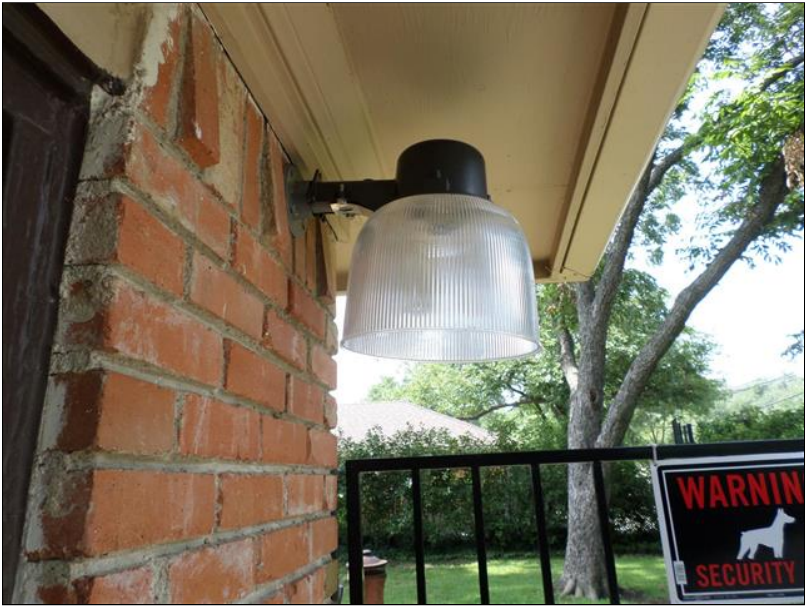
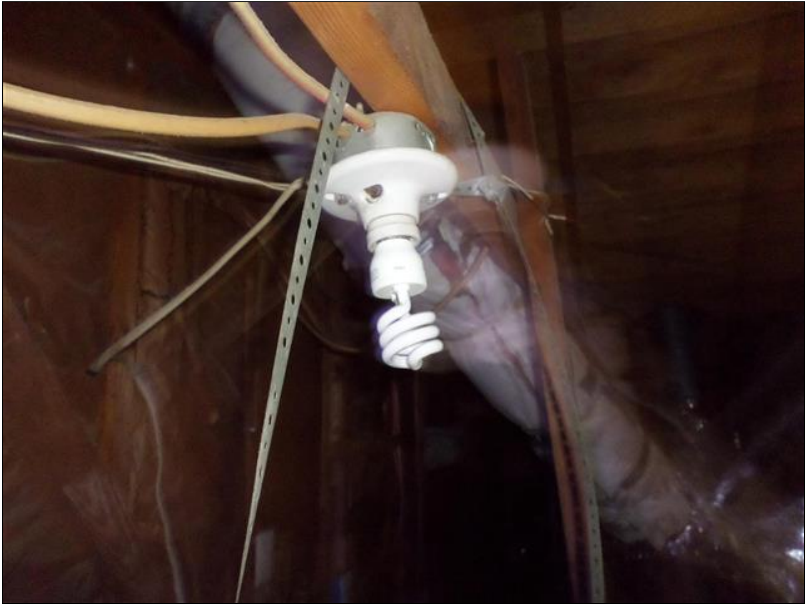
B. Item 6(Picture) Master bath

(5) Some light fixtures in the home appeared to be inoperable. The bulbs may be burned out, or a problem may exist with the fixtures, wiring or switches. If after the bulbs are replaced, these lights still fail to respond to the switch, this condition may represent a potential fire hazard, and the Inspector recommends that an evaluation and any necessary repairs be performed by a qualified electrical contractor.

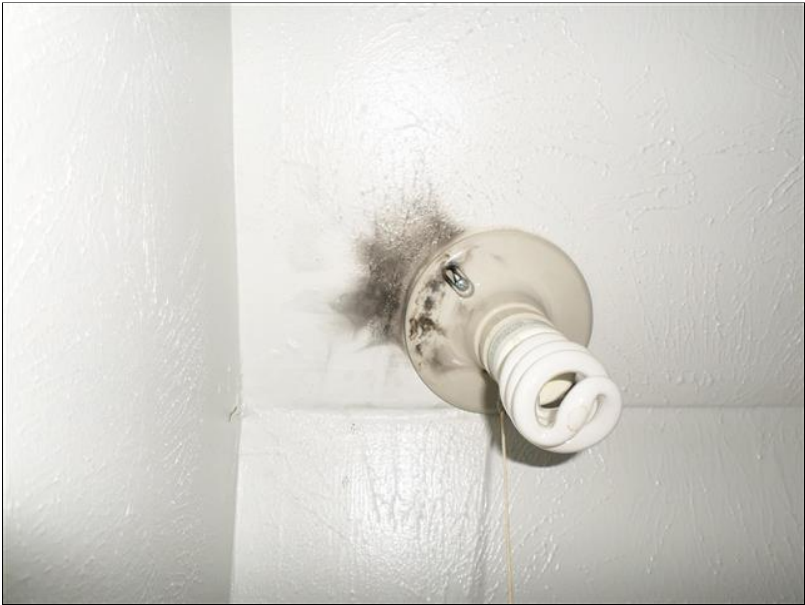
B. Item 9(Picture) Master bedroom closet

(6) Light in master bedroom closet showed signs of possible arcing at some time. Recommend having qualified electrician assess further.

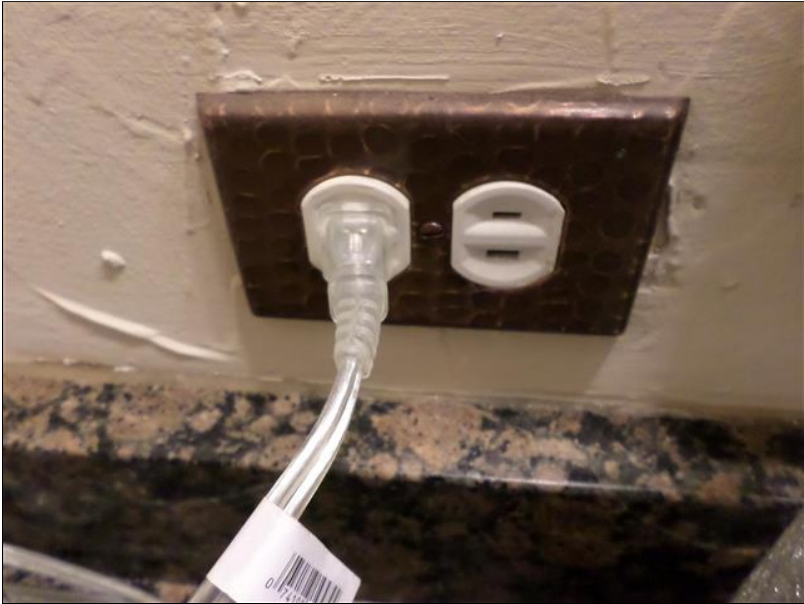
B. Item 10(Picture) Master bath

(7) Outlets in the master bath room near sink are not grounded outlets.

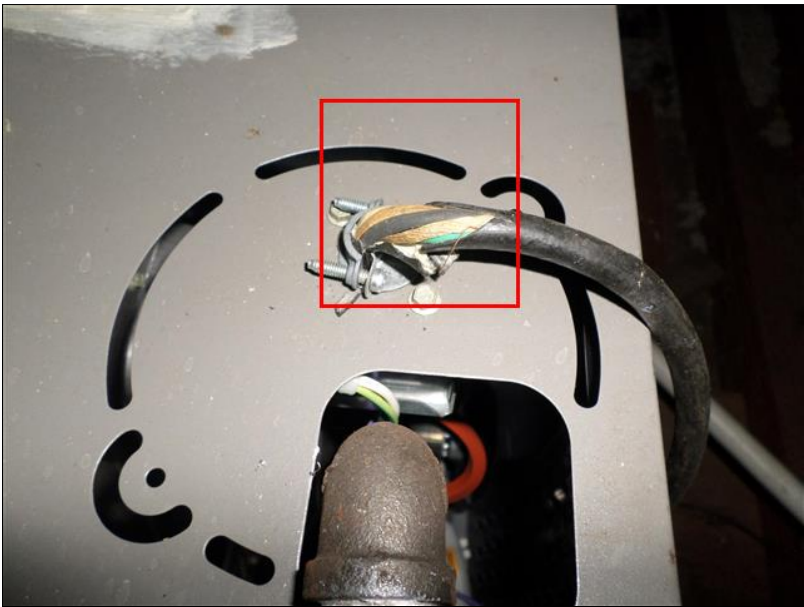
B. Item 11(Picture)

(8) Wires entering the upstairs a/c unit were damaged. Recommend qualified electrician repairs.
