# Inspection Report

# PROPERTY INSPECTION REPORT

**Concerning:** 1234 No Where Ln, Dallas, TX 75214

**By:** Brian Ruiz Trec#10502 / Built Right Home Inspections 8/7/2014

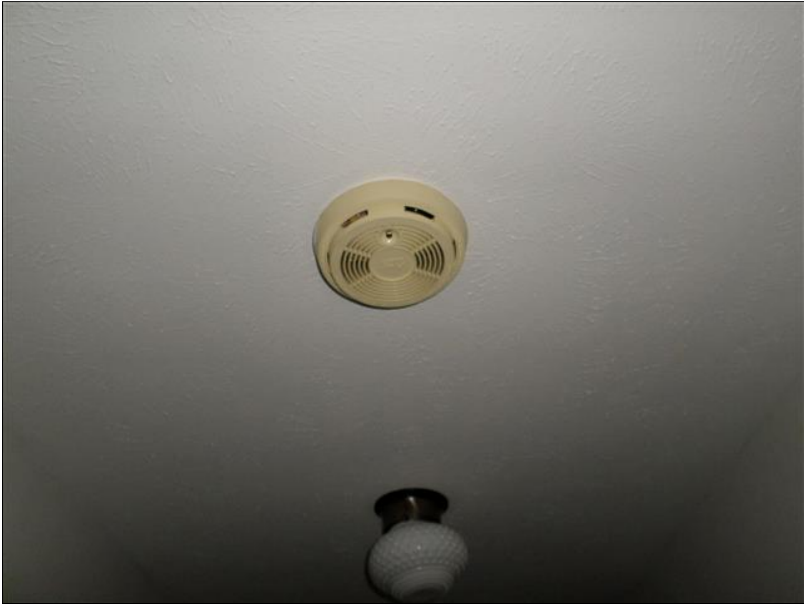
B. Item 12(Picture)

(9) Smoke detectors are missing in bedrooms. The installation of smoke alarm(s) is required inside of all bedrooms and in any rooms designated for the purpose of sleeping, and outside within the proximity of the doors to those rooms. Test all alarms and detectors weekly or monthly per manufacture instructions . The installation of carbon monoxide (CO) detector(s) is required in homes with fuel-fired appliances at every floor elevation and any areas where fuel-fired equipment is located. The installation of Type ABC fire extinguisher(s) at the kitchen, laundry, and garage, if applicable, is also advised. Test all of these devices monthly. Install new batteries yearly. Initiate and practice plans of escape and protection for all occupants in case any emergencies arise. Failure to repair defective or install absent alarms, detectors, and other safety equipment immediately can result in serious injury or death.

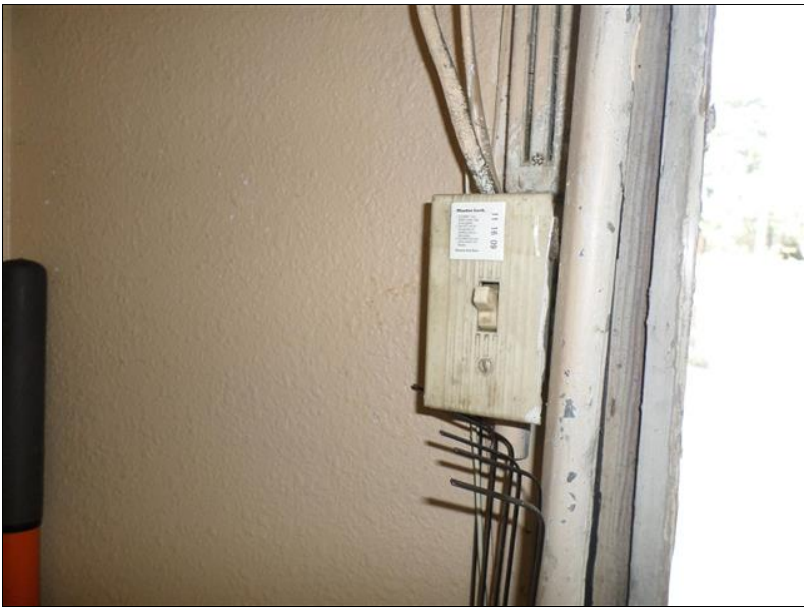
B. Item 13(Picture)

(10) Unknown what switch controls near garage door. Recommend contacting current home owners.

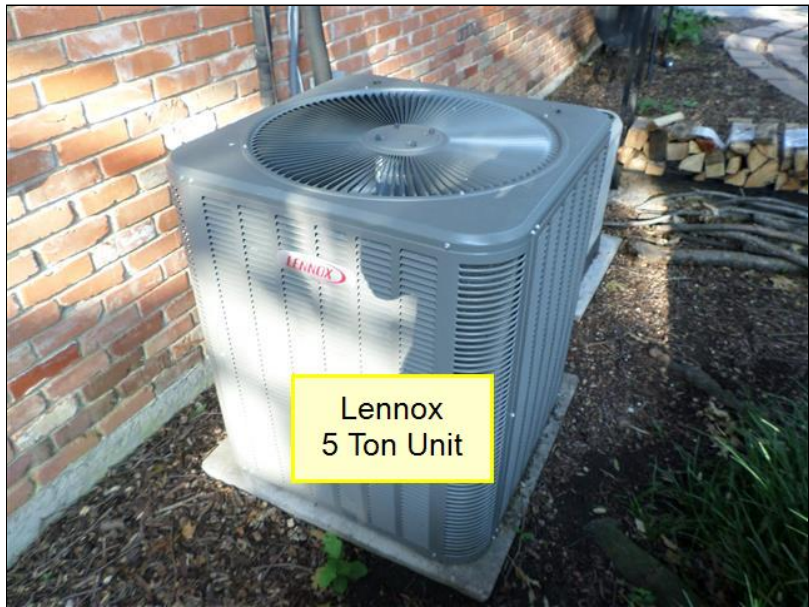
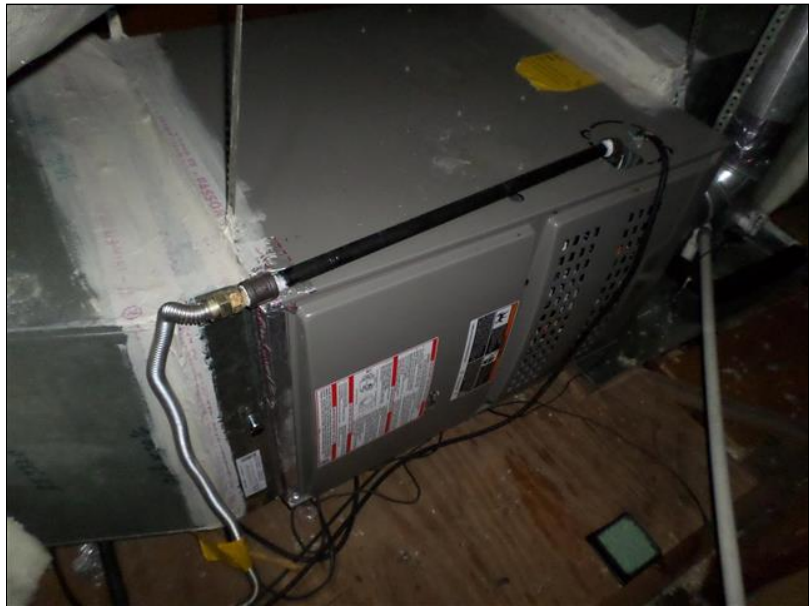
B. Item 1(Picture) Down stairs unit

(1) (Downstairs unit) The ambient air test was performed by using thermometers on the air handler of Air conditioner to determine if the difference in temperatures of the supply and return air are between 14 degrees and 22 degrees which indicates that the unit is cooling as intended. The supply air temperature on your system read 55 degrees, and the return air temperature was 74 degrees. This indicates the range in temperature drop is normal.

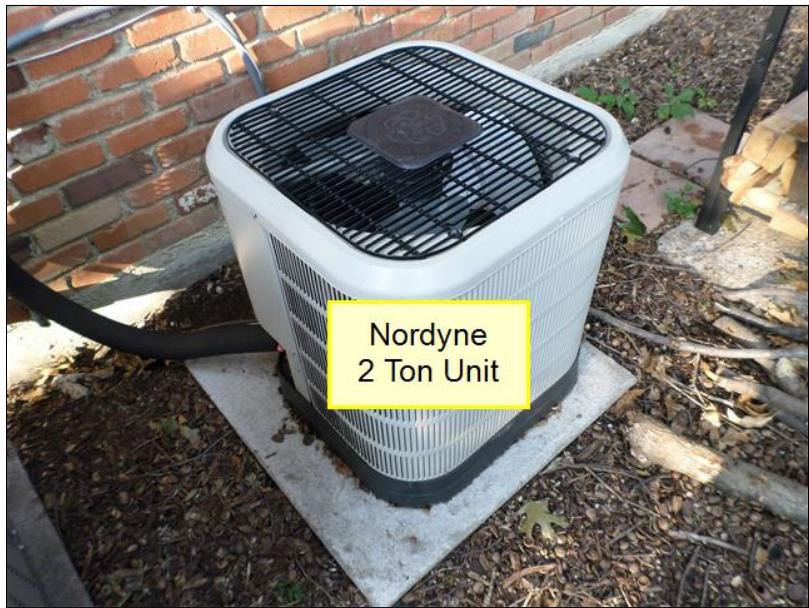
B. Item 3(Picture) Upstair Unit

(2) (Upstairs Unit) The ambient air test was performed by using thermometers on the air handler of Air conditioner to determine if the difference in temperatures of the supply and return air are between 14 degrees and 22 degrees which indicates that the unit is cooling as intended. The supply air temperature on

your system read 64 degrees, and the return air temperature was 78 degrees. This indicates the range in temperature drop is normal.

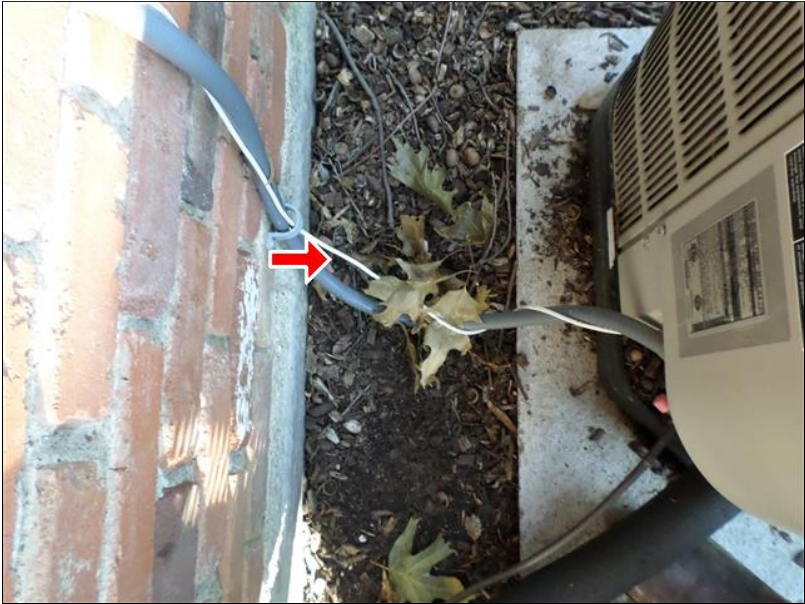
B. Item 5(Picture)

(3) Thermostat wire on condenser needs to be protected in conduit or by other means.

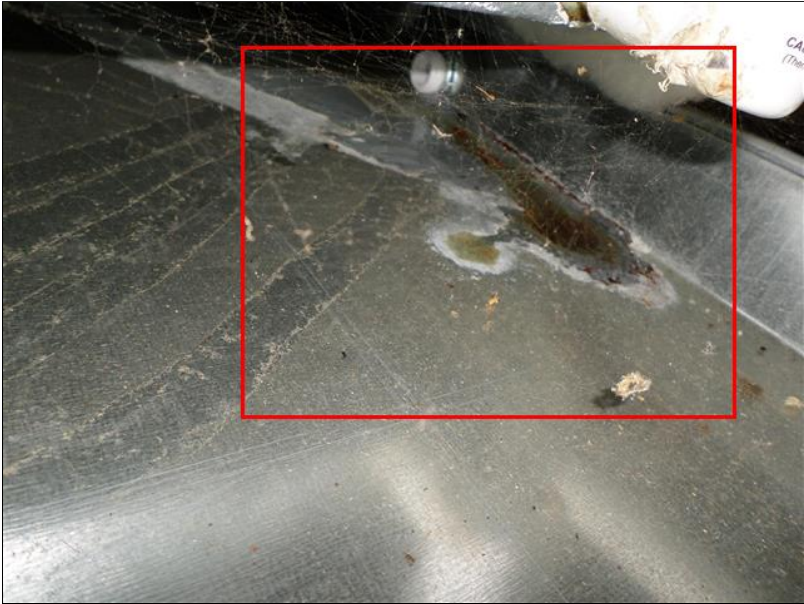
B. Item 7(Picture)

(4) The emergency condensate drain pan under the indoor EVAP coil housing has a rust build-up. This indicates that the pan has held water in the past and should be closely monitored. Rust and/or debris may be partially clogging the condensate drain lines. The primary and secondary drain lines should be flow checked and cleaned if necessary as well as being checked for proper termination.

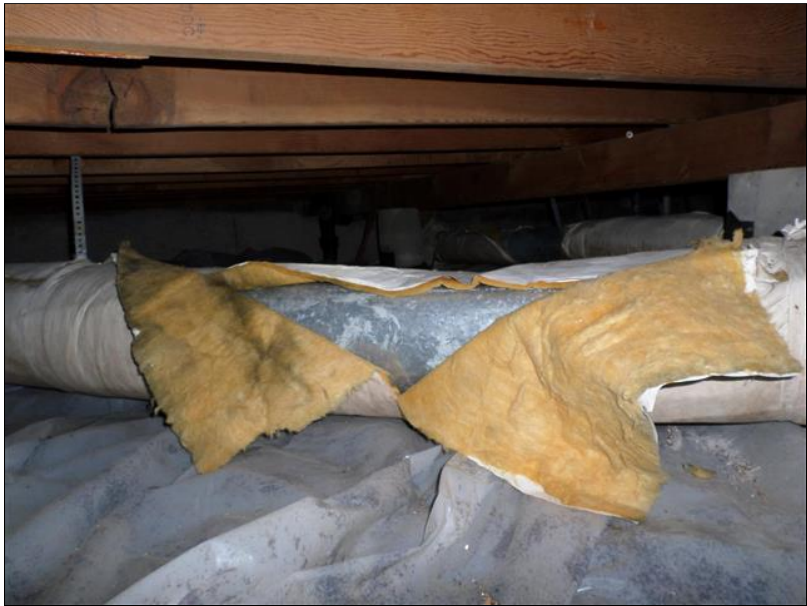
C. Item 1(Picture)

(1) Ducting insulations is coming off in multiple locations in crawl space. Recommend repair to prevent heating and cooling loss.

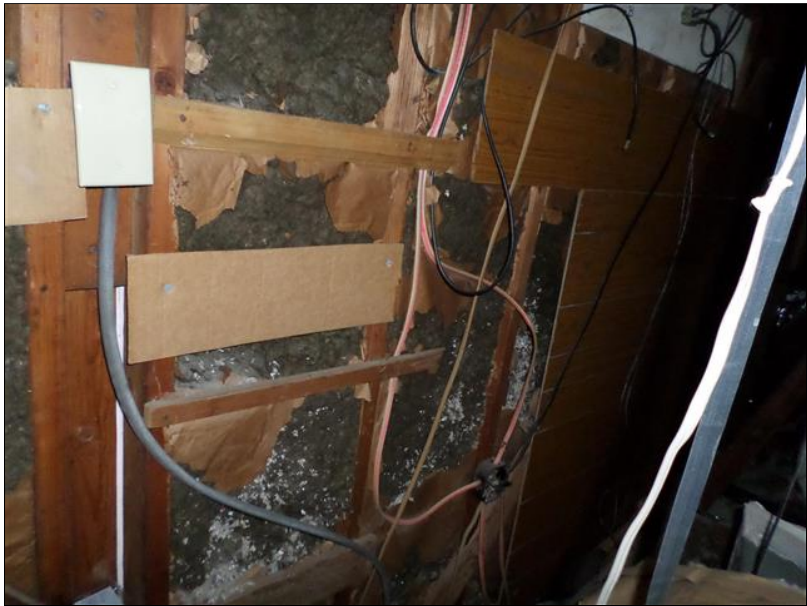
C. Item 3(Picture)

(2) Vertical insulation in attic is loosing its paper. At this time it is not effecting its service.

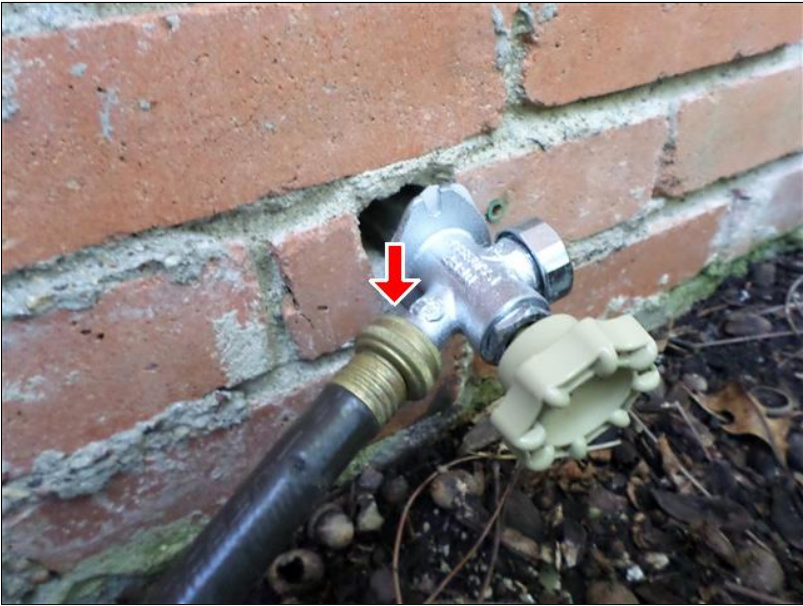
A. Item 1(Picture)

**Comments:**  
(1) Outdoor facets are missing anti siphon devices. Recommend repair as needed.

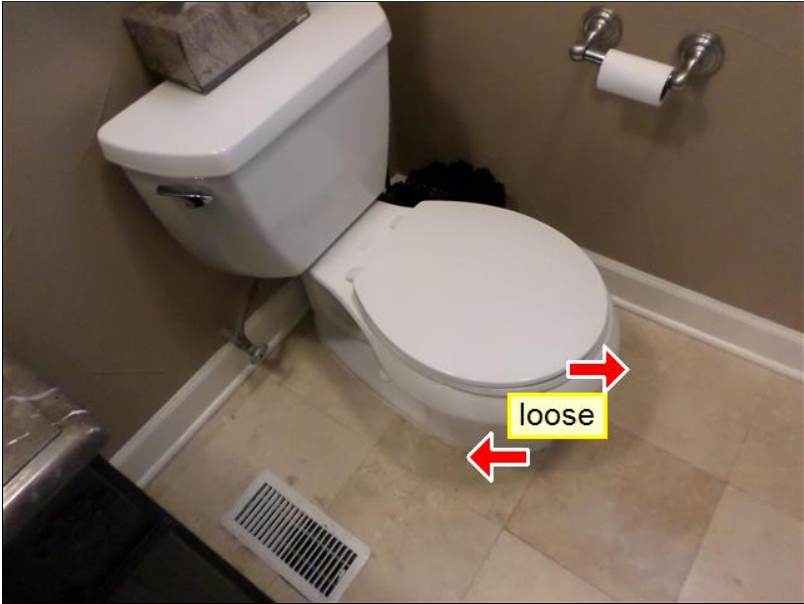
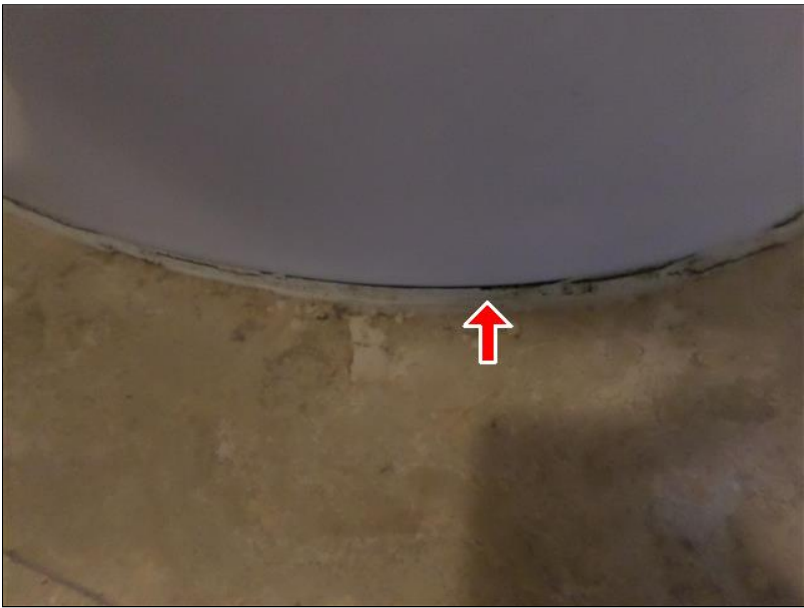
A. Item 2(Picture)

(2) The toilet is loose at floor at the master bath. Repairs may involve re-setting the toilet on a new wax seal and re-sealing at the floor. I recommend a qualified licensed plumber repair or correct as needed.

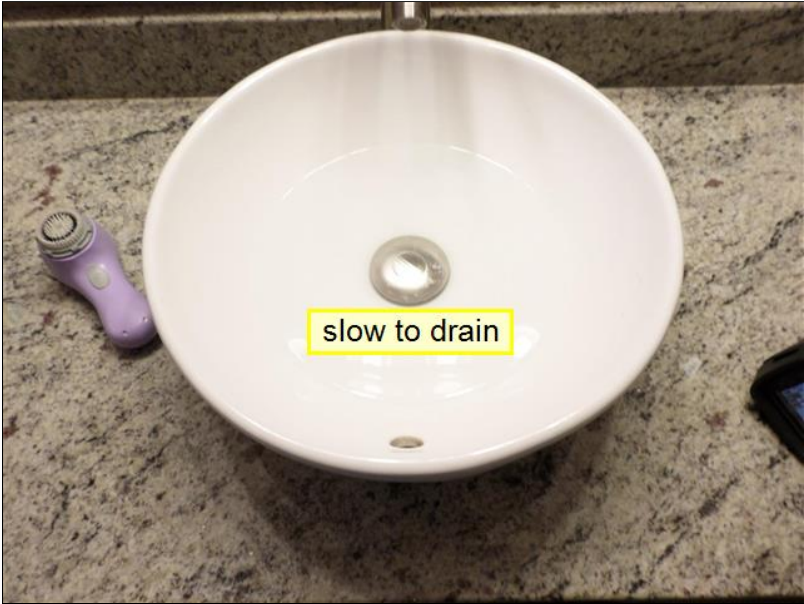
A. Item 4(Picture) Upstairs sink

(3) Upstairs bathroom sink drained slowly, recommend qualified plumber assesses further.

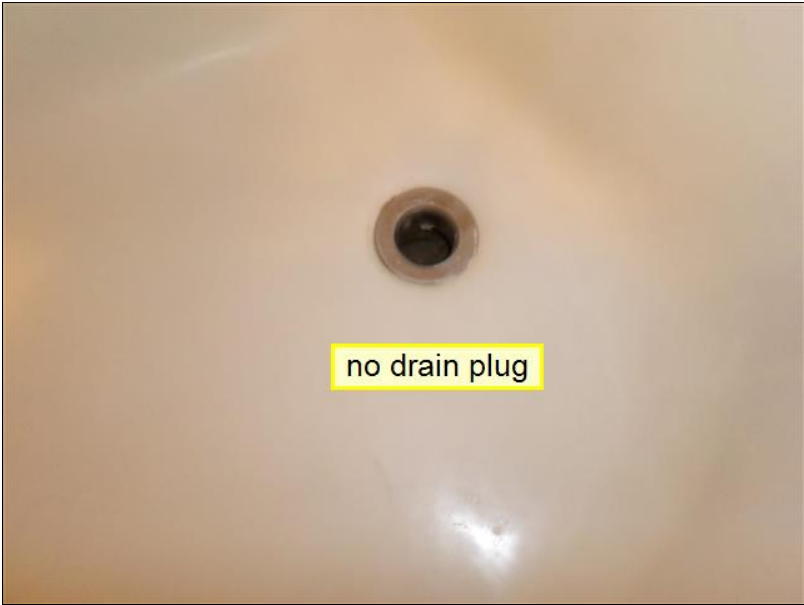
A. Item 5(Picture) Upstairs bath tub

(4) Upstairs bathtub does not have a drain plug in tub.

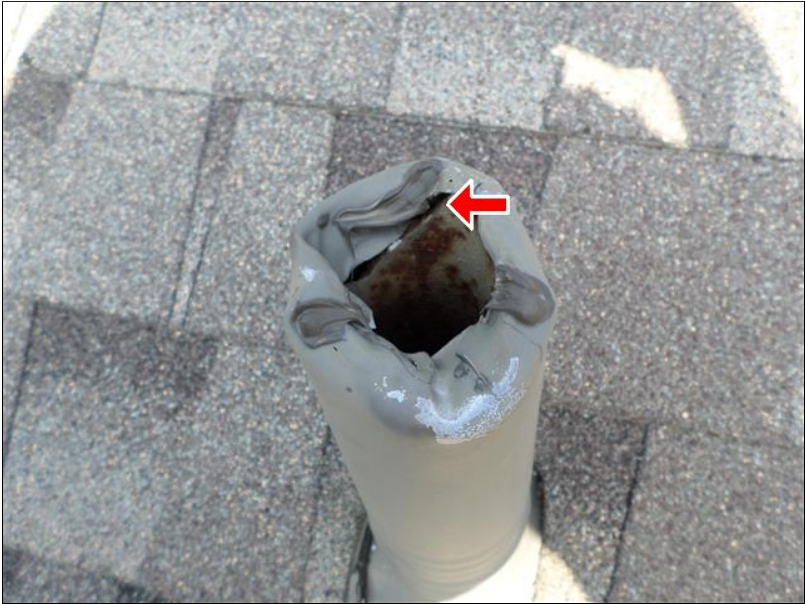
B. Item 1(Picture)

(1) Plumbing vent pipes on roof need to be resealed to prevent water intrusion.

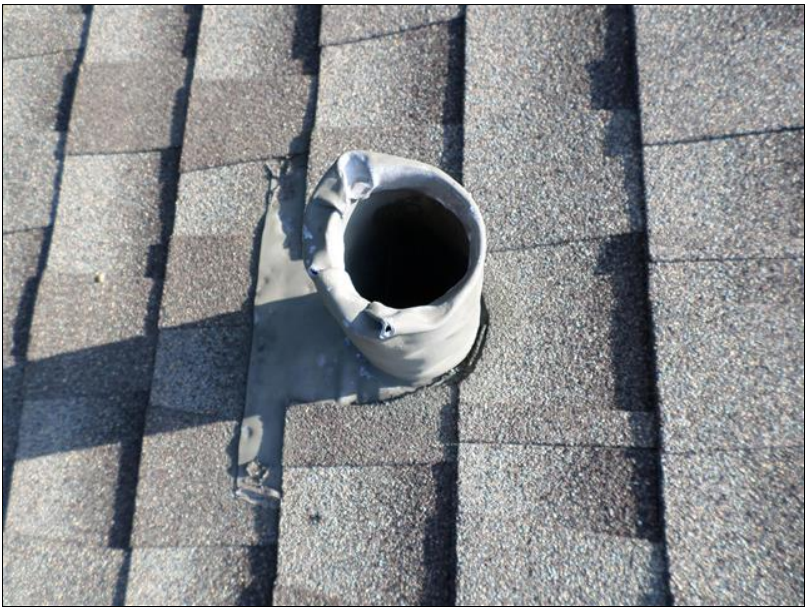
B. Item 2(Picture)

(2) Recommend larger vent pipes on roof be covered with screen to prevent pest from entering.

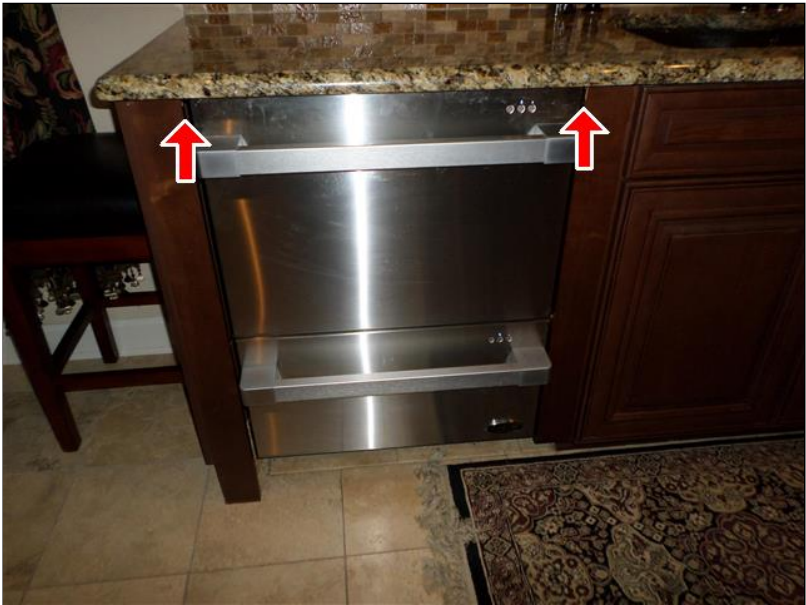
A. Item 1(Picture)

Comments:  
The dishwasher is loose and needs securing to underside of countertop (using a proper length screw). I recommend repair as necessary.

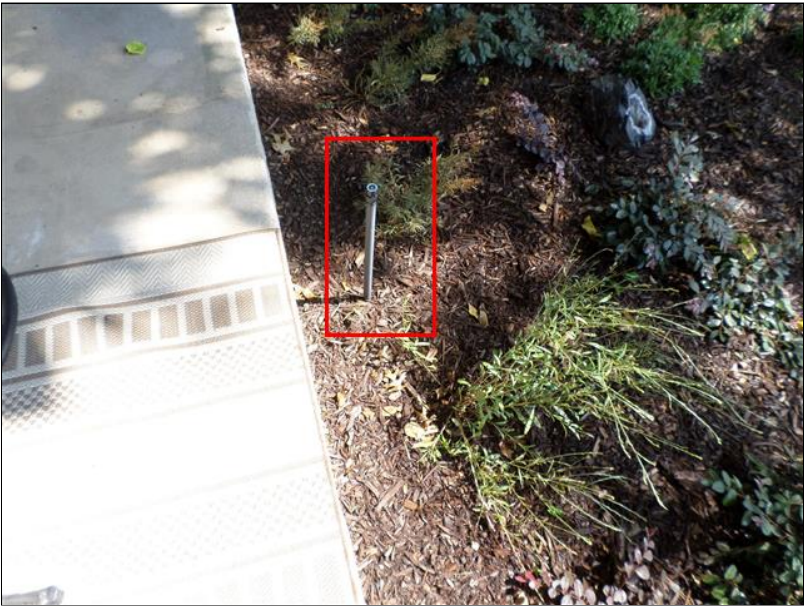
A. Item 1(Picture) Front yard

- (1) Anti-Freeze device for sprinkler system not found. Repair to prevent sprinkler activation during freezing weather.
- (2) Several sprinkler heads did not activate in front yard. Recommend qualified technician repair.
