# Inspection Report

**Property Address:**  
1234 No Where Ln  
Dallas TX 75214

# PROPERTY INSPECTION REPORT

1234 No Where Ln, Dallas, TX 75214

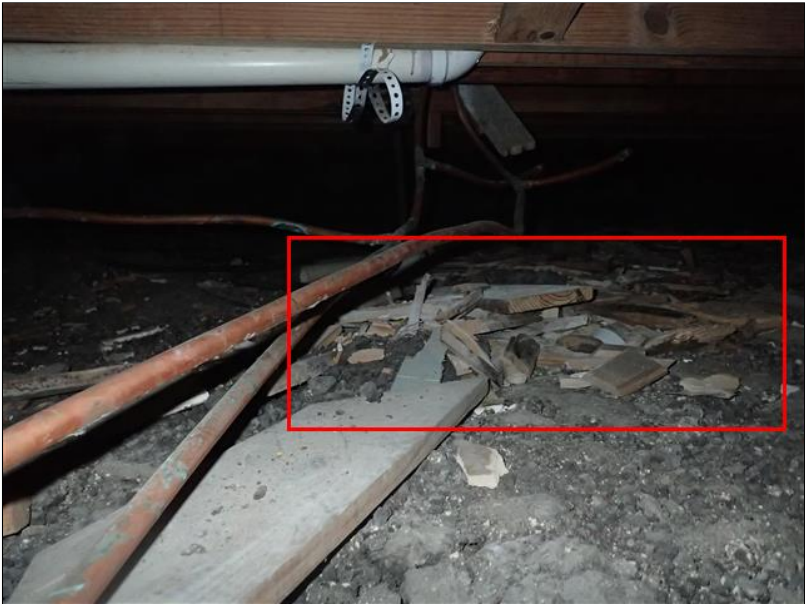
A. Item 1(Picture) Crawl space debris

- (1) Foundations on clay -based soils require adequate and evenly-distributed moisture around the perimeter of the foundation to prevent excessive movement. Trees and shrubbery can cause foundation damage when growing too close. Water should not be permitted to erode the soil or to pond alongside or under any part of the foundation. Depending on the design and construction of a pier and beam foundation, periodic leveling may be required.
- (2) The construction debris needs removing from the crawlspace under home.

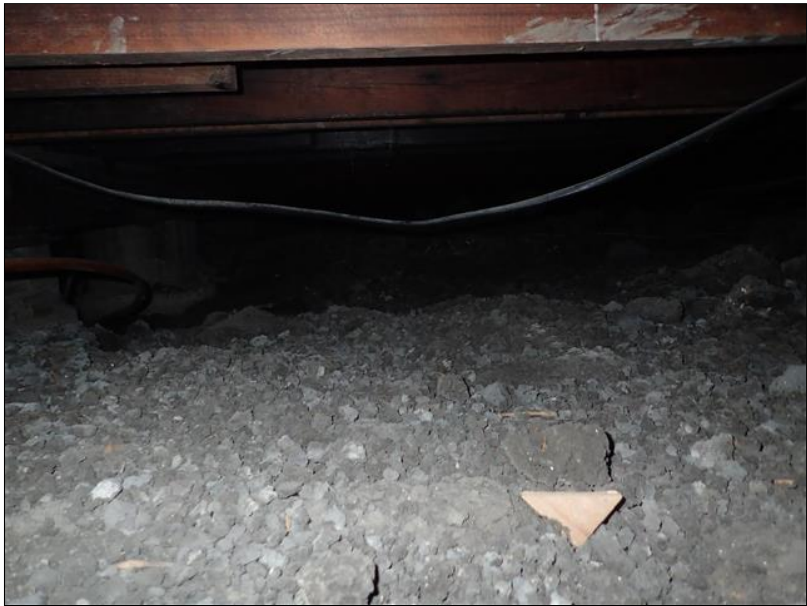
A. Item 2(Picture) Crawl space

- (3) No vapor barrier was installed at the time of the inspection. Soil covers help reduce humidity levels in crawlspaces by limiting moisture evaporation into the air from soil. Reducing humidity levels can help reduce the chances for mold growth.

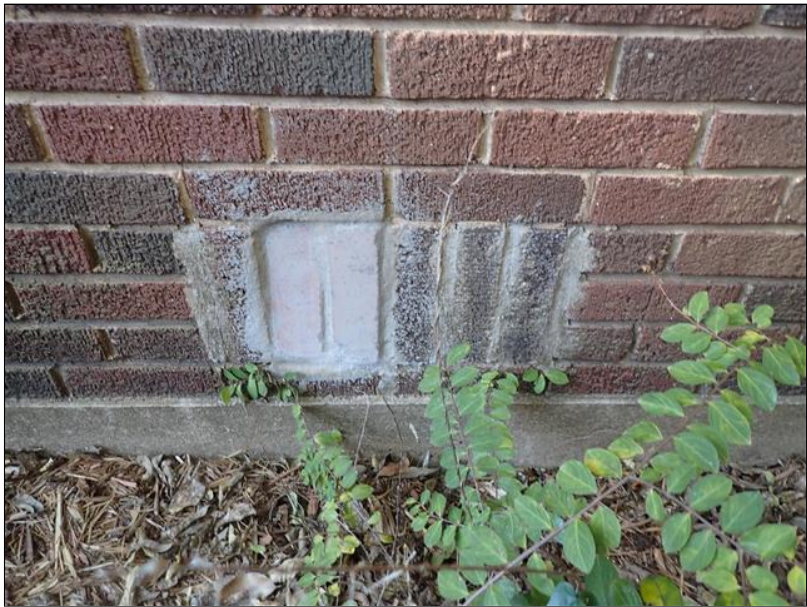
A. Item 3(Picture) Crawl space vents

(4) The crawlspace was equipped with operable vents which should be closed during cold weather to prevent pipes in the crawlspace from freezing and to save on heating costs. Vents should be opened during warm weather to allow natural air movement to carry away moisture evaporating from the soil. Most of the crawl space vents of this home have been permanently sealed not allowing sufficient ventilation of crawl space during warm weather.

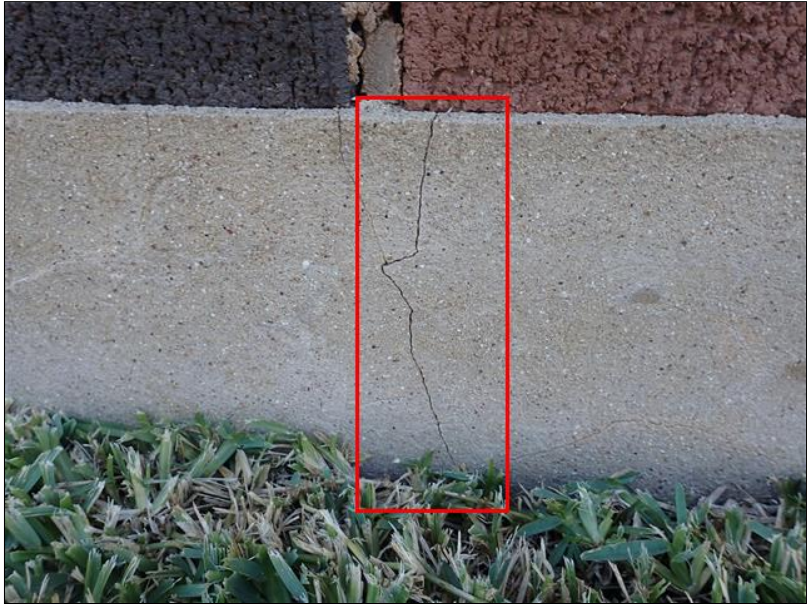
A. Item 4(Picture) West side of home

(5) Foundation walls had several minor cracks around the home. Recommend sealing these cracks to prevent water intrusion.

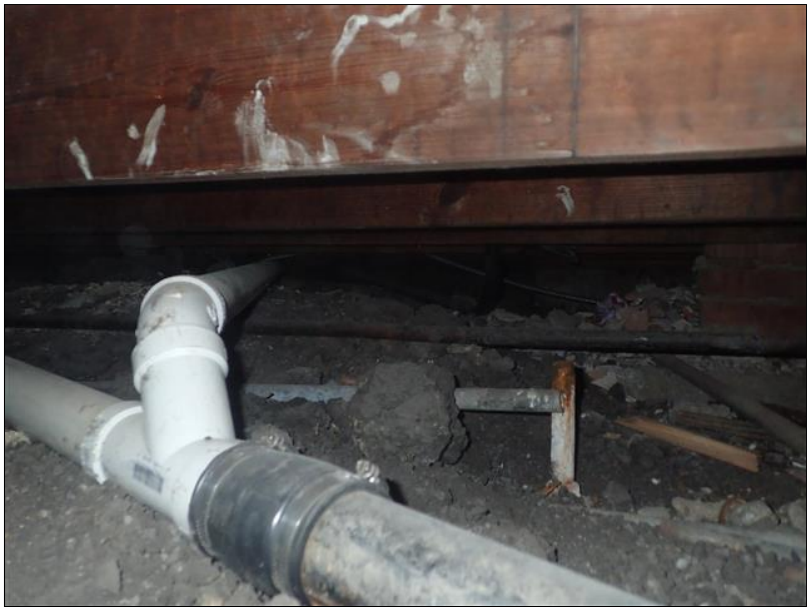
A. Item 5(Picture) Low clearance

(6) Only about 50% of the crawl space was accessible due to low clearance.

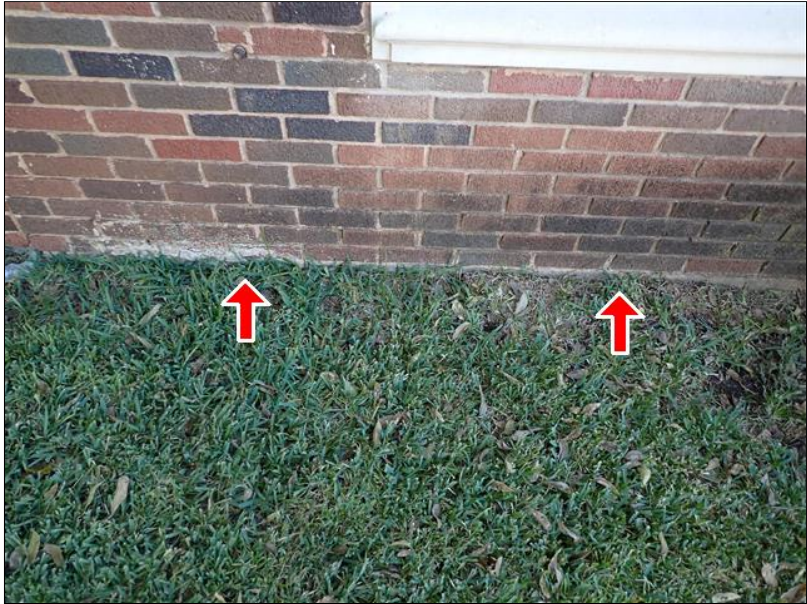
B. Item 1(Picture) Backyard

Comments:  
High soil levels around the home. The foundation is not visible in some areas. There should be 4-6" of foundation visible to help prevent water and/or pest intrusion.

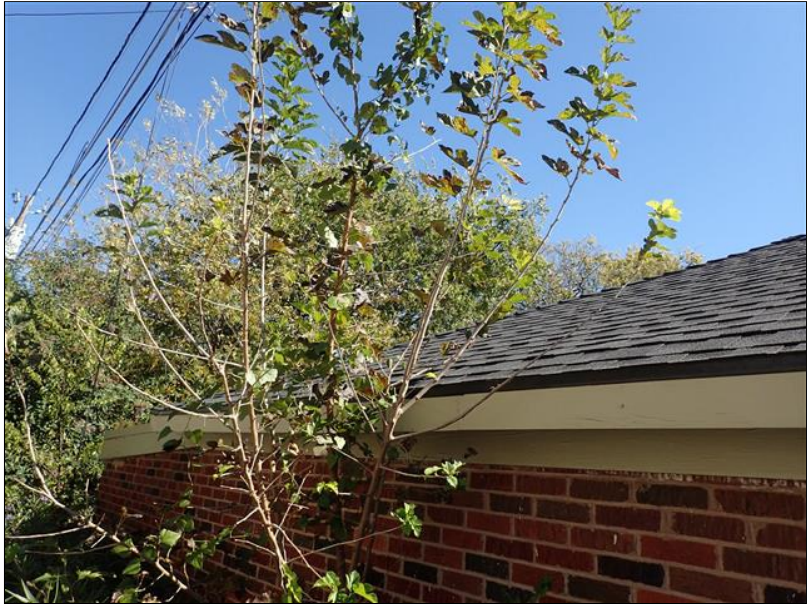
C. Item 1(Picture) North side of garage

- Comments:**
- (1) Note: Not all roofs are walked on during the inspection due to height, slope of roof, type of Roofing material, weather, and/or other safety concerns. Weather conditions (wind, hail, extreme temperatures, etc.) affect all roofing materials day to day. Periodic observations by the homeowner is recommended. Roofs are not checked for insurability due to the fact that different insurance companies have different standards for insuring homes.
  - (2) Roof shingles are in good condition. No hail or wind damage observed day of inspection.
  - (3) The tree limbs that are in contact with roof or hanging near roof should be trimmed.

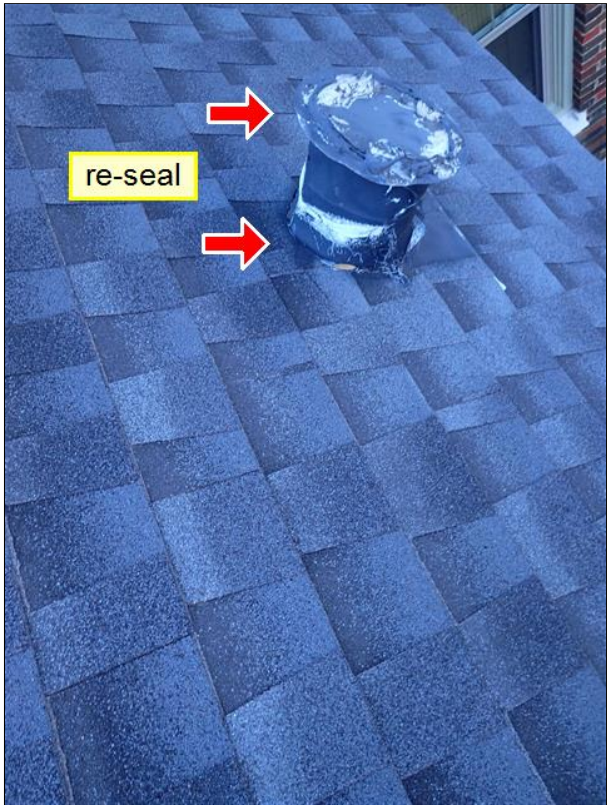
C. Item 2(Picture) Over east porch

(4) Multiple roof vents need to be re-sealed.

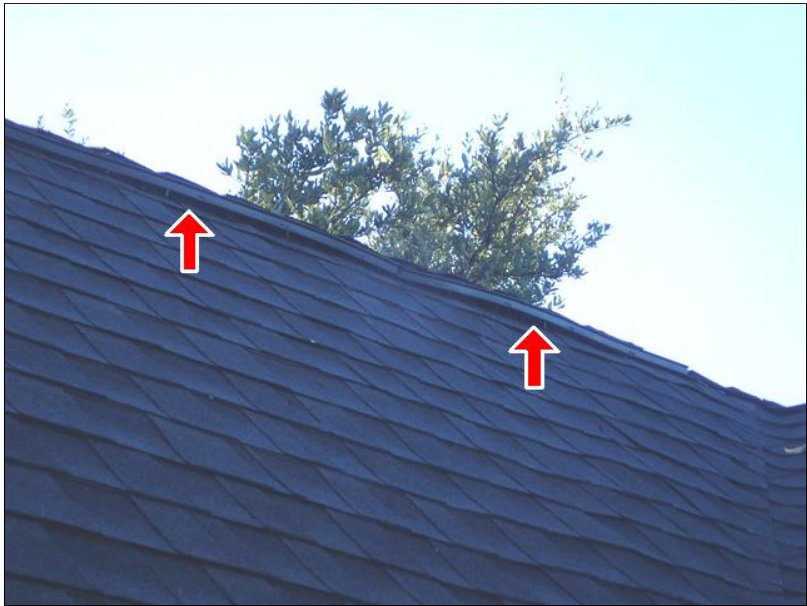
C. Item 6(Picture) Ridge vents

(6) Ridge vents appear to be lifting up. Recommend qualified roofing contractor assess this area.

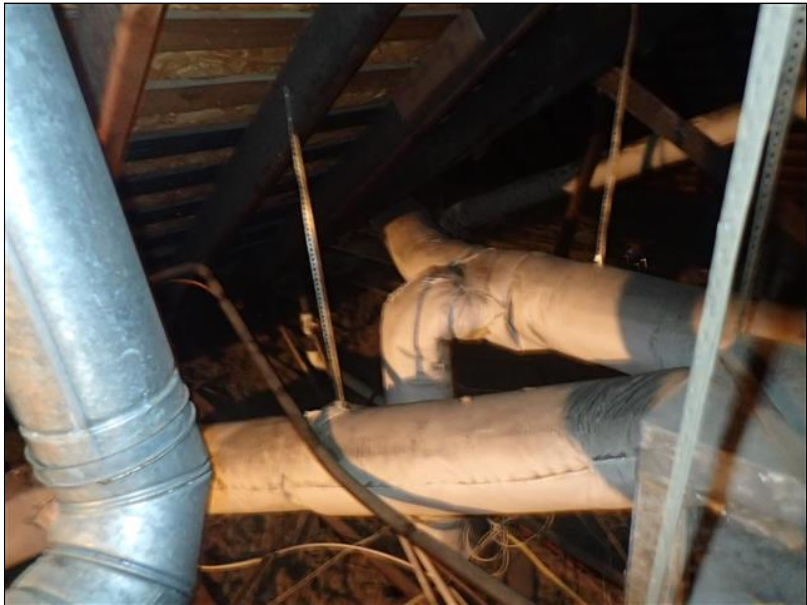
D. Item 1(Picture)

(1) Portions of the attic could not be accessed for inspection. Mechanical equipment and ducts blocked some areas of attic.

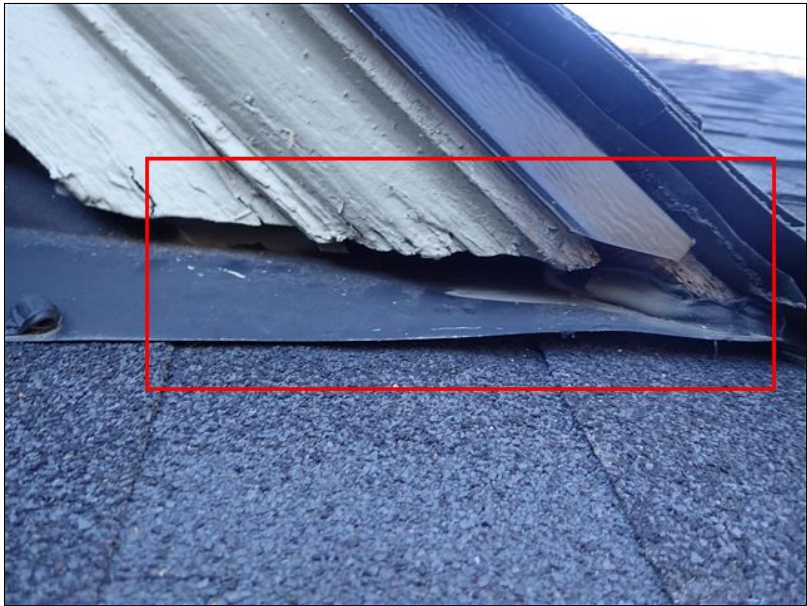
D. Item 2(Picture) Roof over east porch

(2) Fascia board over the east porch is not sealed, area is open tot the attic.

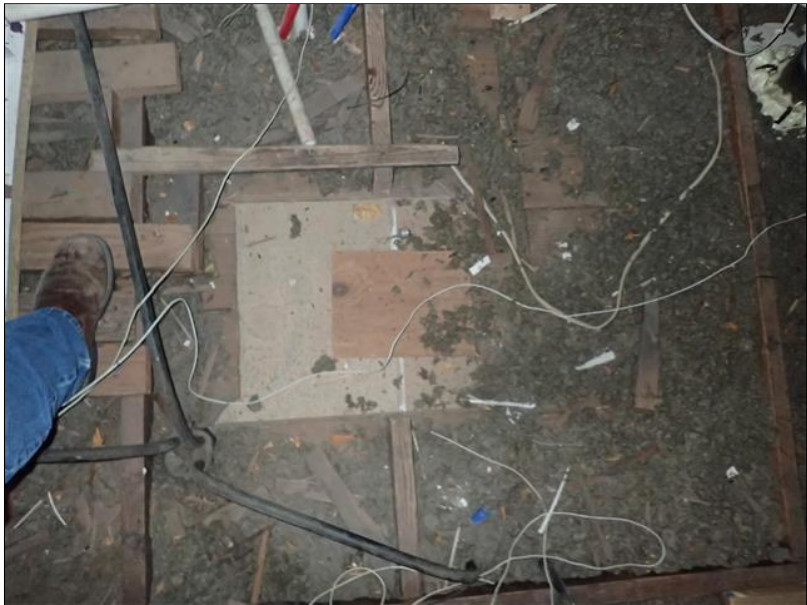
D. Item 3(Picture) Attic

(3) Attic insulation thickness was less than six inches. The Inspector recommends adding more attic insulation. The modern recommended value is R-38.

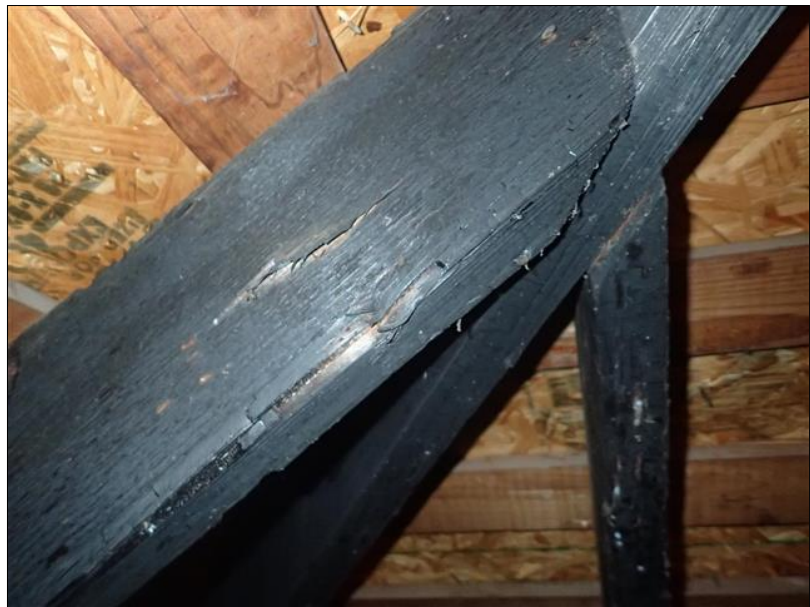
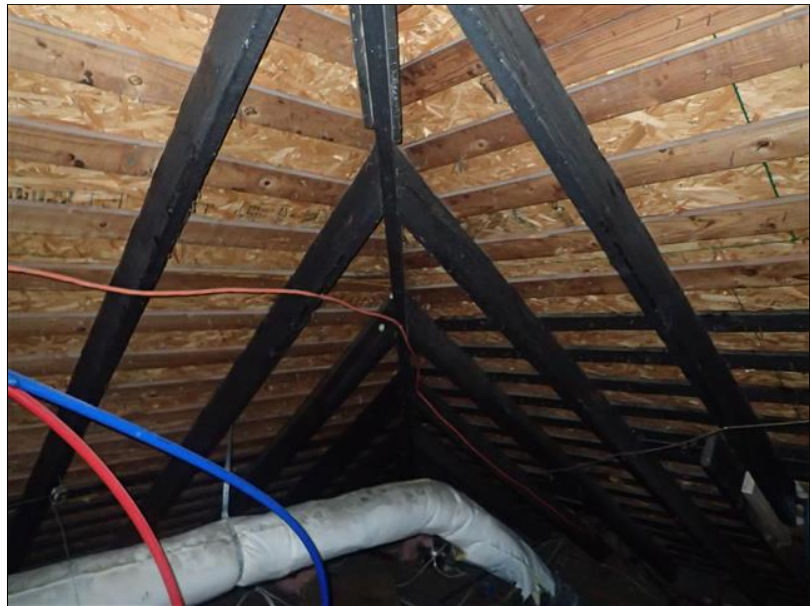
D. Item 4(Picture)

(4) Framing visible in the attic had charring indicating that the attic structure had experienced a fire.

The Inspector recommends that you have damaged framing members evaluated by a structural engineer to determine whether they heat retain sufficient residual strength. Depending upon the engineers findings you may need to consult with a qualified contractor to discuss options and costs for any necessary repairs.

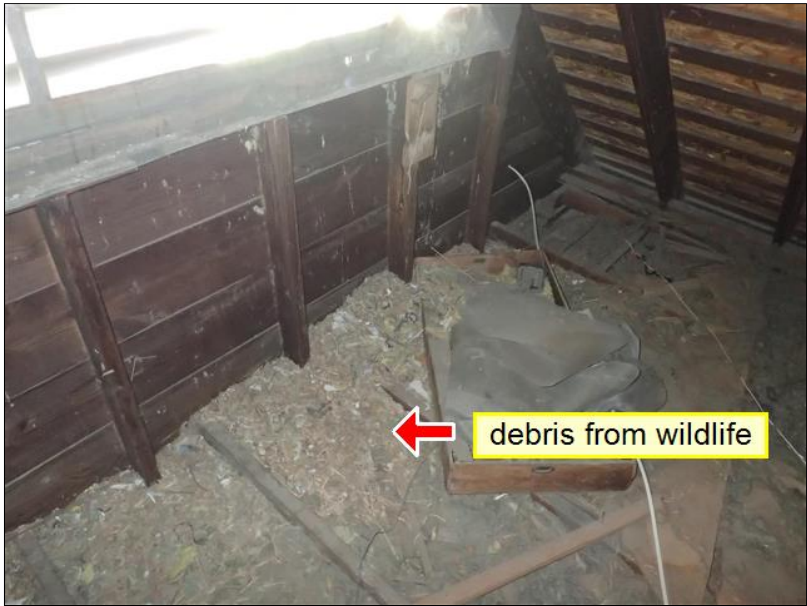
D. Item 6(Picture) East side attic, near gable vent

(5) East side gable has multiple areas where wildlife are entering the attic. Recommend this area be sealed properly and cleaned of debris.

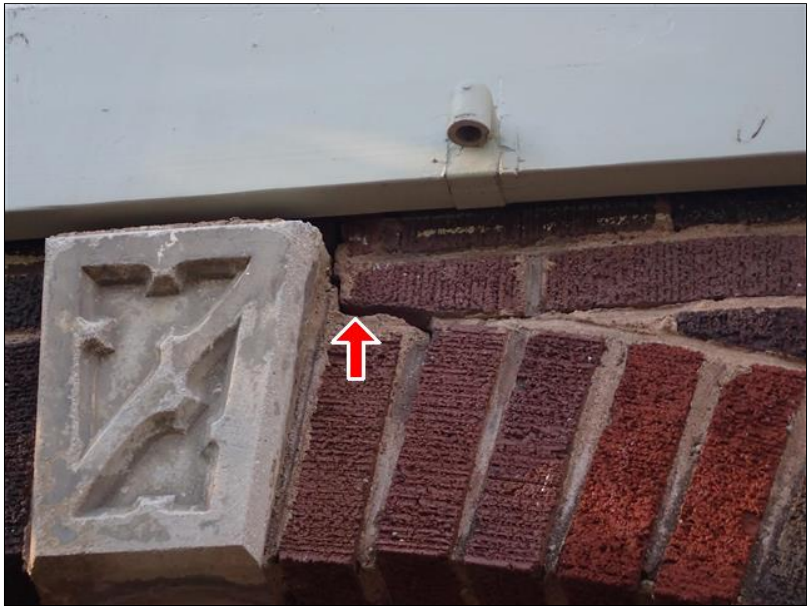
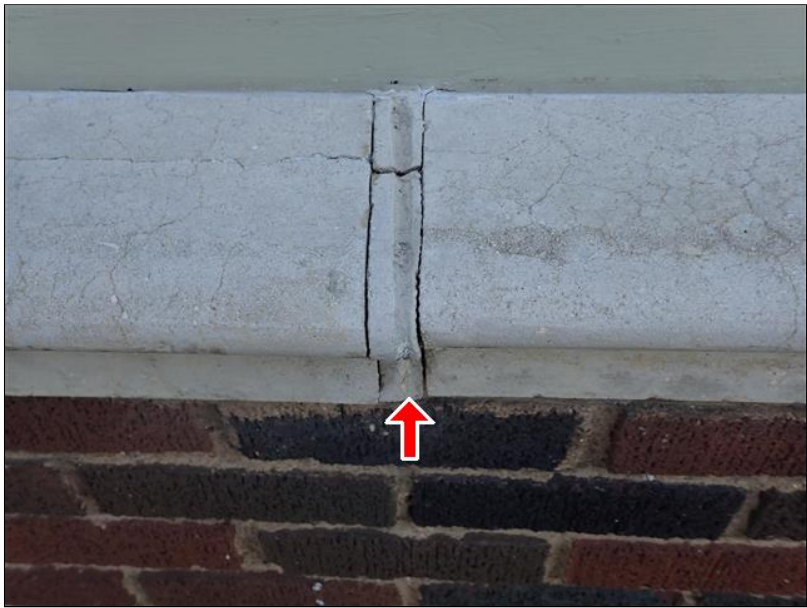
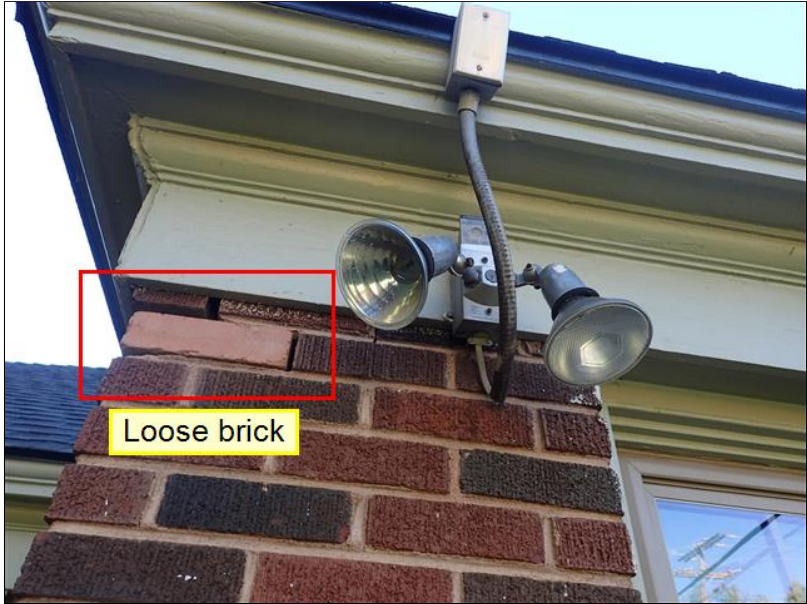
E. Item 6(Picture) East side over porch

(3) Brick covering exterior walls had areas of missing mortar.

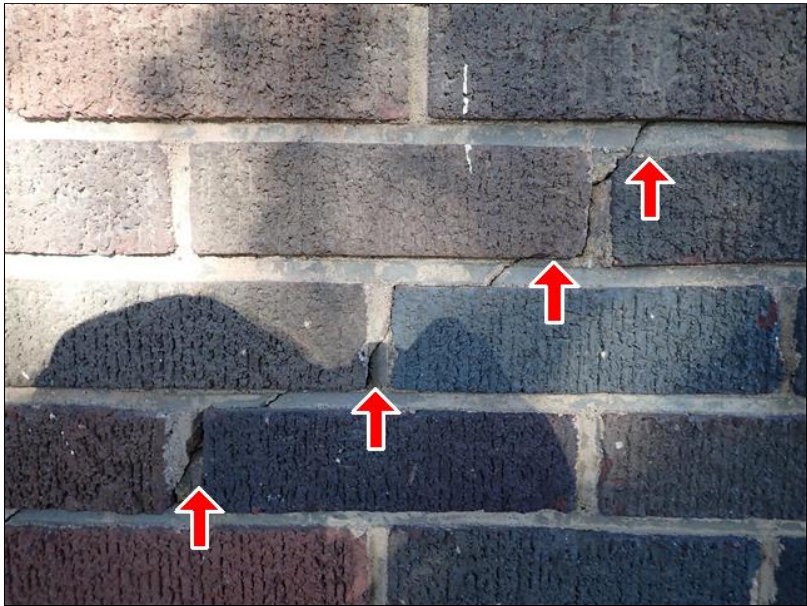
E. Item 9(Picture) East side of home

(4) Stepped cracking was visible in areas of the brick exterior at the time of the inspection. The Inspector recommends that the cause of cracking be determined by a qualified contractor and corrected and that existing cracks be patched to avoid damage from moisture intrusion.

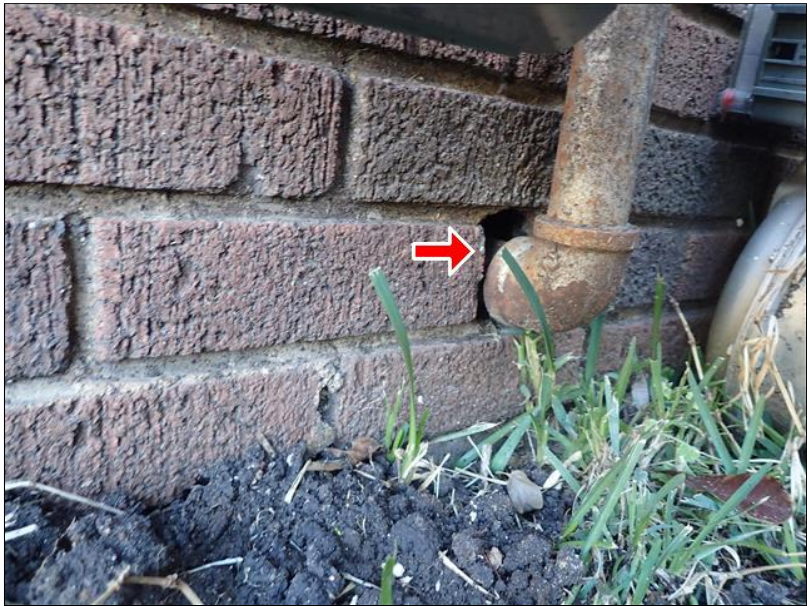
E. Item 13(Picture) Gas line, west side

(6) All drain's or anything exiting or entering through exterior wall should be properly sealed to prevent water or insect intrusion.

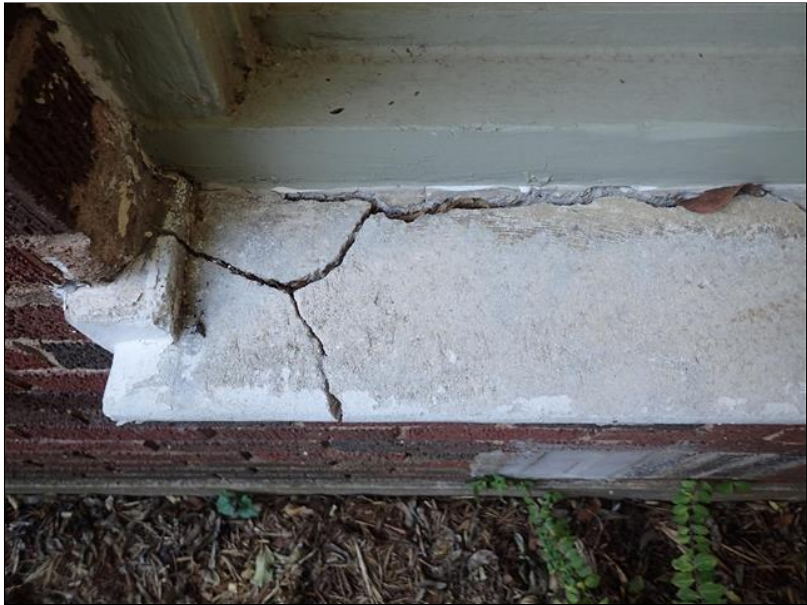
E. Item 16(Picture) East side window sill

(7) East side exterior window sill has cracking, recommend sealing to prevent water intrusion and further damage.

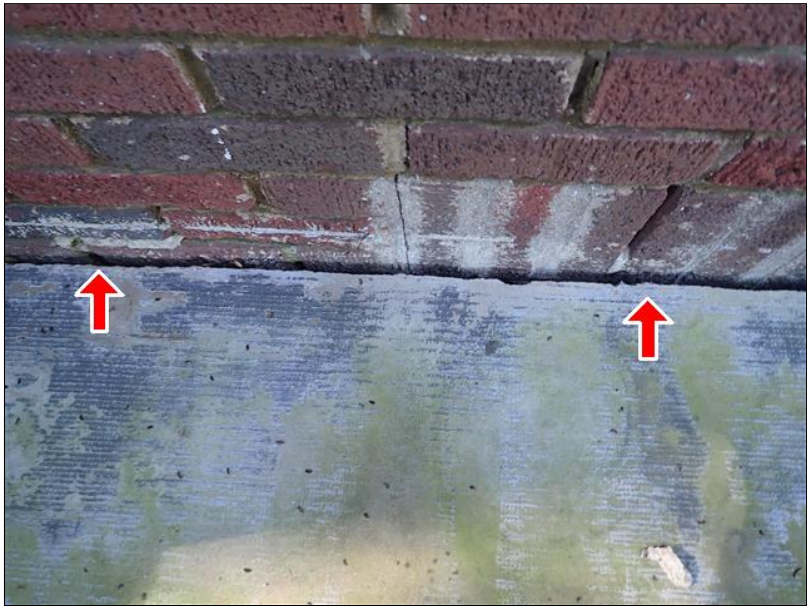
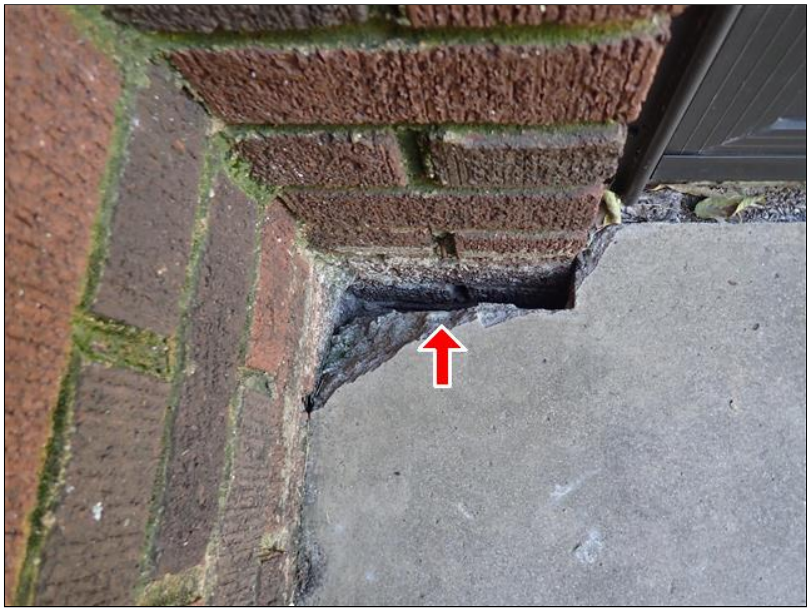
E. Item 17(Picture)

(8) Multiple areas around home at porches and foundations should be sealed to prevent water intrusion.

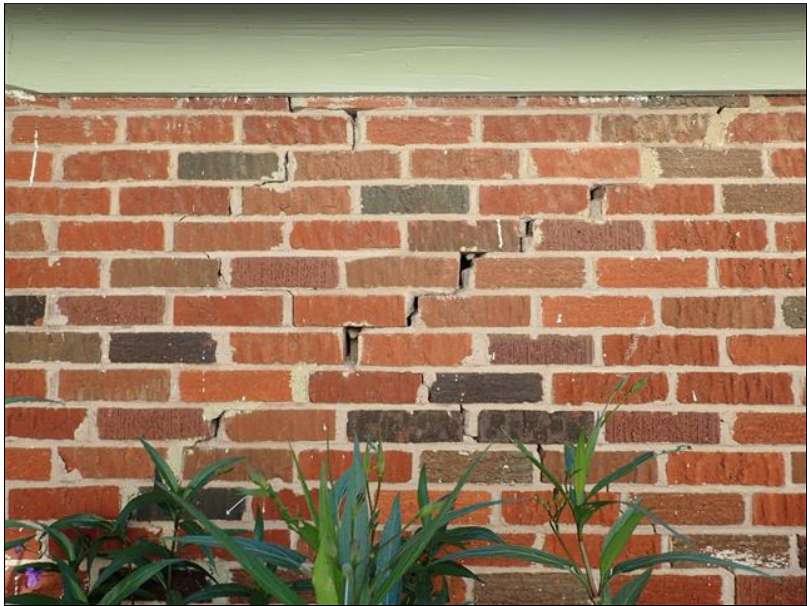
E. Item 19(Picture) North wall of garage

(9) North wall of garage had major cracking. There are several areas you can see completely through wall. Recommend qualified contractor repair wall to prevent further damage.

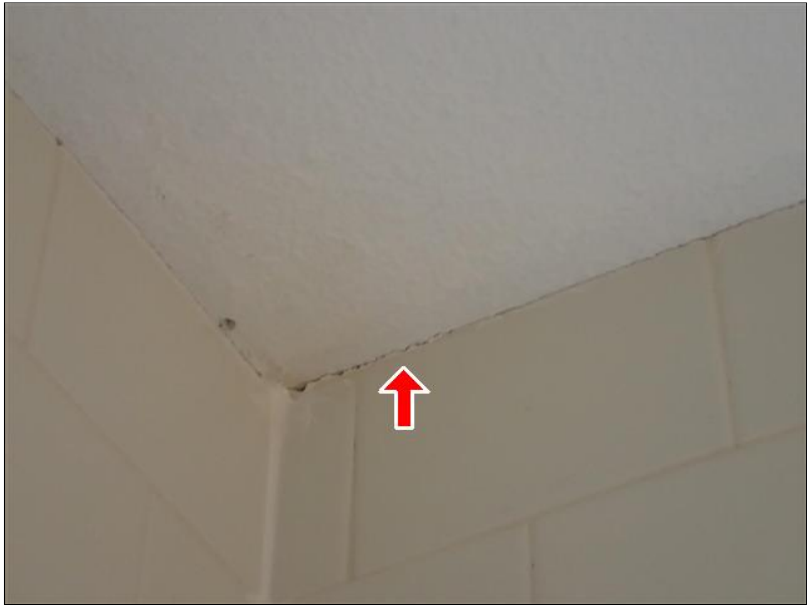
E. Item 20(Picture) Shower walls

(10) Several small area in the master shower need minor caulking at tile and wall to prevent water intrusion.

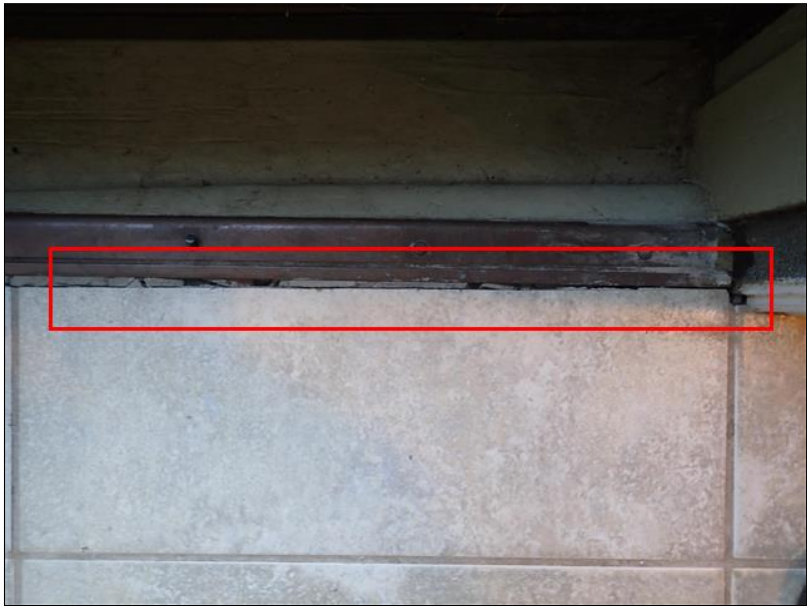
F. Item 1(Picture) Back door

(1) Tiles at the front door and backdoor have not been grouted at the threshold.

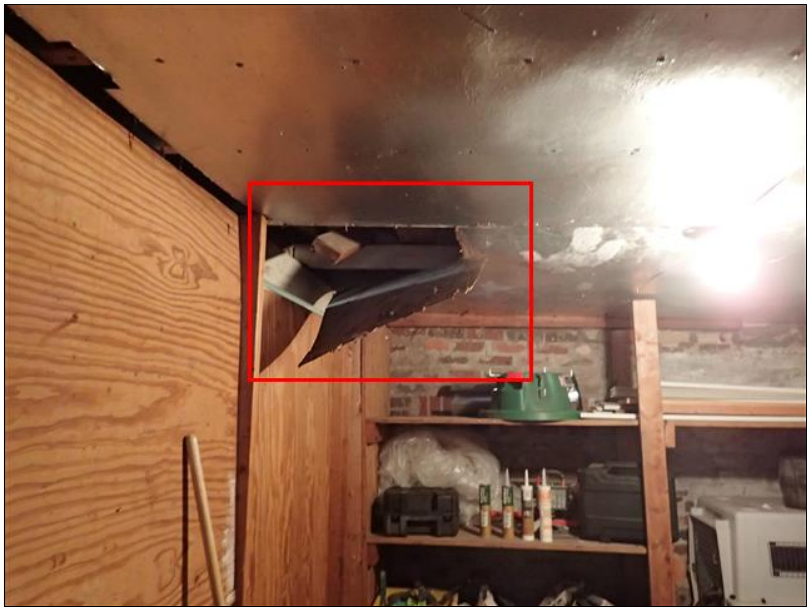
F. Item 2(Picture) Gsarage

(2) Ceiling in garage is falling down in storage area. Recommend qualified contractor make repairs.

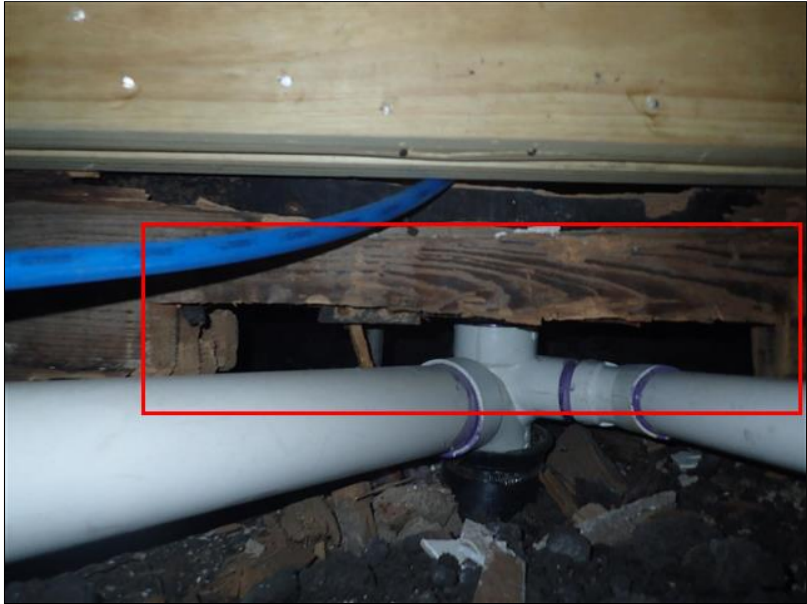
F. Item 3(Picture) Below hallway bathroom

(3) Improper notching has weakened joists visible in the crawlspace. The Inspector recommends a qualified contractor assesses and corrects if needed.

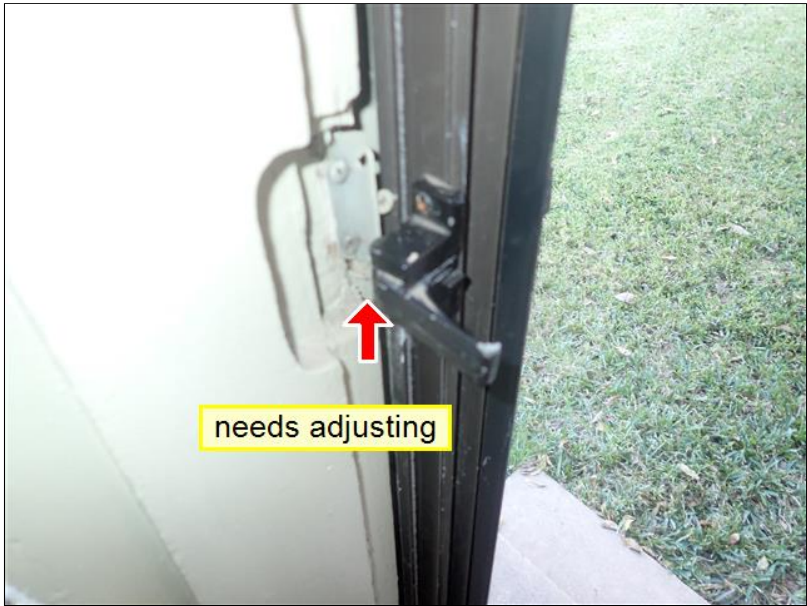
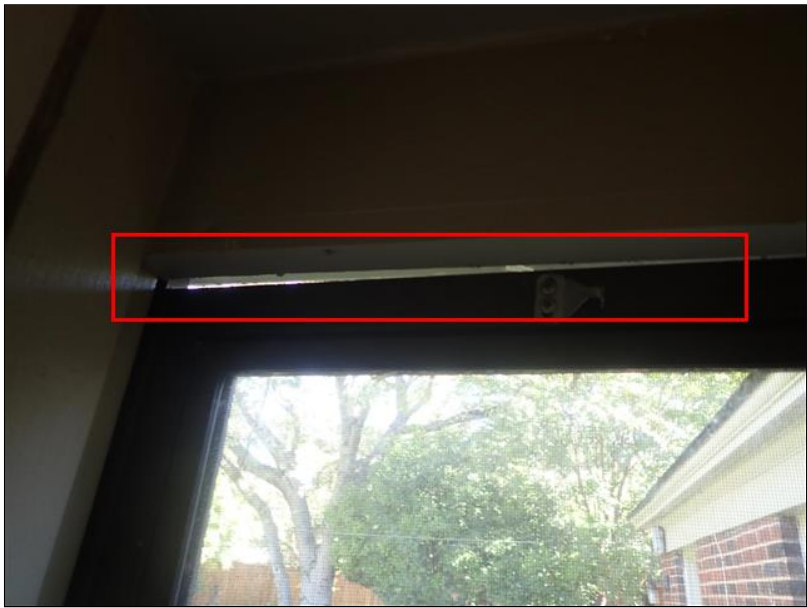
G. Item 1(Picture) Rear storm door

- (1)
- 1. Rear storm door does not latch
  - 2. Rear storm door does not seal correctly.

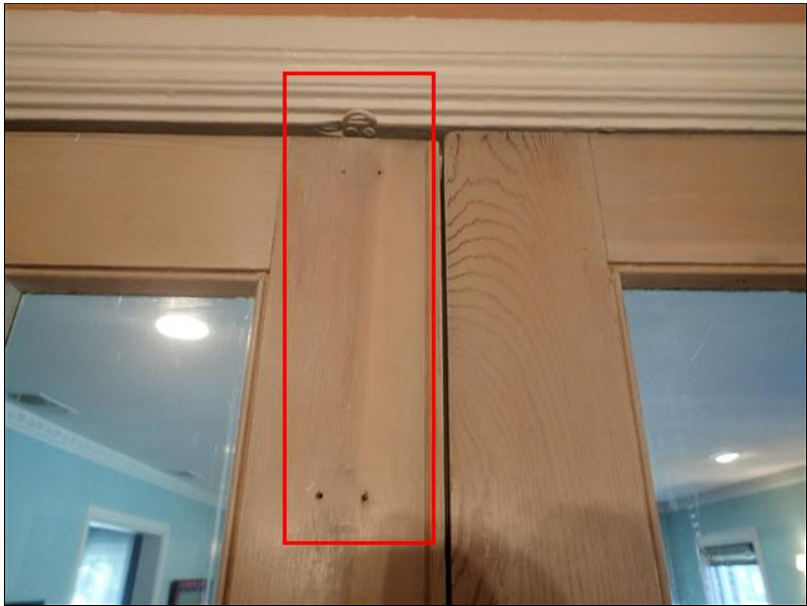
G. Item 3(Picture) Dining room door

(2) Doors between dining room and kitchen are missing latch assembly to hold door in place.

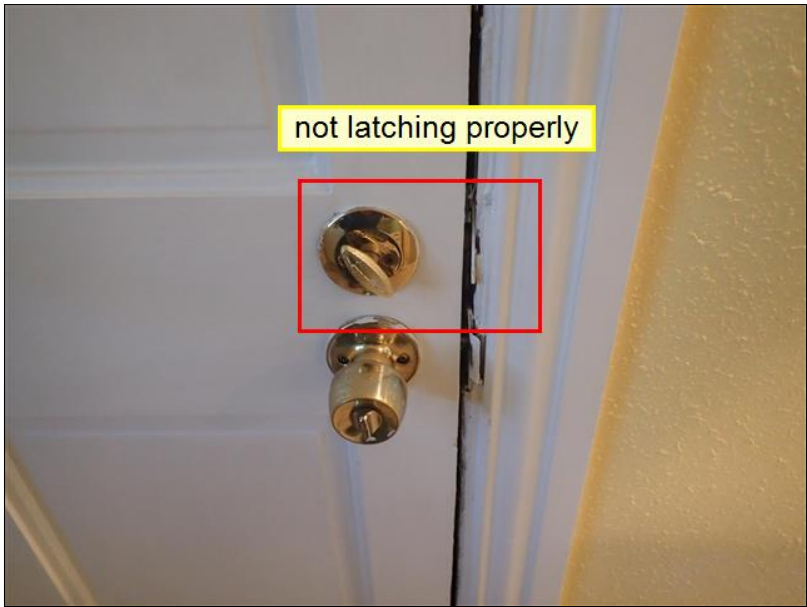
G. Item 4(Picture) Back door

(3) Dead bolts on front door, side door and back door all need to be adjusted to latch easily and fully.

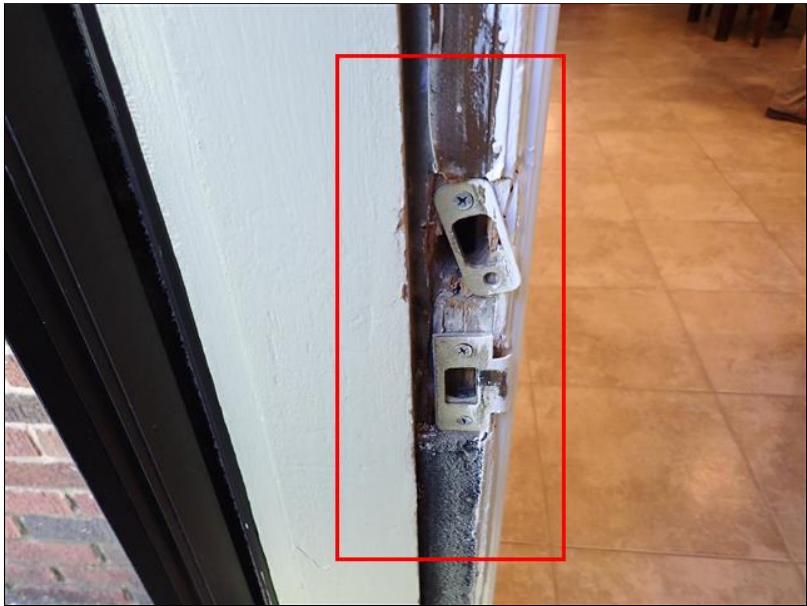
G. Item 5(Picture) Back door

(4) Door frame is damaged at the back door. Repair as needed.

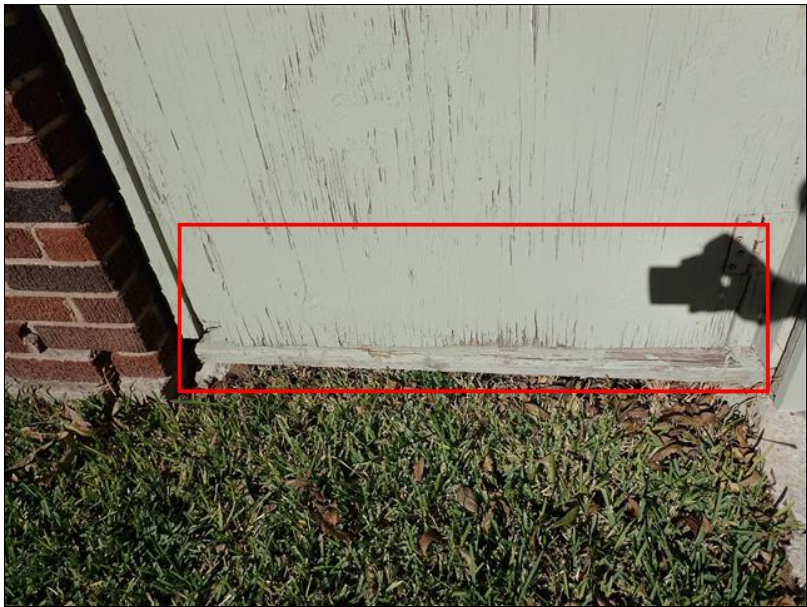
G. Item 6(Picture) Garage door

(5) Garage door is rotten along bottom edge.

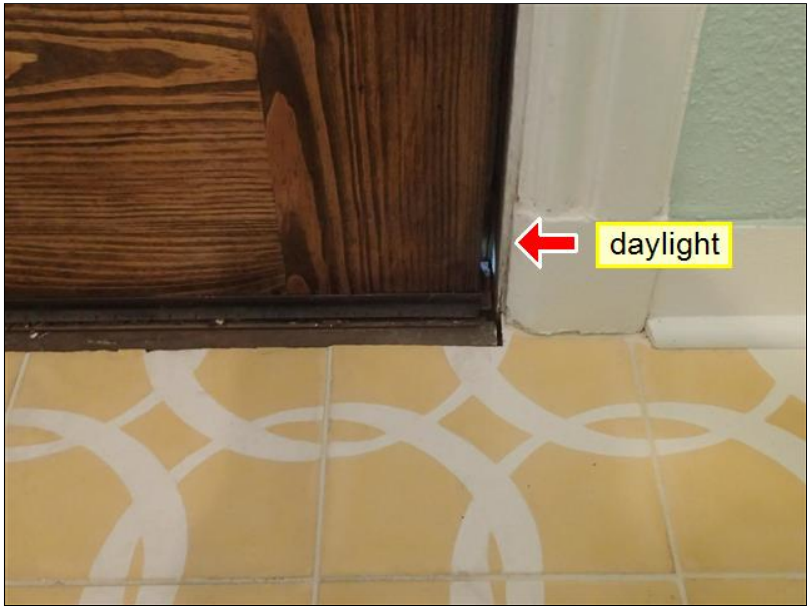
G. Item 7(Picture)

(6) Front door does not seal properly.

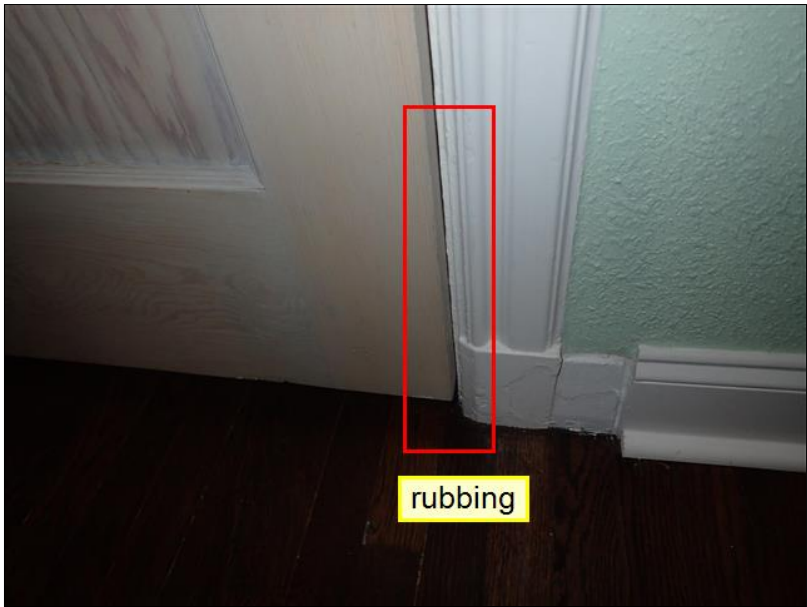
G. Item 8(Picture) East bedroom

(7) Multiple interior doors are rubbing on door frames. Recommend qualified contractor adjust.

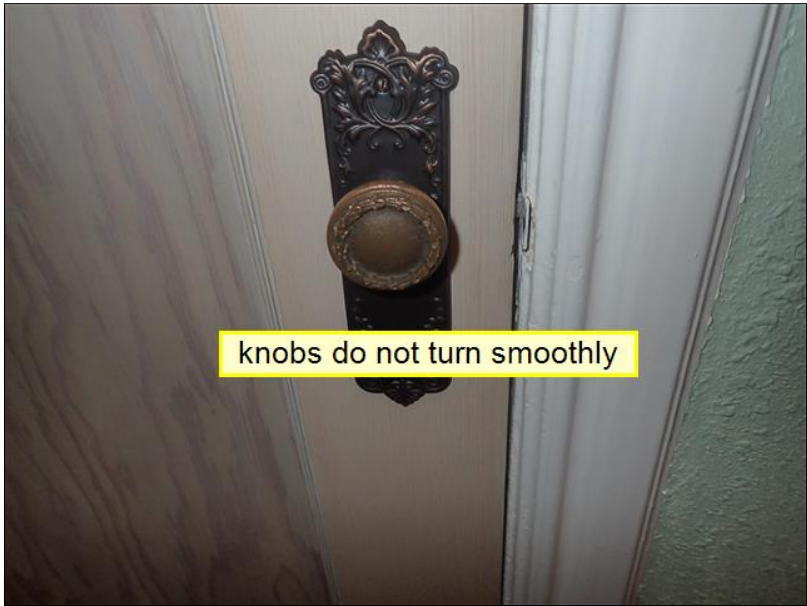
G. Item 9(Picture) bedroom

(8) Several door knobs are not turning easily. These are old and should be replaced at your desire.

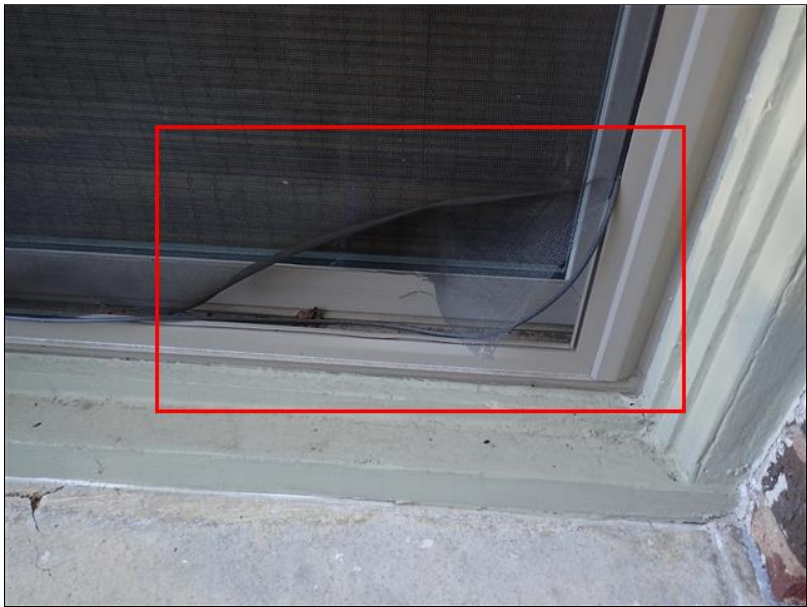
H. Item 1(Picture) East side window

(1) A few of the window screens were damaged at the time of the inspection and you may wish to have them repaired or replaced.

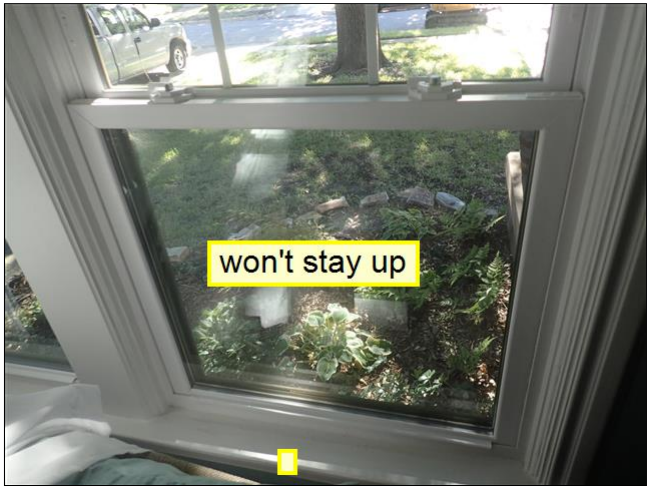
H. Item 2(Picture) Front living room

(2) Two windows one in the front living room and one in the master bedroom would not stay up on their own. Recommend qualified contractor repair as needed.

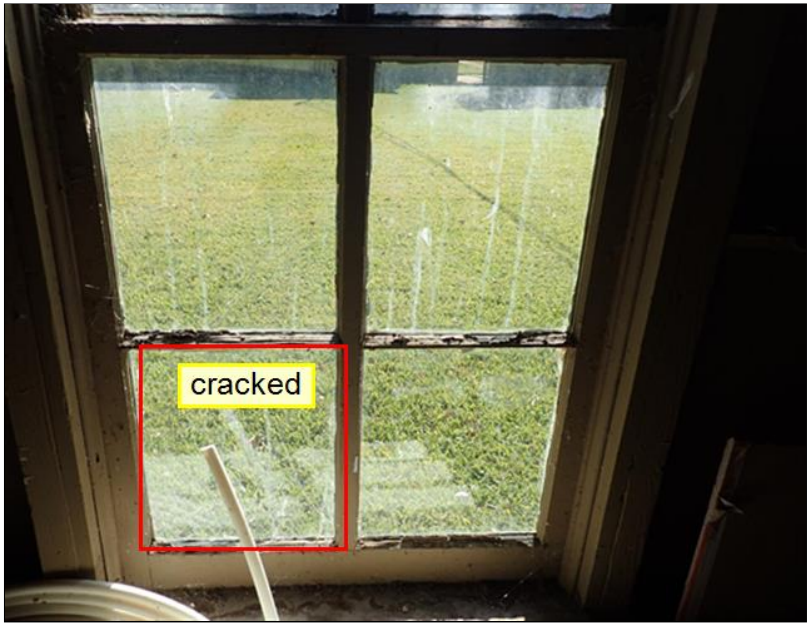
H. Item 3(Picture) South side garage

(3) Window on the south side of garage is cracked. This window is very old and does need other repairs also such as painting.

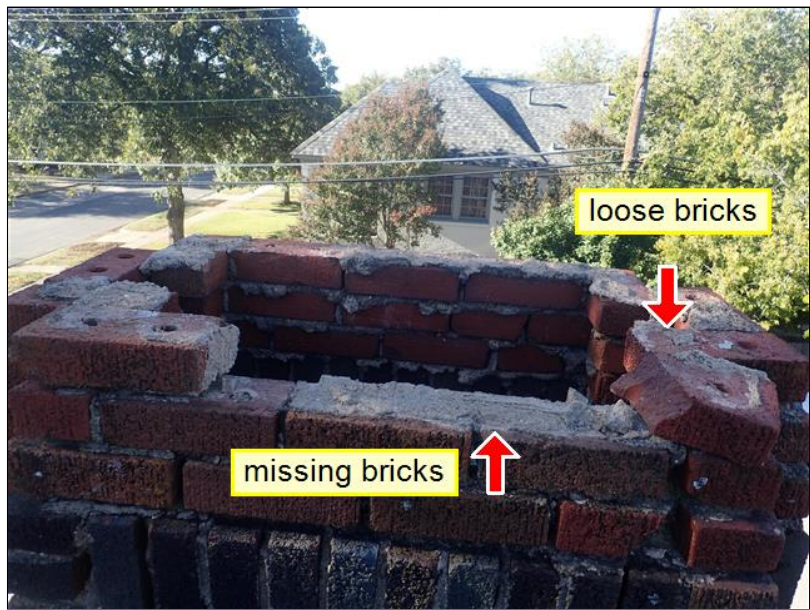
J. Item 1(Picture) Chimney

(2) The chimney had bricks missing at the time of the inspection. This condition may cause other bricks to fall if not corrected. Falling bricks may cause injury or death.

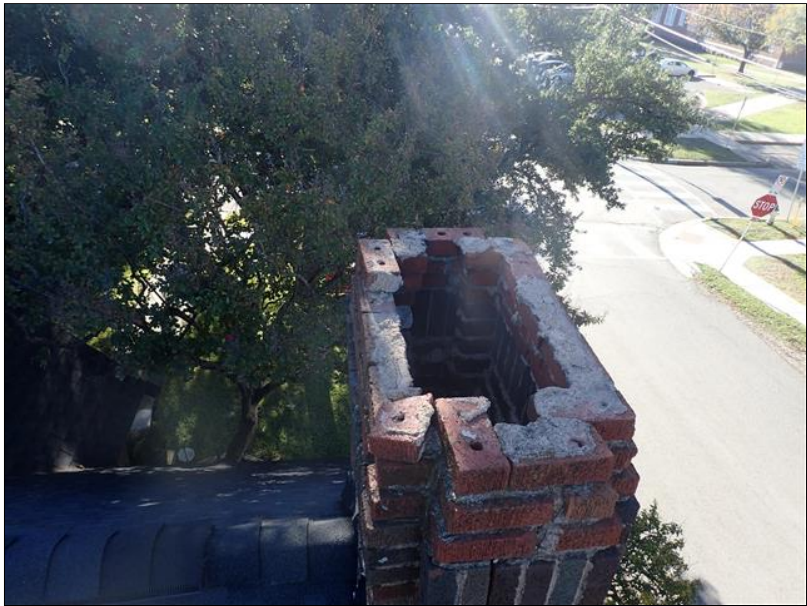
J. Item 2(Picture) Chimney

(3) No chimney cap was installed at the time of the inspection. A chimney cap should be provided to prevent moisture intrusion and freeze damage to the chimney structure.

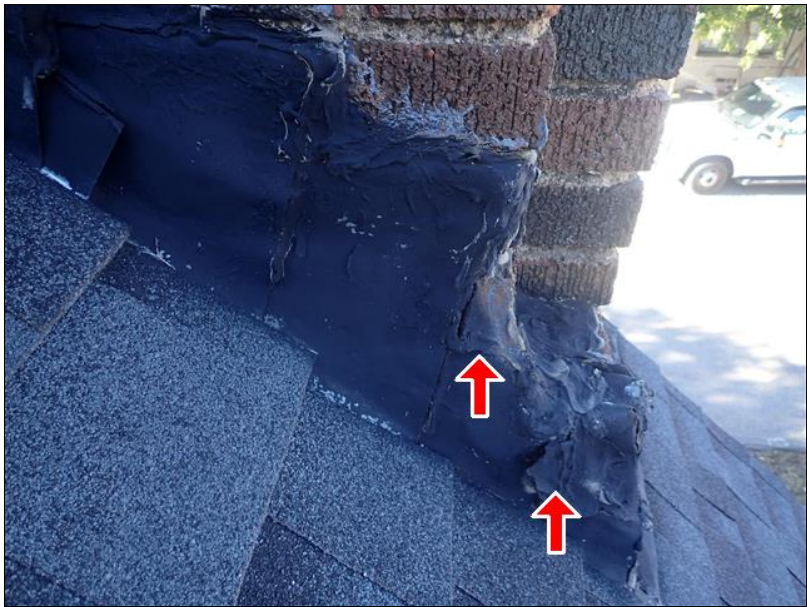
J. Item 3(Picture) Chimney flashing

(4) Chimney flashing needs to be resealed.
