# Inspection Report

**Property Address:**  
1234 No Where Ln  
Dallas TX 75214

# PROPERTY INSPECTION REPORT

1234 No Where Ln, Dallas, TX 75214

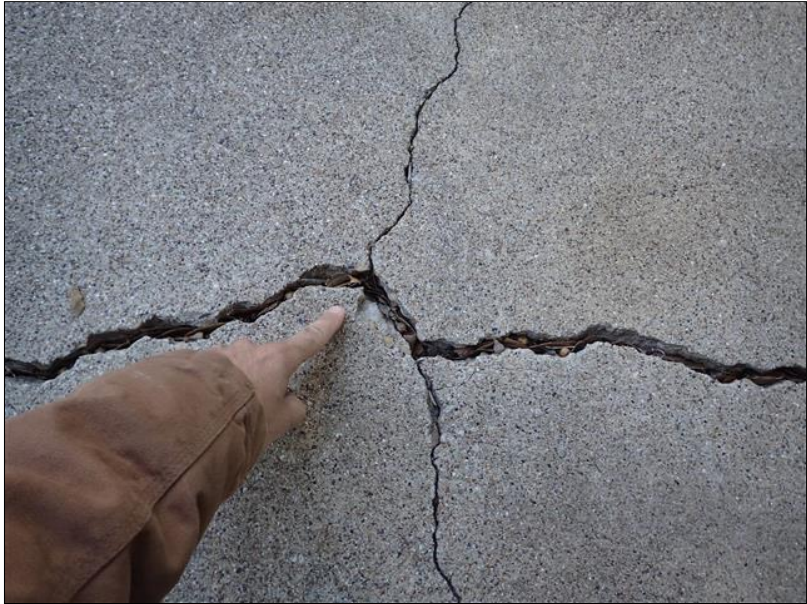
L. Item 1(Picture) Front drive way

(3) The concrete drive at the front of home deteriorated in areas. Further erosion or deterioration can occur if not corrected. A qualified contractor should inspect and repair as needed.

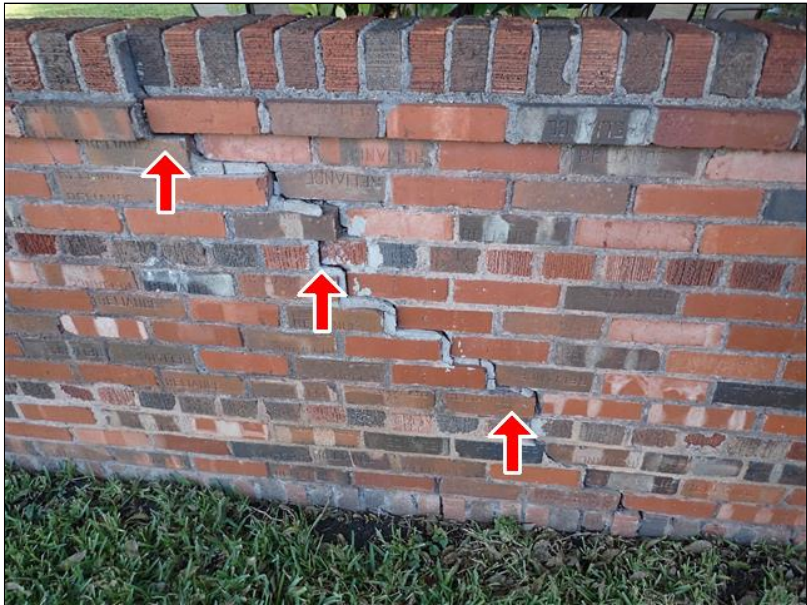
M. Item 1(Picture) East fence

(1) Stepped cracking was visible in areas of the brick fence at the time of the inspection. The Inspector recommends that the cause of cracking be determined by a qualified contractor and corrected and that existing cracks be patched to avoid damage from freezing water.

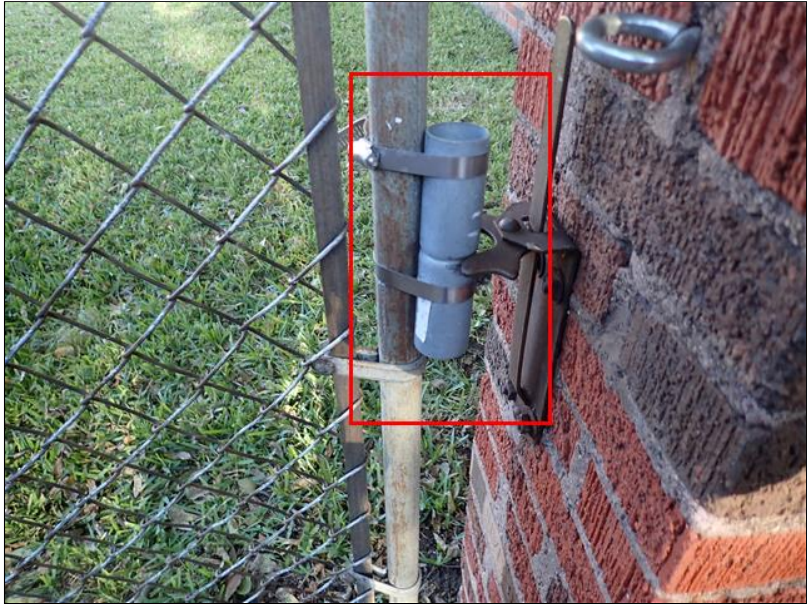
M. Item 2(Picture) East side of home

(2) East gate has had some repairs, gate opens but can be difficult.

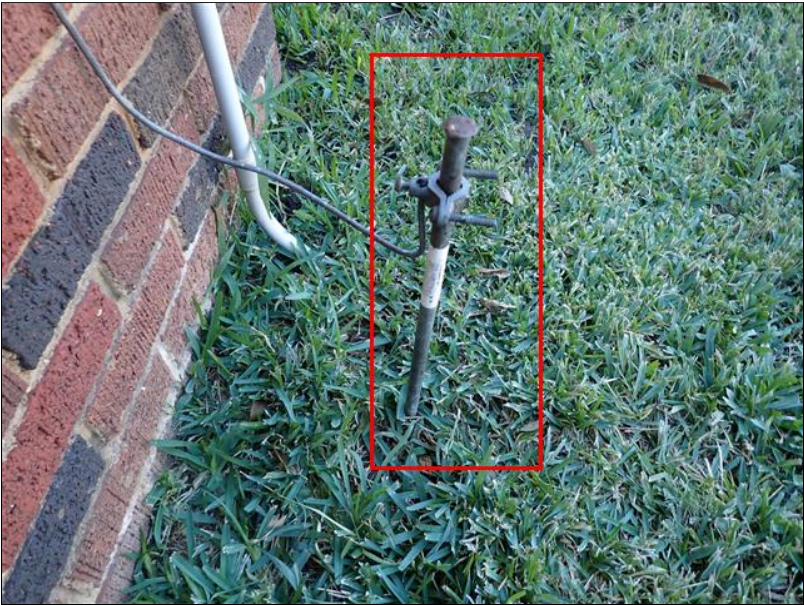
A. Item 1(Picture) North side of home

(1) The main electrical service Grounding rod was not completely driven. Although this condition is common, it can reduce the effectiveness of the service grounding device.

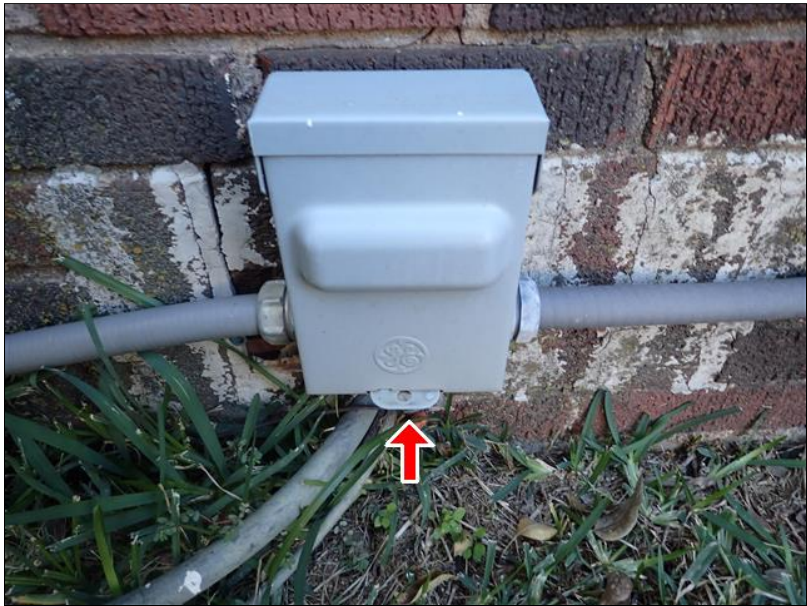
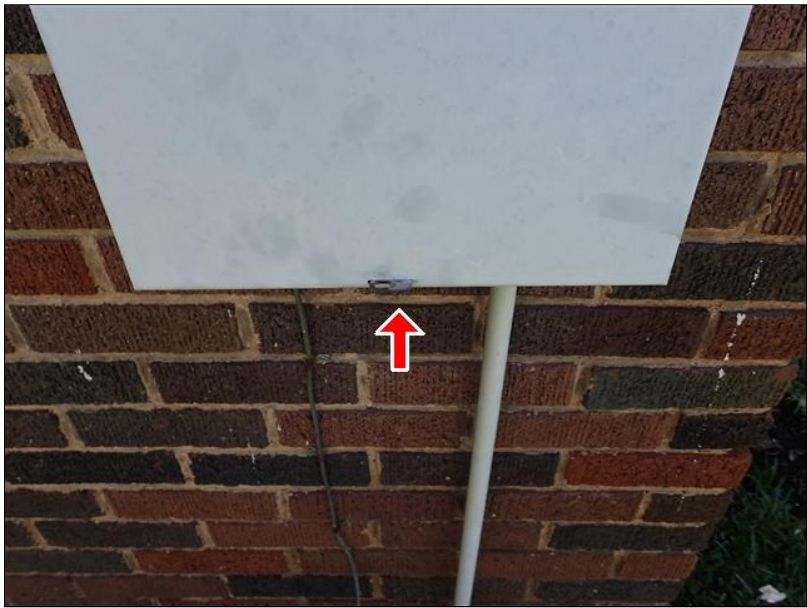
A. Item 3(Picture) Main Panel

(2) Recommend locks for all exterior electrical panels.

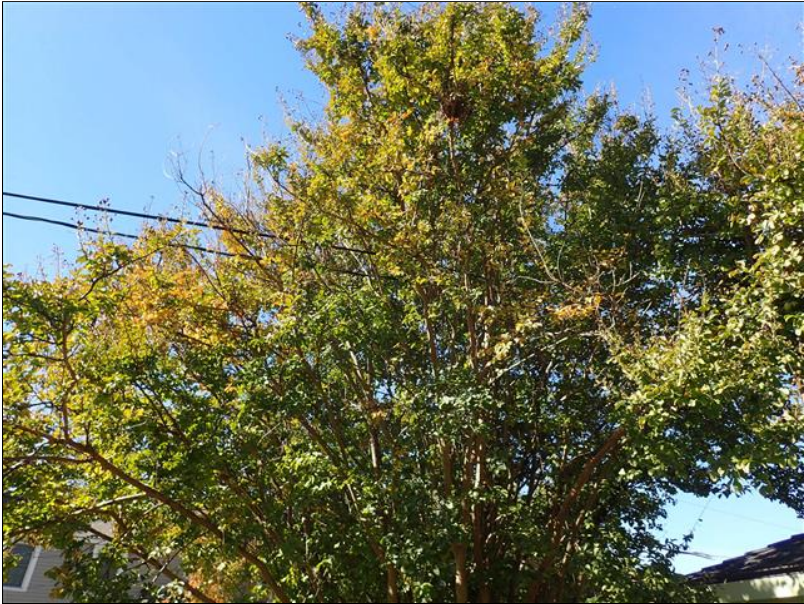
A. Item 4(Picture) Service to home

(3) Service entrance to home is in direct contract with trees. Recommend notifying appropriate person to make repairs.

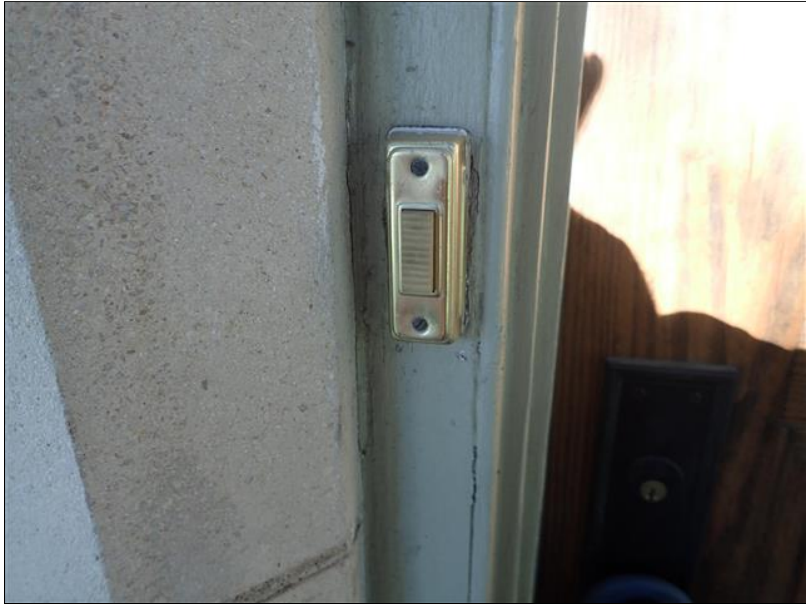
B. Item 1(Picture) Front door

**Type of Wiring:** Romex  
**Branch wire 15 and 20 amperage:** Copper  
**Comments:**  
(1) Doorbell is not working.

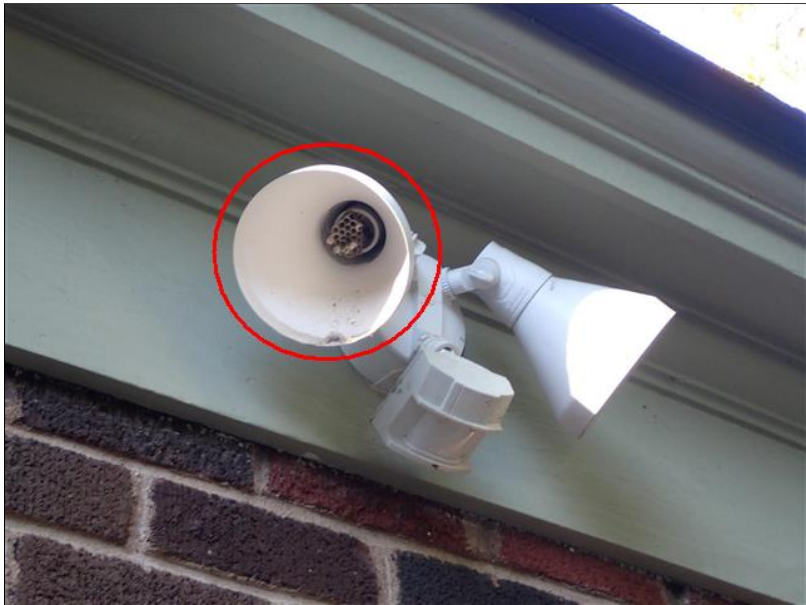
B. Item 2(Picture) N/E corner of home

(2) Some light fixtures in the home appeared to be inoperable. The bulbs may be burned out, or a problem may exist with the fixtures, wiring or switches. If after the bulbs are replaced, these lights still fail to respond to the switch, this condition may represent a potential fire hazard, and the Inspector recommends that an evaluation and any necessary repairs be performed by a qualified electrical contractor.

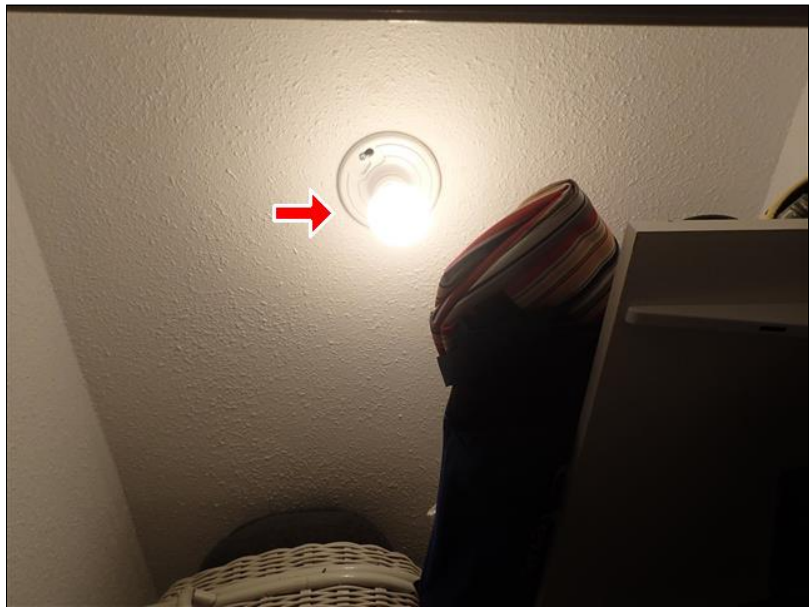
B. Item 3(Picture) Bedroom closet

(4) Incandescent lights mounted on the bedroom closet ceilings in this bedroom was too close to a shelf. This condition may result in personal injury from damage to the bulb or may be a potential fire hazard. The Inspector recommends that this condition be corrected by a qualified electrical contractor.

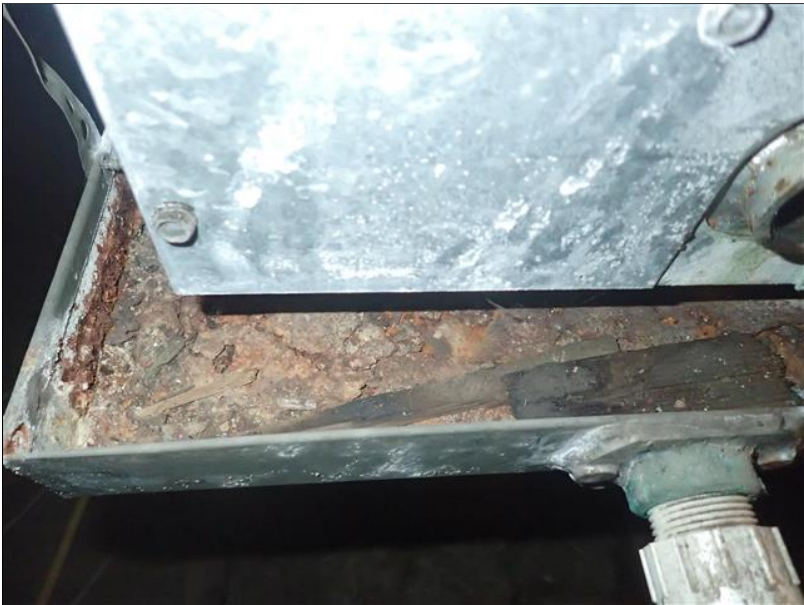
B. Item 4(Picture) Attic A/C unit

(2) The emergency condensate drain pan under the indoor EVAP coil housing has a rust build-up. This indicates that the pan has held water in the past and should be closely monitored. Rust and/or debris may be partially clogging the condensate drain lines. The primary and secondary drain lines should be flow checked and cleaned if necessary as well as being checked for proper termination by qualified HVAC technician.

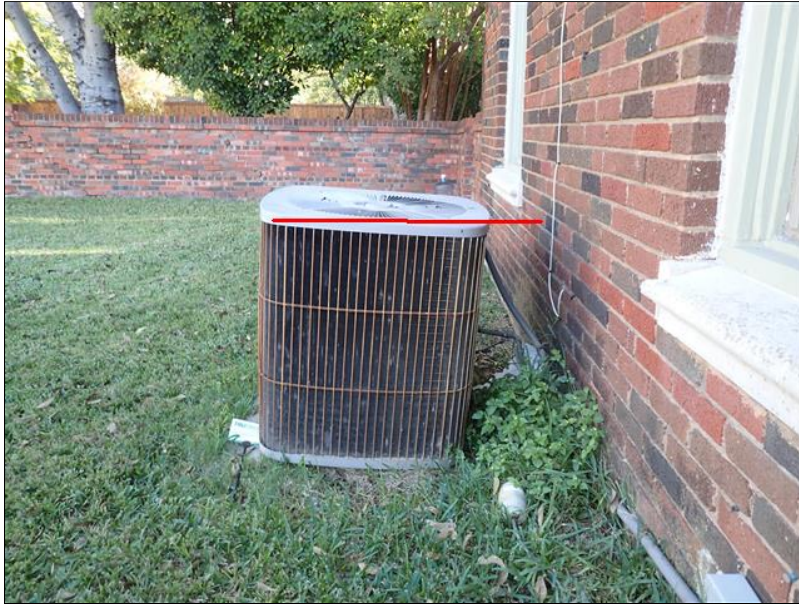
B. Item 5(Picture)

(3) The pad supporting the air-conditioner compressor housing was not level. Over time, this may result in damage to the fan bearings and a shortened fan lifespan, or it may result in movement of the compressor housing which can cause leaks in refrigerant lines resulting in expensive service.

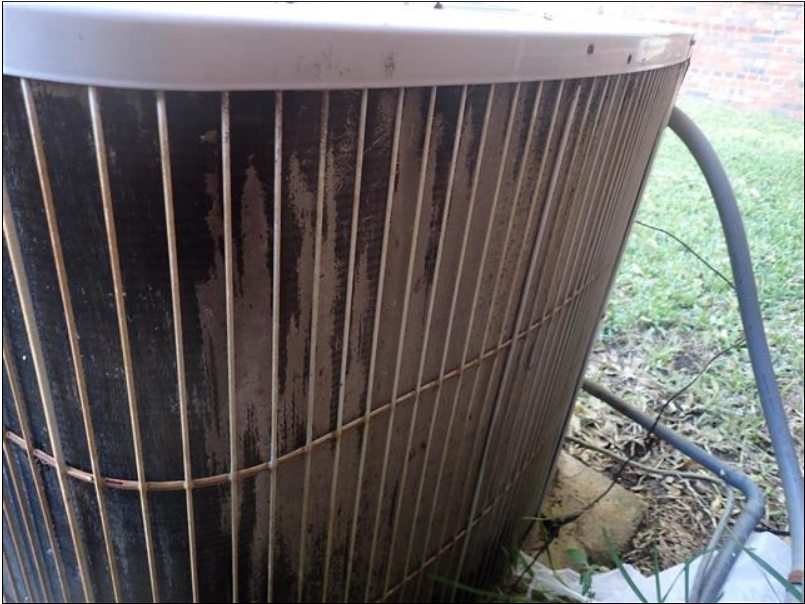
B. Item 7(Picture) A/C unit, north side

(5) The fins of the air-conditioner condensing coil were slightly corroded and the coil should be cleaned and evaluated by a qualified HVAC technician.

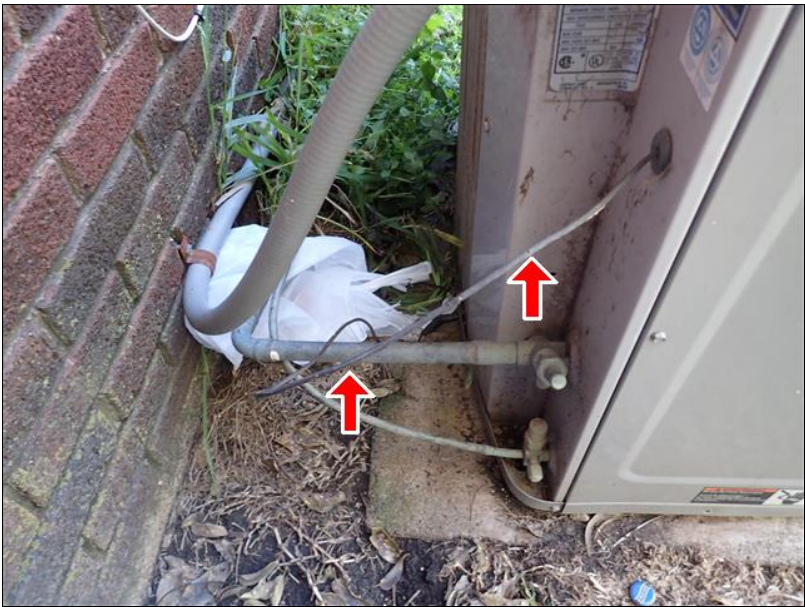
B. Item 8(Picture) A/C thermostat wire, north side

(6) Thermostat wire on condenser needs to be protected in conduit or by other means.

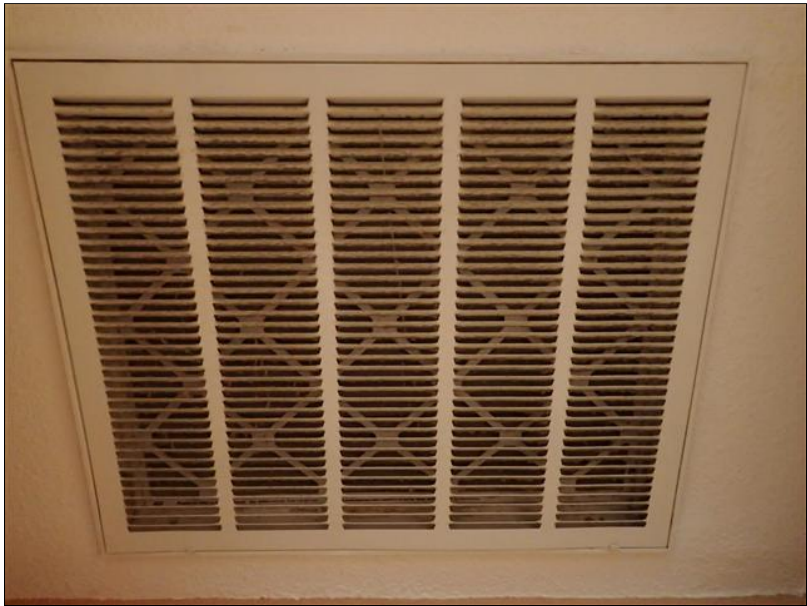
B. Item 9(Picture) A/C filter

(7) The disposable filter is clogged and is dirty. The filter needs to be replaced.

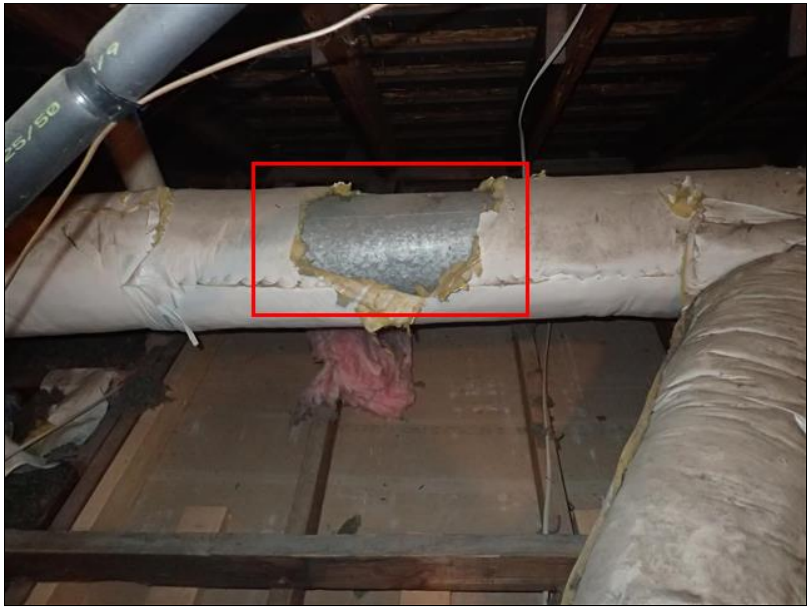
C. Item 1(Picture) Attic

HVAC duct work in attic has multiple area of failing duct insulation. Recommend qualified HVAC technician repairs.

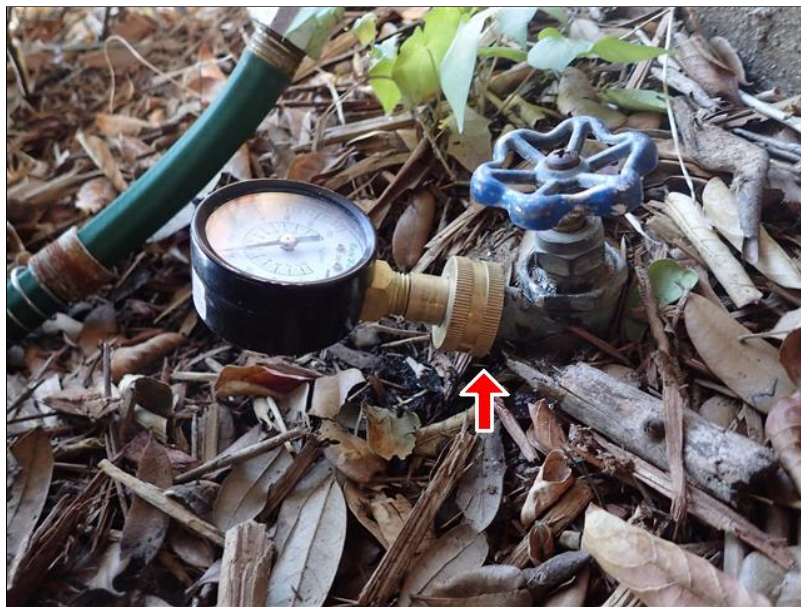
A. Item 1(Picture) Front of home

- (1) Outdoor faucet at the N/E corner of home did not have water supply.
- (2) Outdoor facets are missing anti siphon devices. Recommend repair as needed.

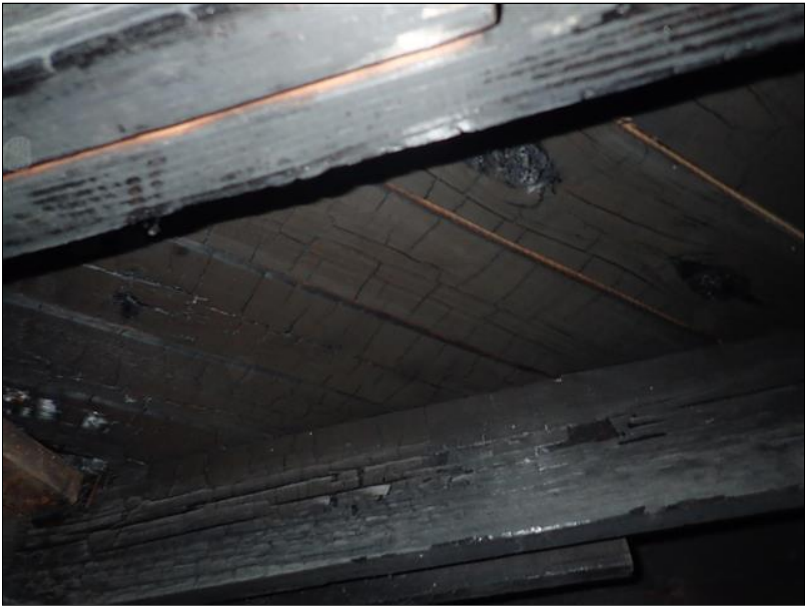
B. Item 2(Picture) Area below Kitchen/Dining

The Inspector recommends this area be evaluated by a structural engineer to determine whether structural components weakened by fire retain sufficient residual strength. Depending on the engineers recommendation you may need to consult with a qualified contractor to gain an idea of options and costs for any necessary repairs.

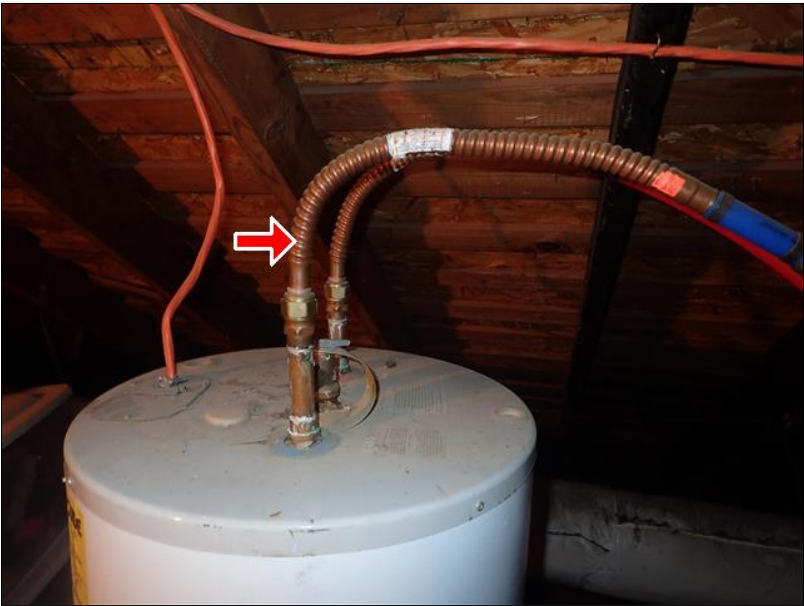
C. Item 1(Picture) Attic

**Comments:**  
(1) The copper water lines to water heater should be insulated.

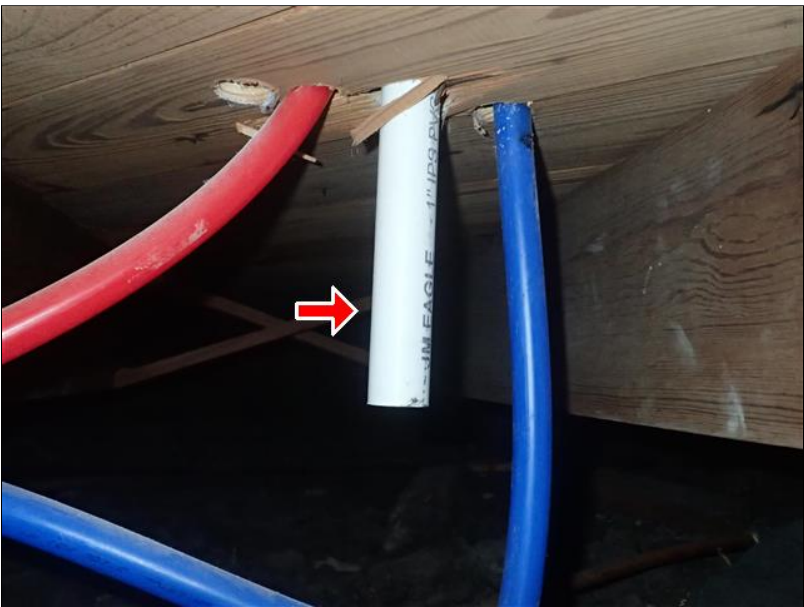
C. Item 2(Picture) Hot water heater pan drain line

(2) Hot water pan drain line empties to the crawl space. Recommend this drain be moved to the exterior home to prevent water from entering the crawl space.

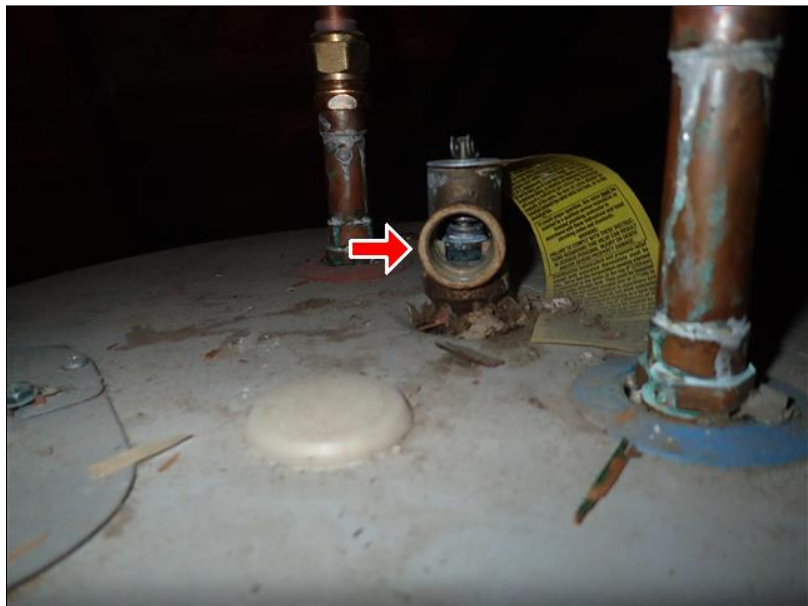
C. Item 3(Picture) Hot water heater, attic

(3) The pressure relief valve on the water heater did not have a discharge pipe.

A discharge pipe from the relief valve should be installed by a qualified plumbing contractor to safely and properly route any discharge to a floor drain or the home exterior.

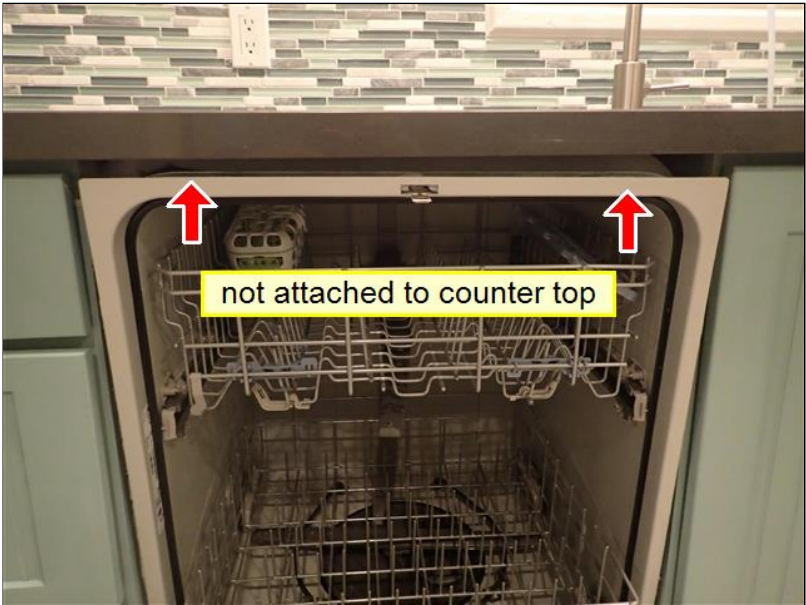
A. Item 1(Picture) Dishwasher

(1) The dishwasher is loose and needs securing to underside of countertop (using a proper length screw). I recommend repair as necessary.

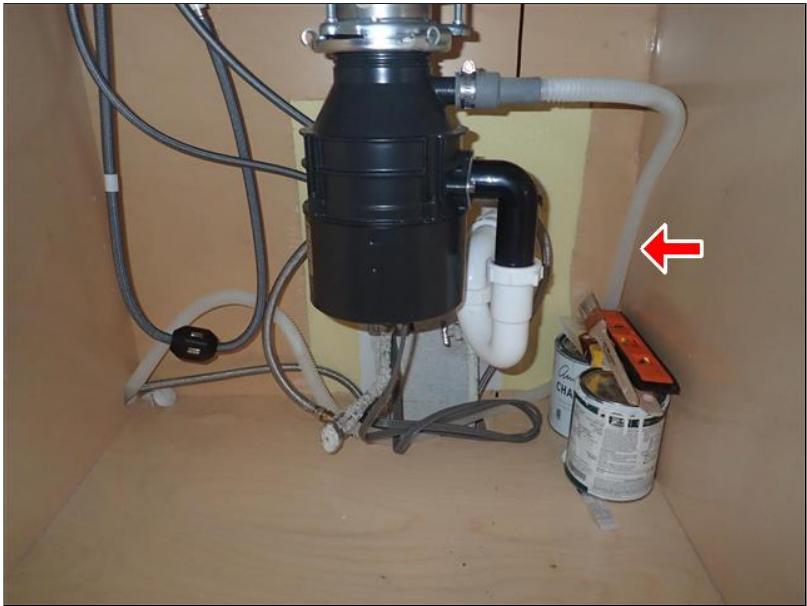
A. Item 2(Picture) Dishwasher drain

(2) Unable to test dishwasher, water was not turned on to dishwasher. There is no loop in the drain hose from dishwasher.

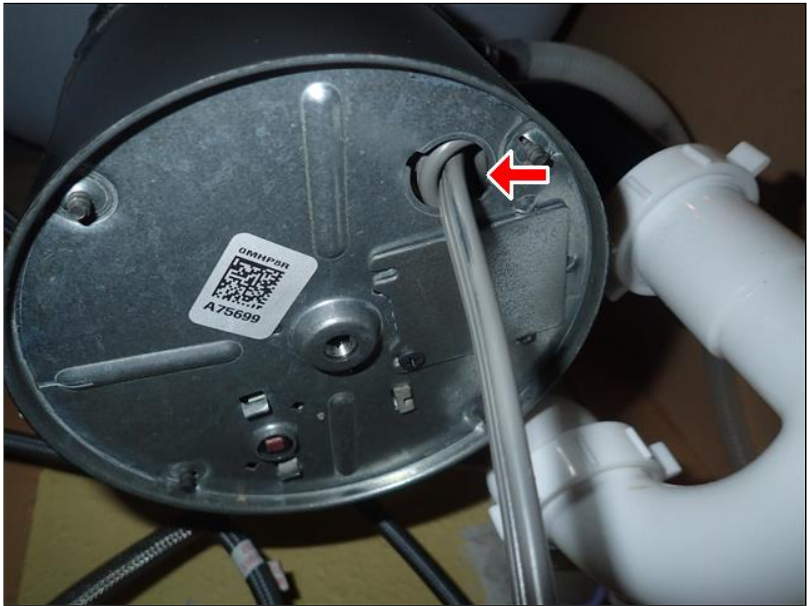
B. Item 1(Picture) Garbage disposal

Comments:  
The food disposer wiring is missing a romex connector (anti-strain device). I recommend repair as needed.

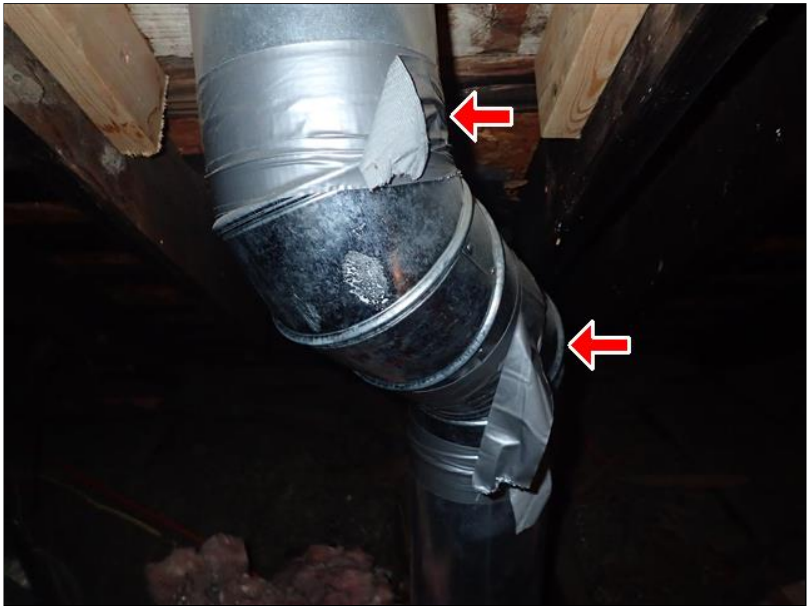
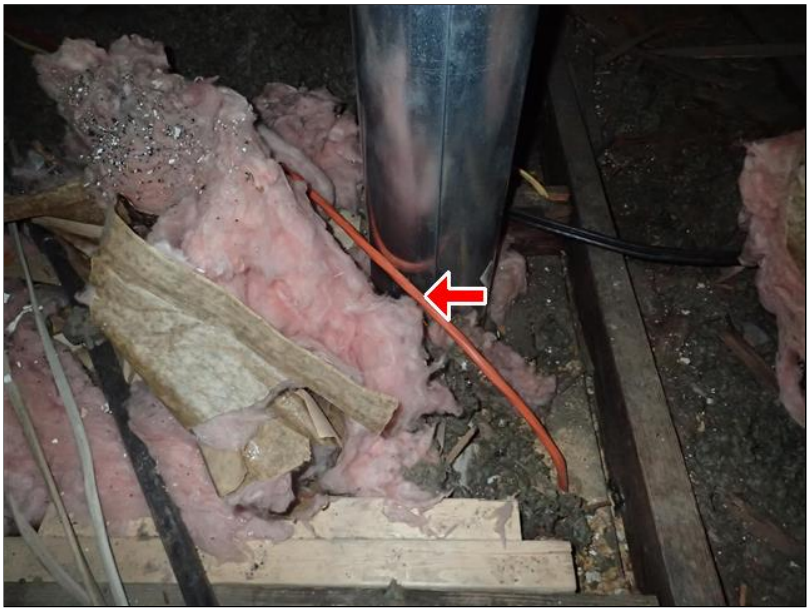
C. Item 1(Picture) Range exhaust pipe, attic

Comments:  
Range exhaust vent pipe in attic has multiple joints secured with duct tape. Debris is piped up against exhaust pipe. Recommend clearing this area. Recommend qualified contractor assess vent pipe for proper connections.

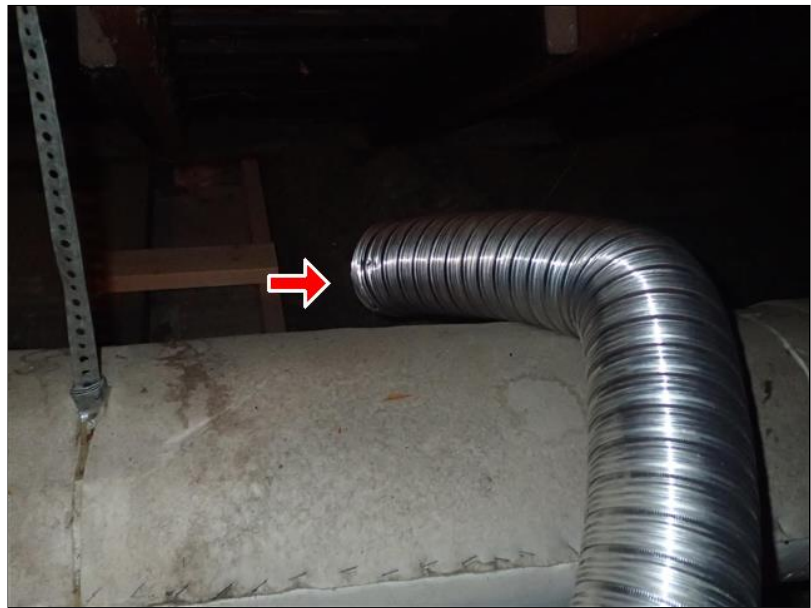
F. Item 1(Picture) Bathroom exhaust vent, attic

moisture vapor levels in the attic to the point at which home materials are damaged or unhealthy conditions related to mold develop. The Inspector recommends correction by a qualified contractor.

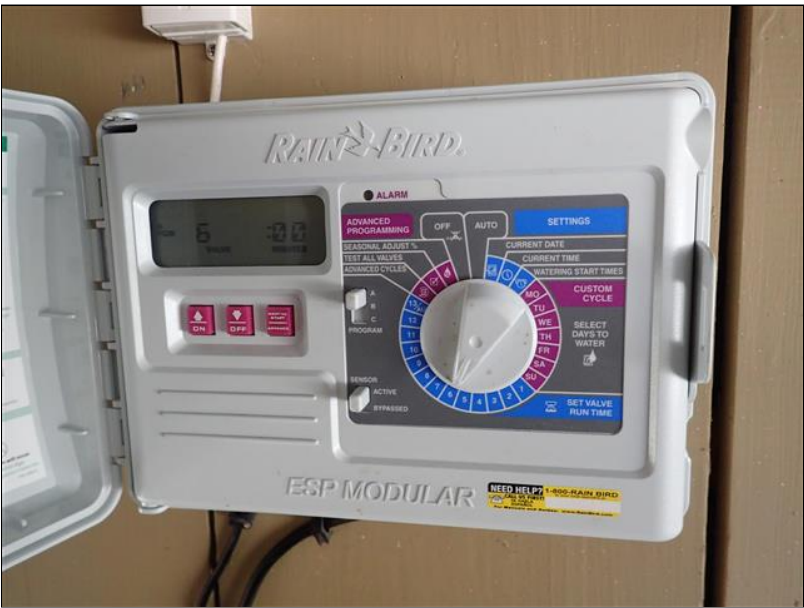
A. Item 1(Picture)

Comments:  
Sprinkler head not performing as intended. Several heads in the back yard need adjusting, they are not spraying in correct direction. Several zones in the front of home would not activate at the time of inspection. Recommend qualified irrigation specialist make repairs.
